**RE: Our Client: Shawn E, Martin**  
**Our File No.: SFL-VJX-QCJ**  
**Subject: Concerns Regarding Construction Project**  
**Address: 1760 NW 73<sup>rd</sup> Avenue, Plantation, FL 33313-4433**

## Exhibit T2 – Structural Drainage Flaw & Strategic Implications

## **Exhibit T – Unauthorized Furring Strips & Missing Insulation at Omega Villas**

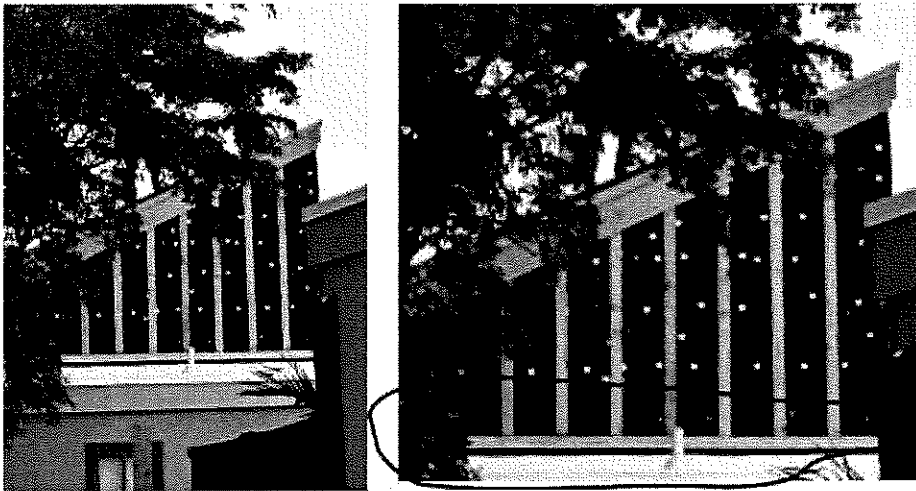
The images below shows furring strips installed over black weather-resistant barrier (WRB) with a horizontal trim board or framing element placed directly at the base of the wall assembly. This board, circled in red, completely blocks gravity-based drainage — preventing water from escaping the wall cavity.

This appears to be a major design flaw. It may transform the vertical drainage plane into a sealed chamber, where any water that seeps behind the siding becomes trapped.

According to building envelope science and Florida Building Code (FBC) Ch. 7 (R703), proper siding installation requires:

- Drainage pathways or weep holes
- Flashing at terminations
- Proper WRB integration with flashing

- A minimum 1/8" ventilation gap if furring strips are used for rainscreening

**None of these elements are visible here.**

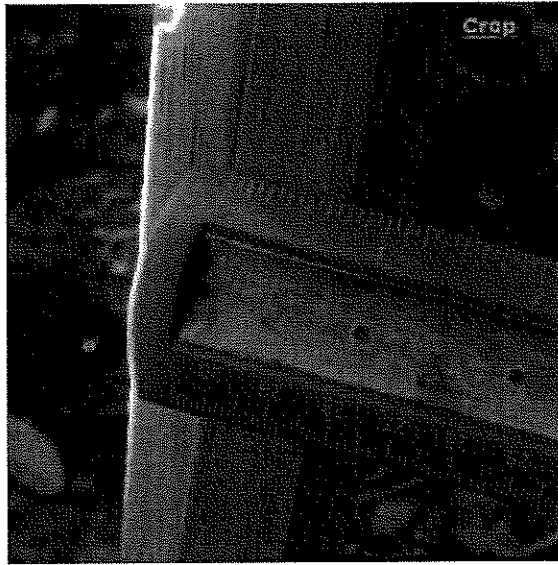
This exhibit documents the unauthorized installation of wall-mounted furring strips observed on May 2, 2025, at Unit Building 10, Unit #48 in Omega Villas. These furring strips have also been documented on the second-floor roofs throughout Phases 1, 2, and 3 of the subdivision, supported by both photographic evidence and multiple witness testimonies from affected unit owners. The furring strips are not approved in the \$4.85 million Austro Construction contract signed on January 17, 2023, which only permits 1x2 furring strips for fascia support. The image below confirms a 1x2 furring strip being used vertically on siding structures.

- Figure 1 – Photo taken May 2, 2025, showing 1x2 furring strip with ruler for scale:

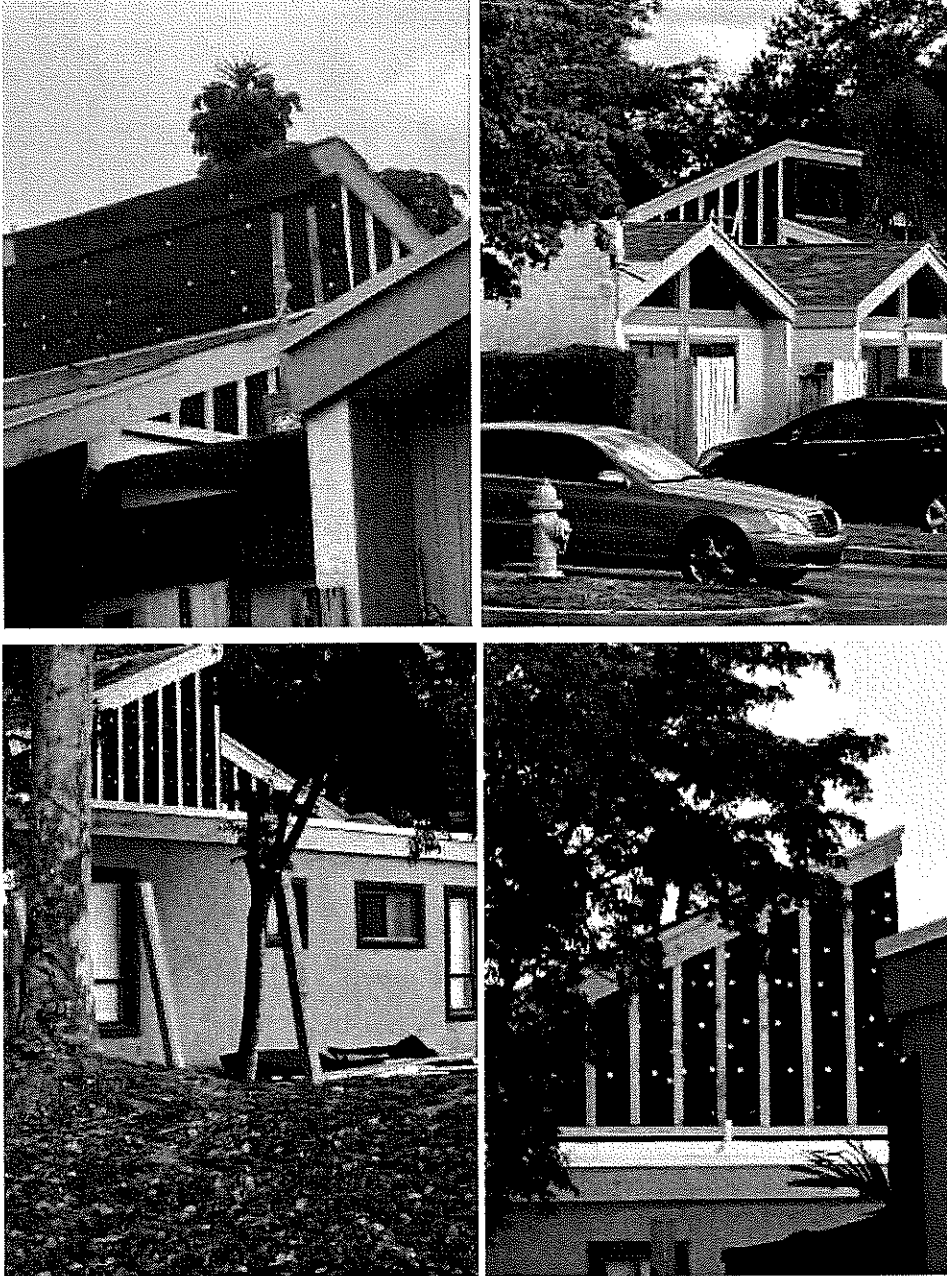
**Figure 3: Furring Strips Installed On My Home, Other Phase 2 & Phase 1 Buildings**

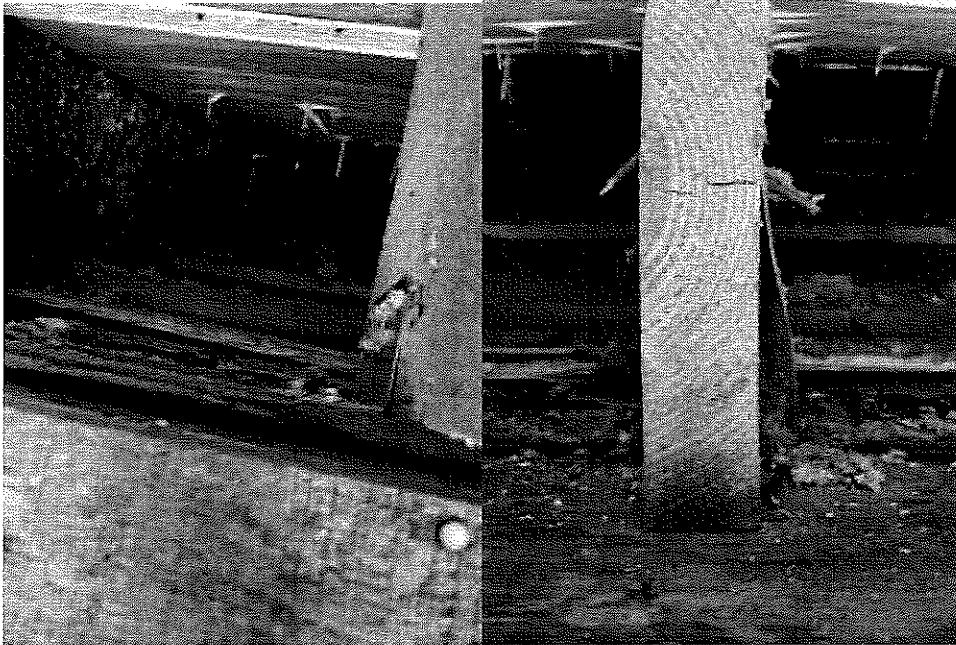
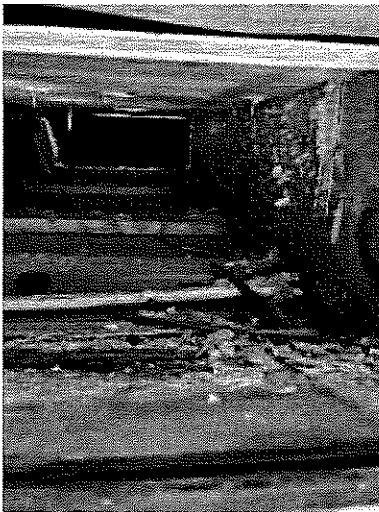
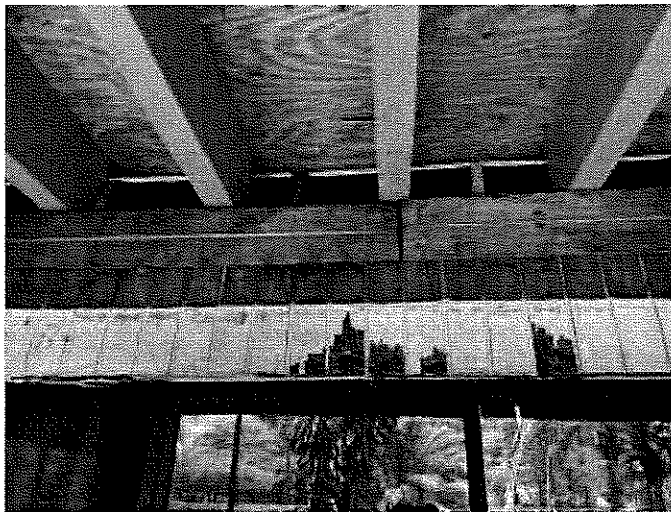
Video and photographic evidence confirms that multiple second-floor roof sections across Phases 1–3 were reconstructed without required roof insulation. The insulation void was discovered through access panel footage recorded by the whistleblower, and corroborated through personal inspection of Unit #48 in Phase 2. This omission violates Florida Building Code insulation standards and materially alters the community’s energy efficiency, comfort, and long-term HVAC lifespan.

**Figure 2: May 2<sup>nd</sup>, 2025 - Images Of Missing Roof Insulation On Whistleblower's Unit**

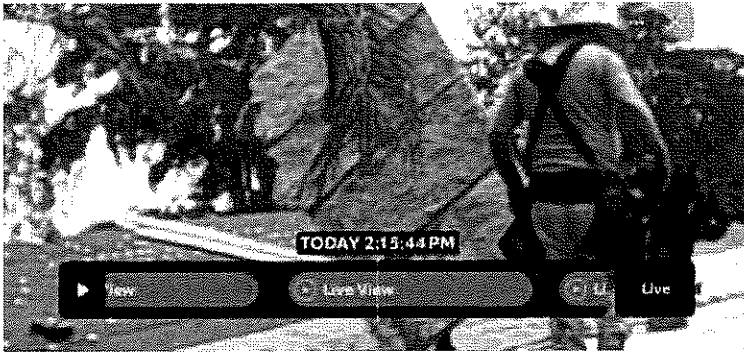
**Figure 2.1: April 30<sup>th</sup>, 2025 - Images of Removal of Roof Insulation On Whistleblower's Unit**
