# Omega Villas Condominium Association

1713 NW 72 Avenue,  
Plantation, FL 33313

## **Windows Evaluation Report** (04/03/2025)

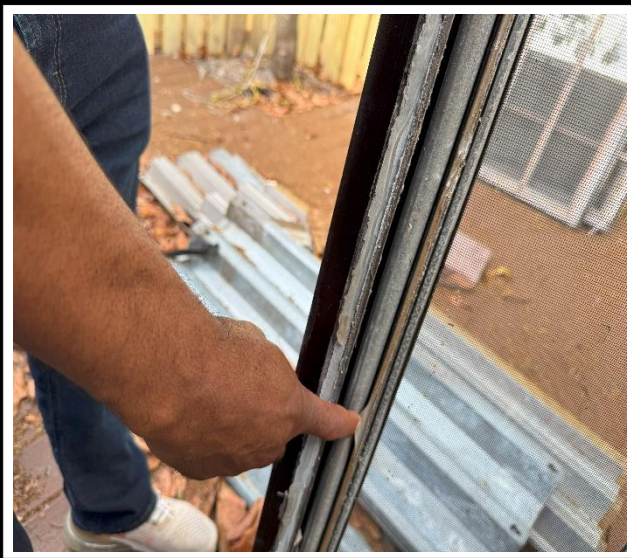
Photo 1 : Bad Weather Strip

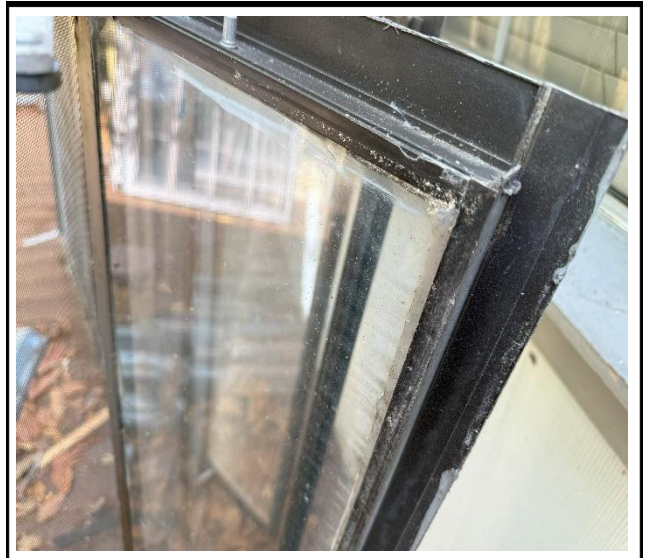
Photo 2 : Bad Seal

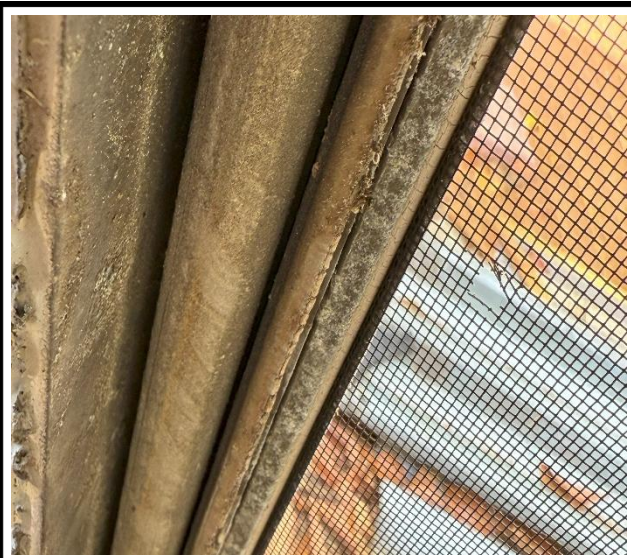
Photo 3 : Bad Weather Strip

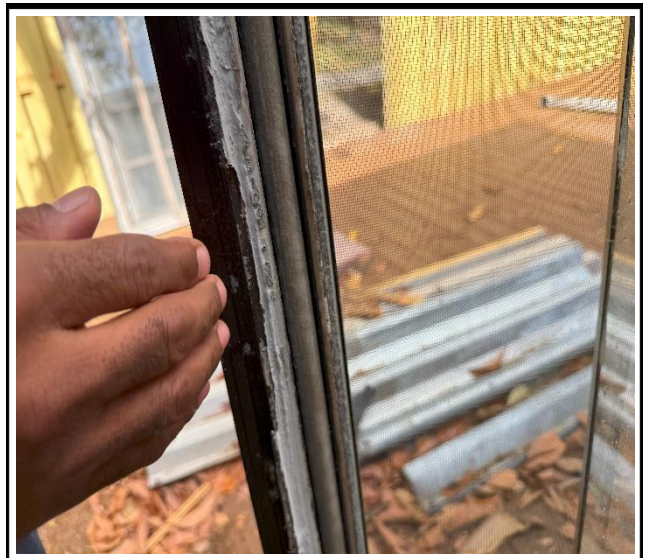
Photo 4 : Bad Weather Strip

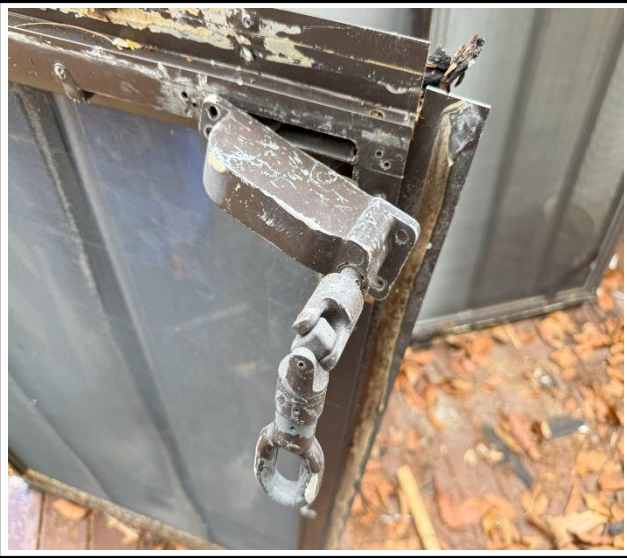
Photo 1 : Bad Latch

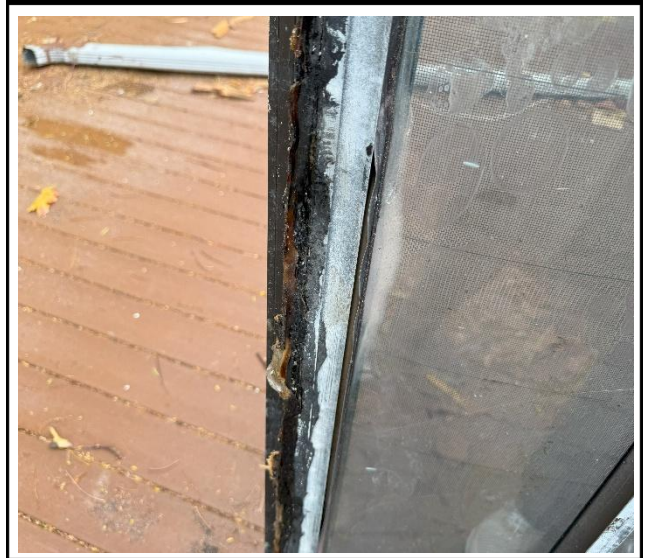
Photo 2 : Bad Weather Strip

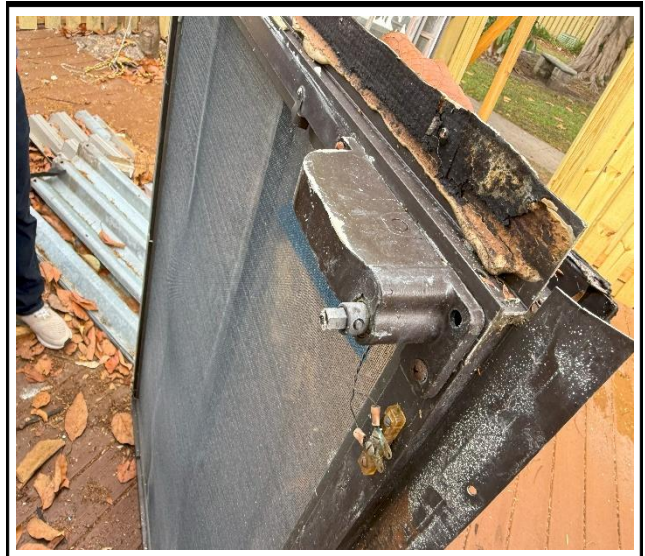
Photo 4 : Bad Latch

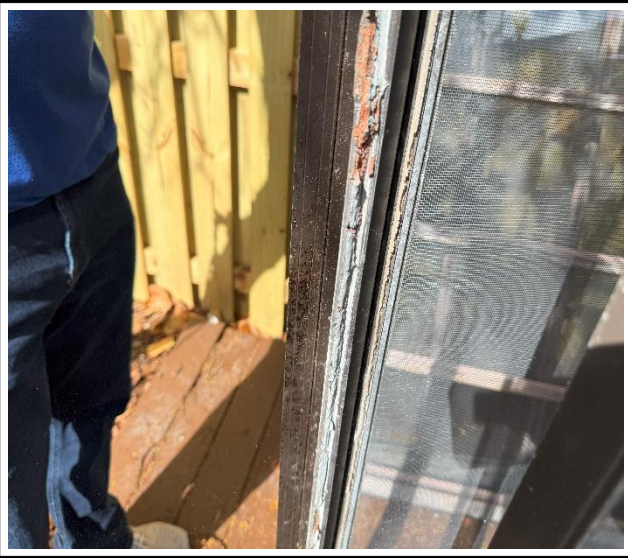
Photo 1 : Bad Weather Strip

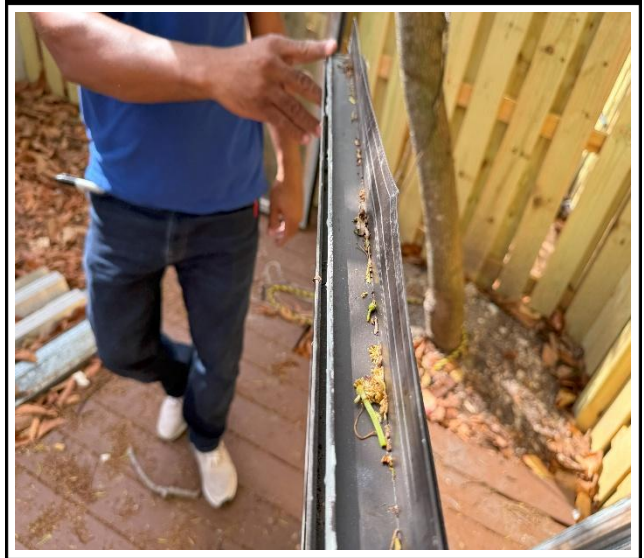
Photo 2 : Bad Frame

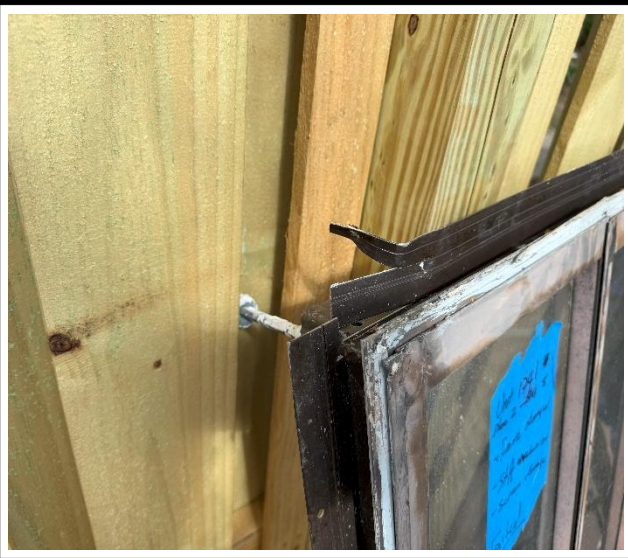
Photo 3 : Bad Frame

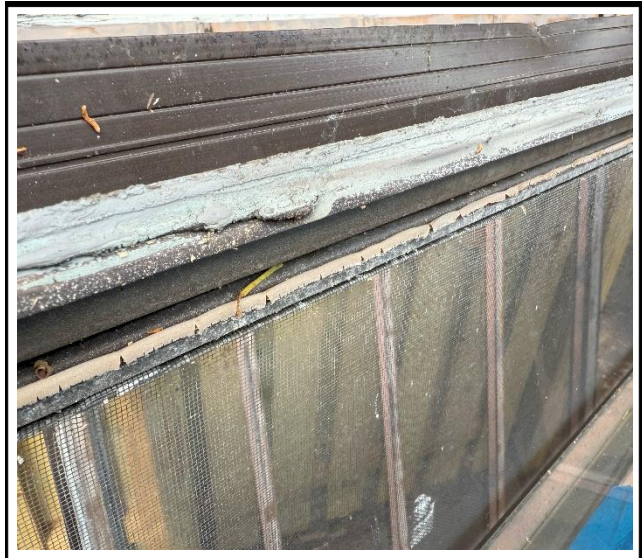
Photo 4 : Bad Weather Strip

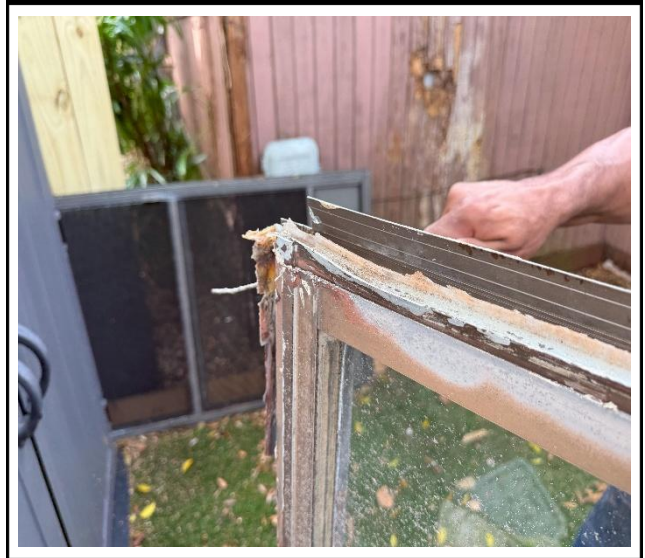
Photo 2 : Bad Frame

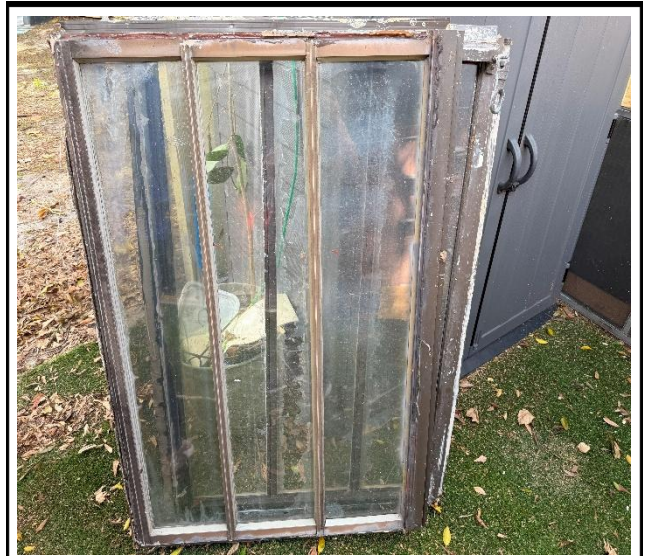
Photo 4 : Bad Frame

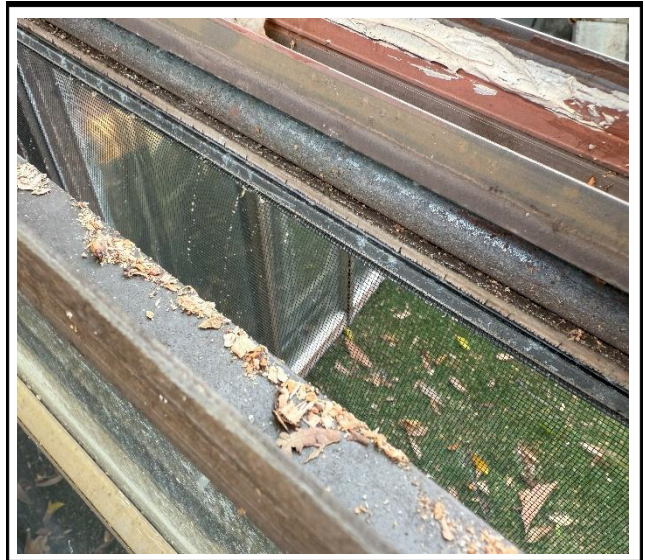
Photo 2 : Bad Weather Strip

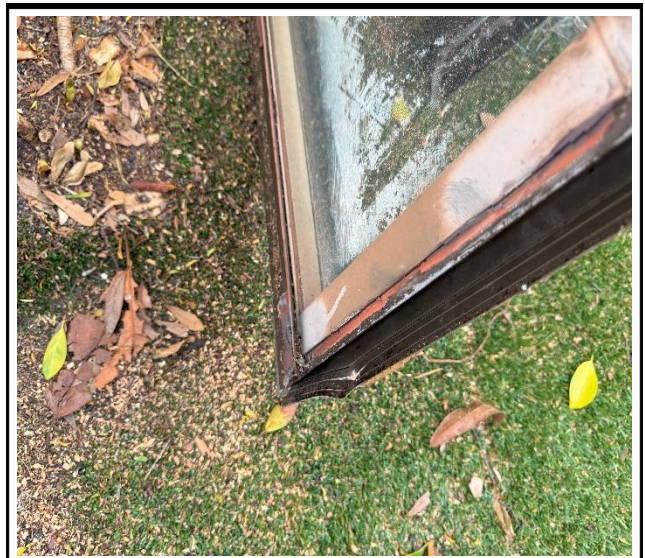
Photo 4 : Bad Frame

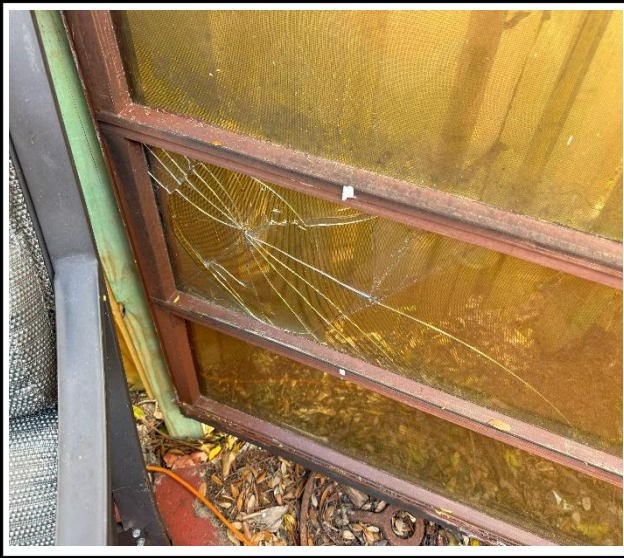
Photo 1 : Broken Glass

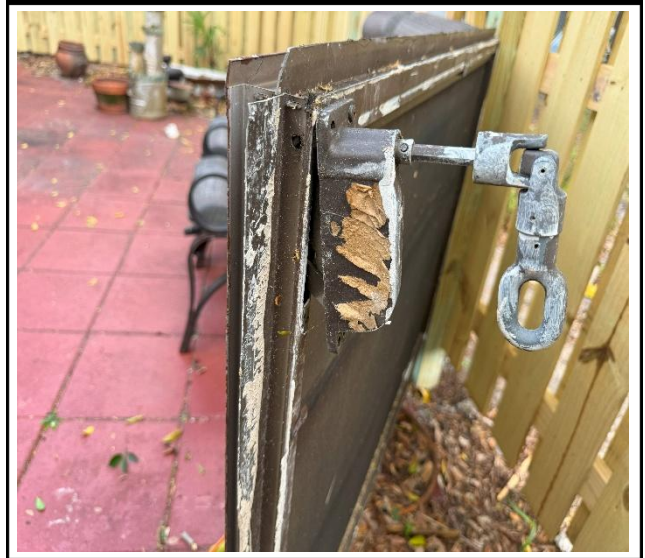
Photo 2 : Bad Latch

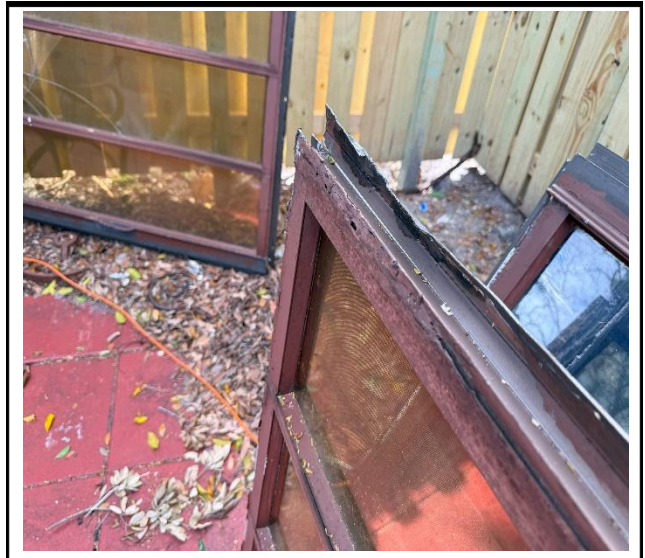
Photo 4 : Bad Frame

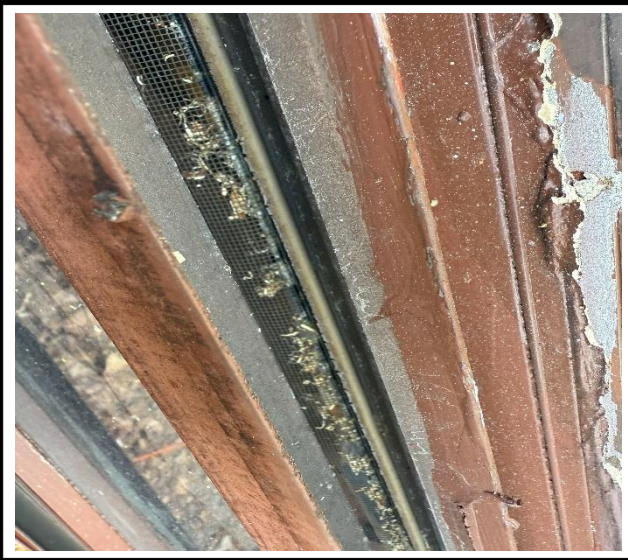
Photo 1 : Bad Weather Strip

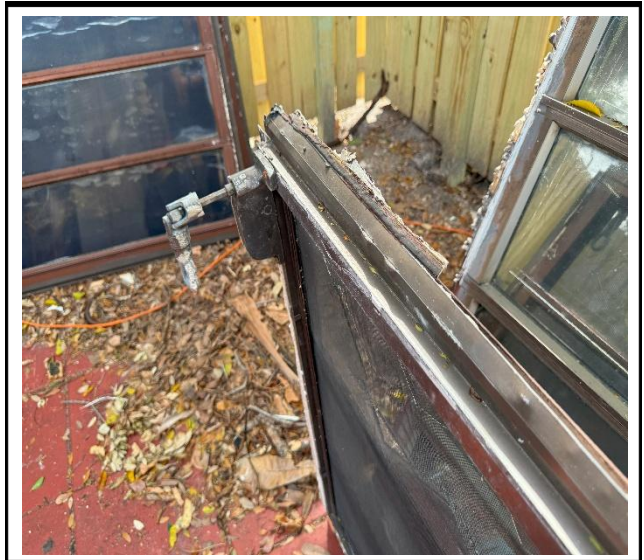
Photo 2 : Bad Frame

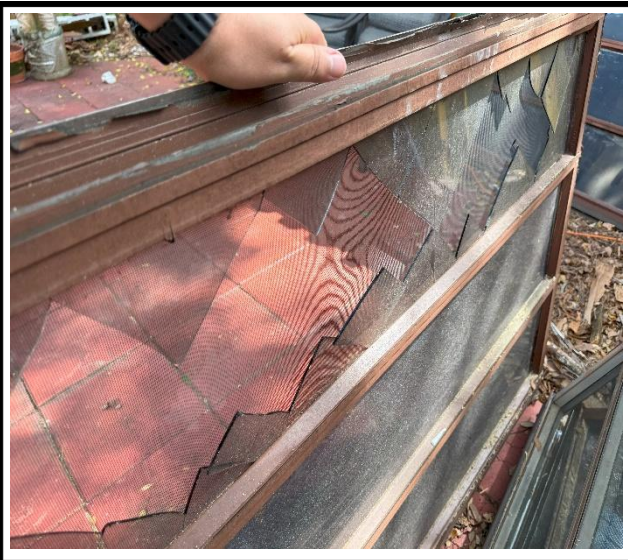
Photo 3 : Broken Glass

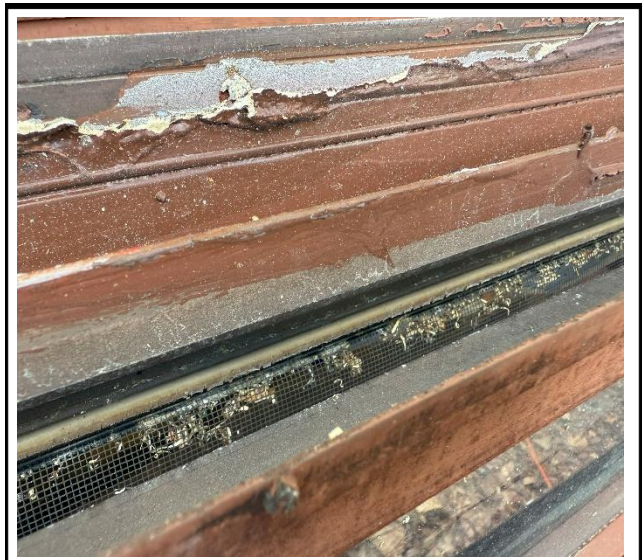
Photo 4 : Bad Weather Strip

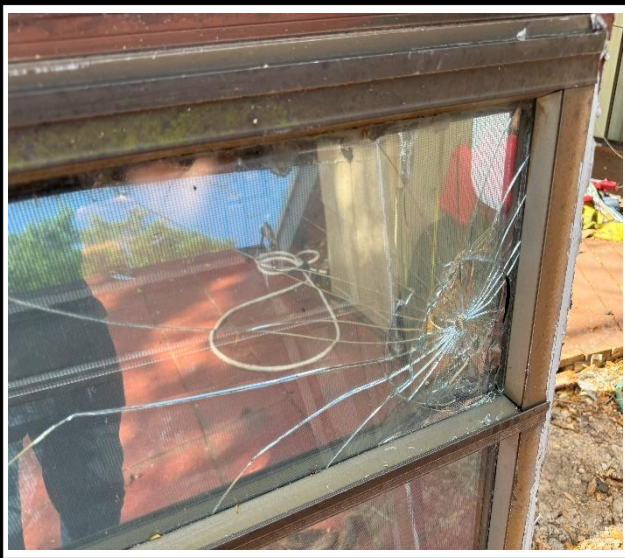
Photo 1 : Broken Glass

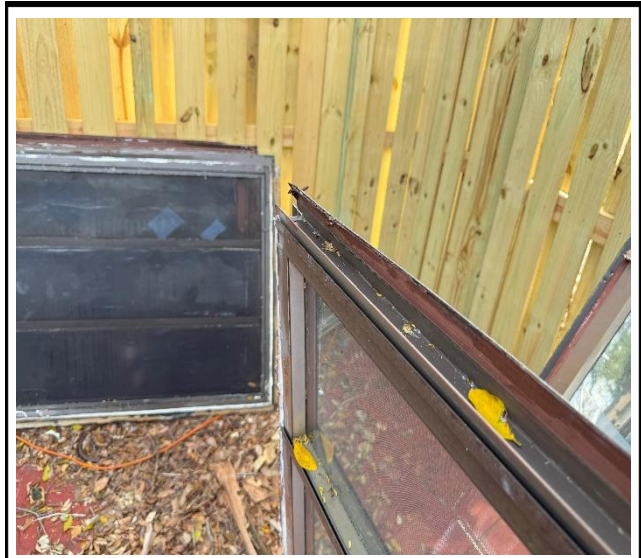
Photo 2 : Bad Frame

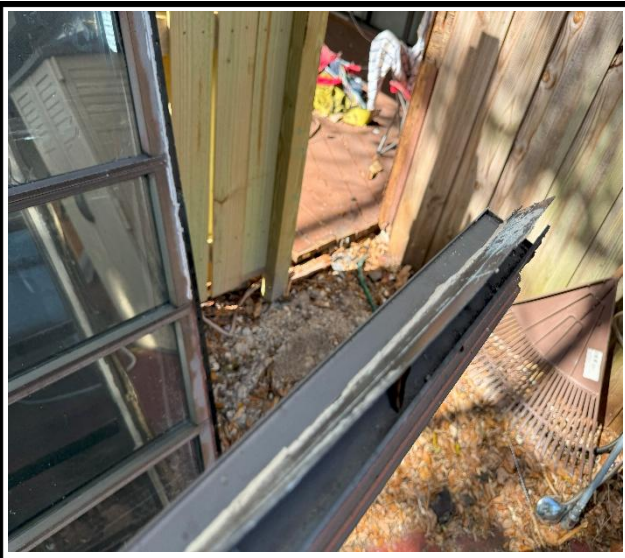
Photo 3 : Bad Frame

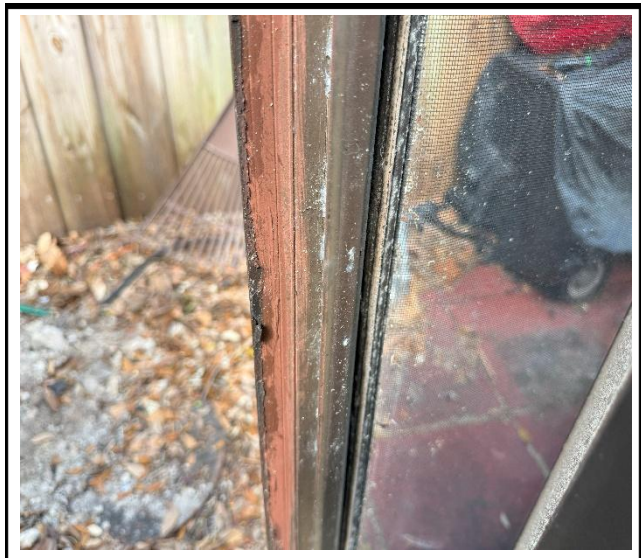
Photo 4 : Bad Weather Strip

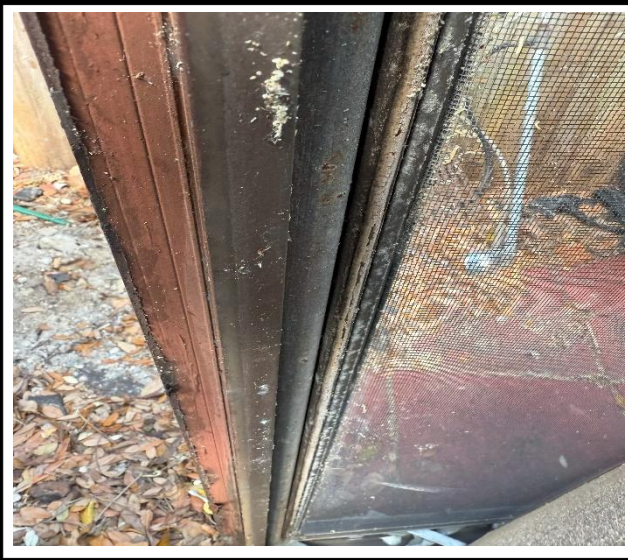
Photo 1 : Bad Weather Strip

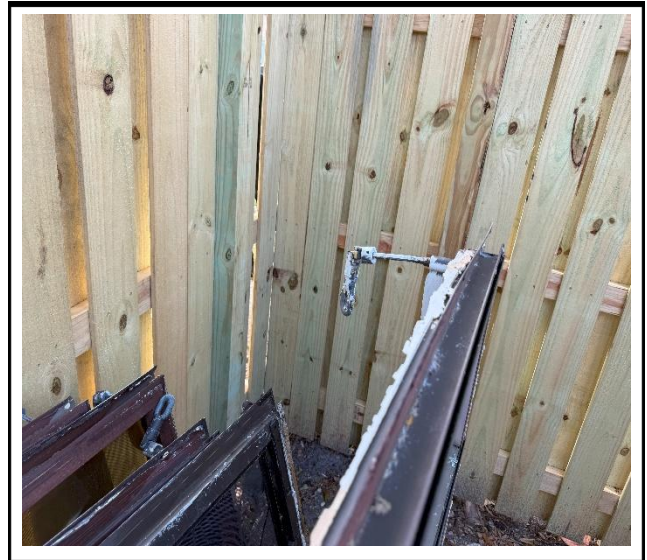
Photo 2 : Bad Frame

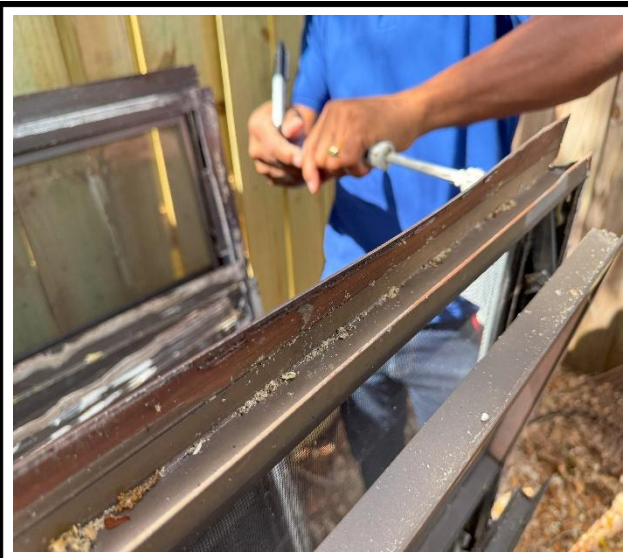
Photo 3 : Stuck Latch

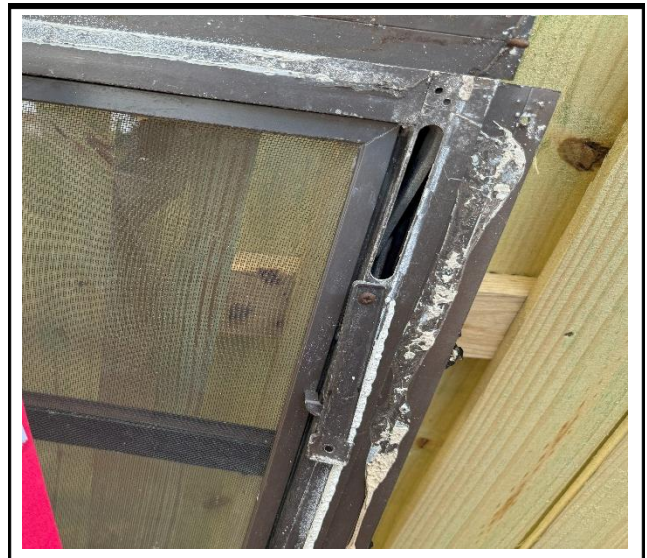
Photo 4 : Loose Components

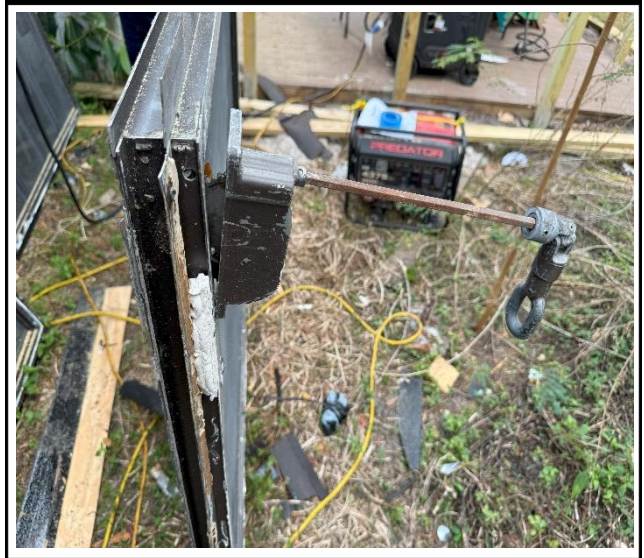
Photo 2 : Bad Latch

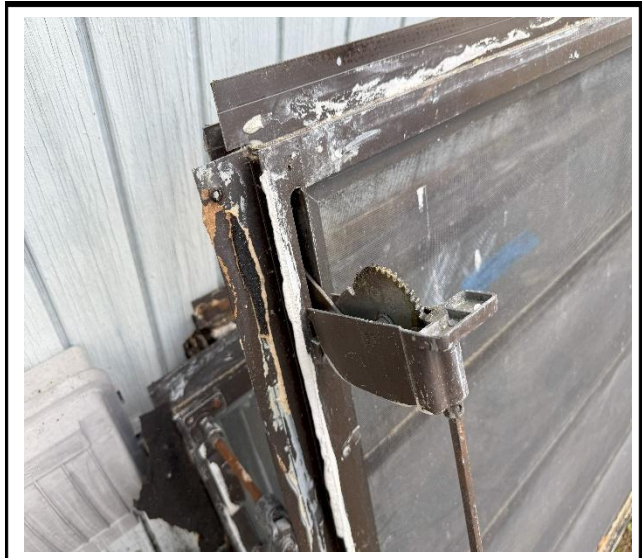
Photo 4 : Bad Latch

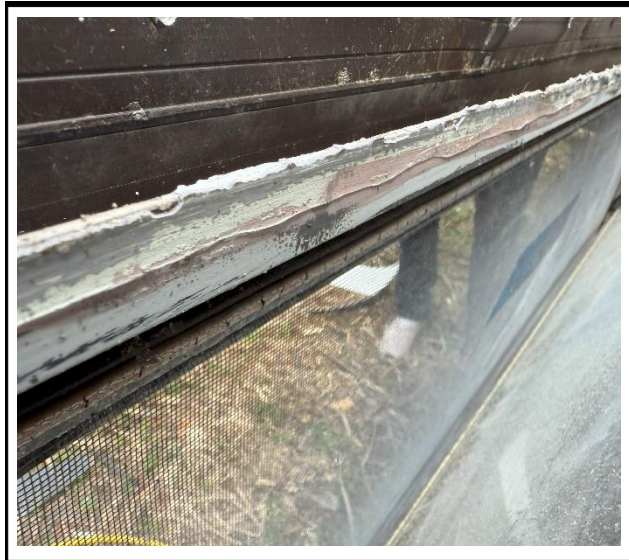
Photo 2 : Bad Weather Strip

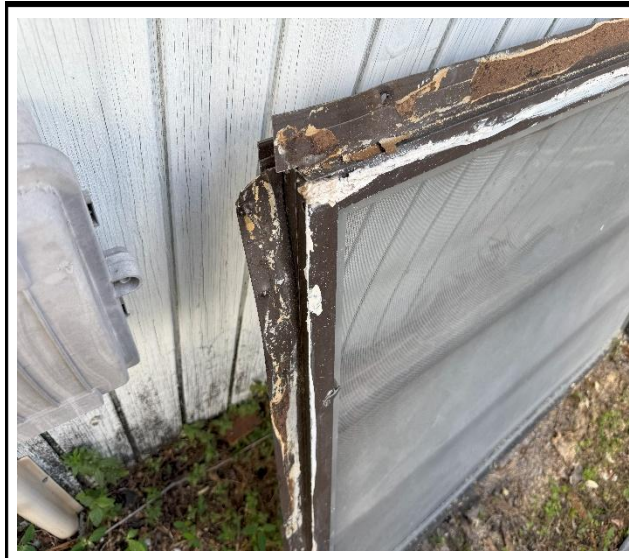
Photo 4 : Bad Frame

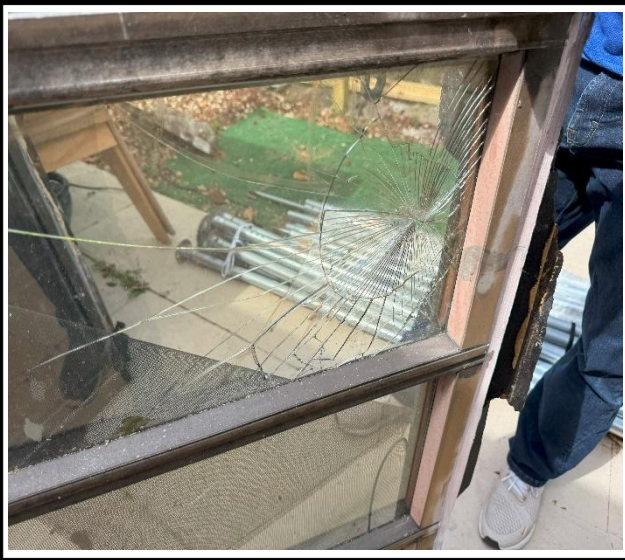
Photo 1 : Broken Glass

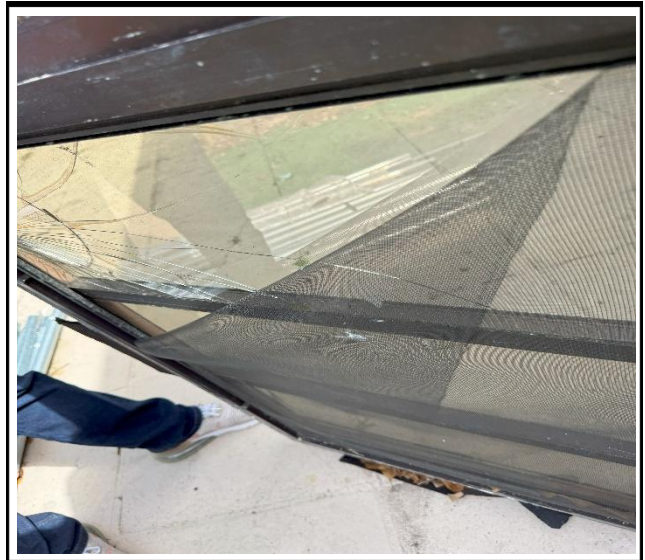
Photo 2 : Loose Mesh

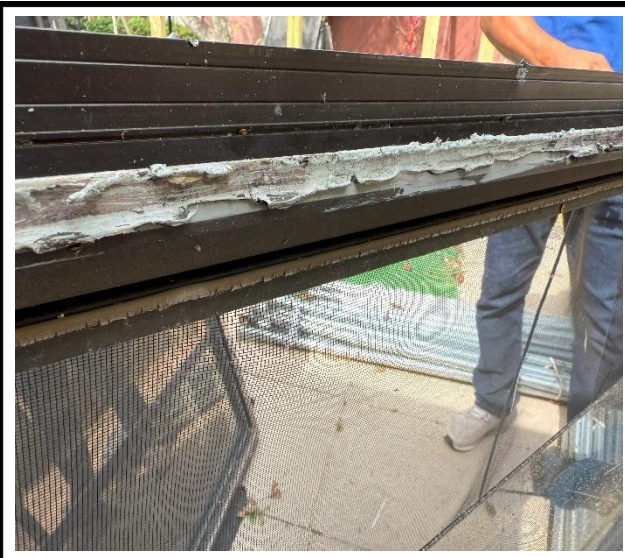
Photo 3 : Bad Weather Strip

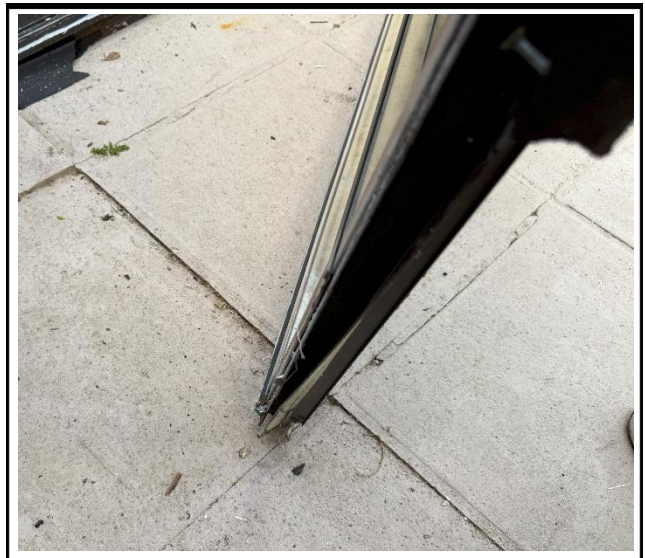
Photo 4 : Bad Frame

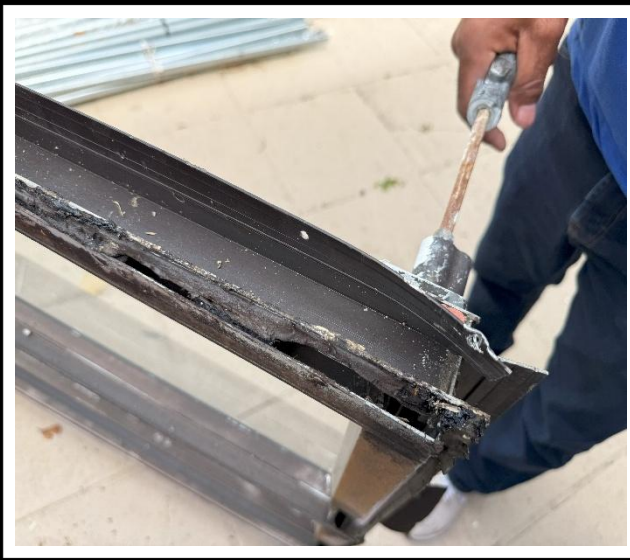
Photo 1 : Stuck Latch

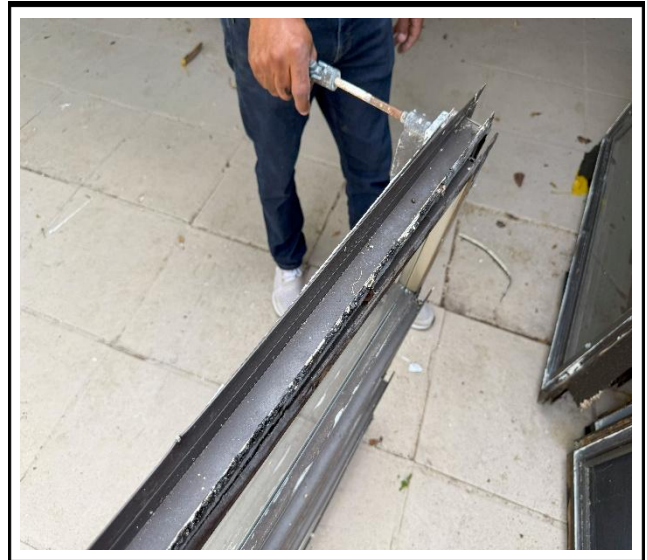
Photo 2 : Stuck Latch

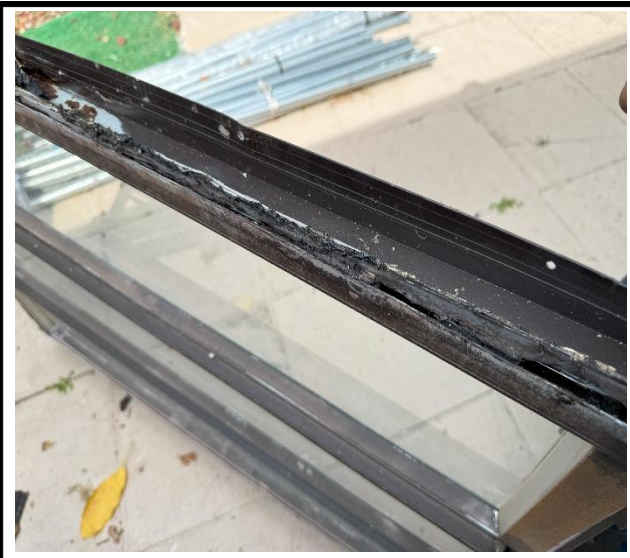
Photo 3 : Bad Frame

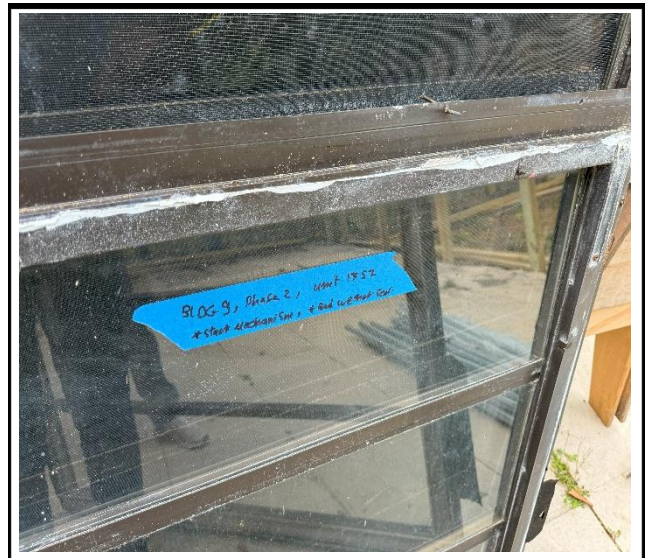
Photo 4 : Bad Frame

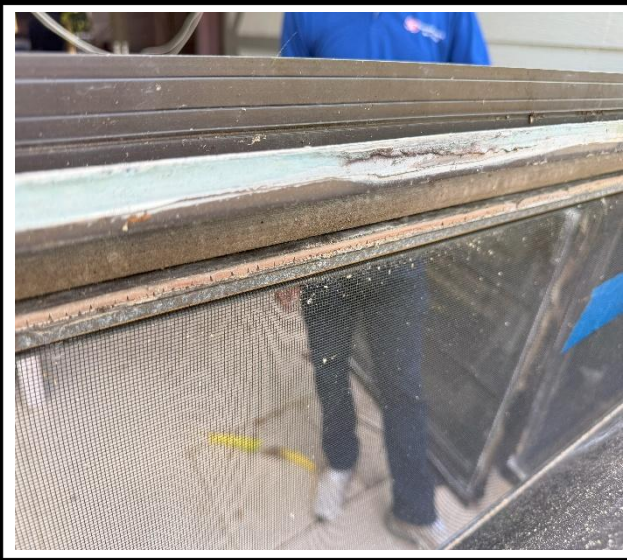
Photo 1 : Bad Weather Strip

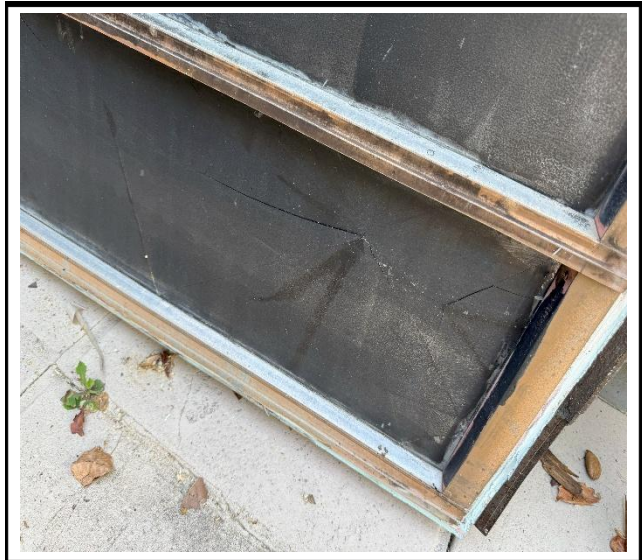
Photo 2 : Broken Glass

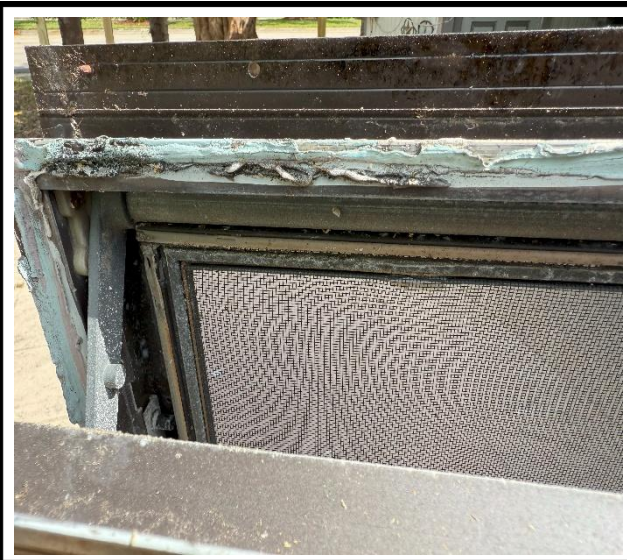
Photo 3 : Bad Weather Strip

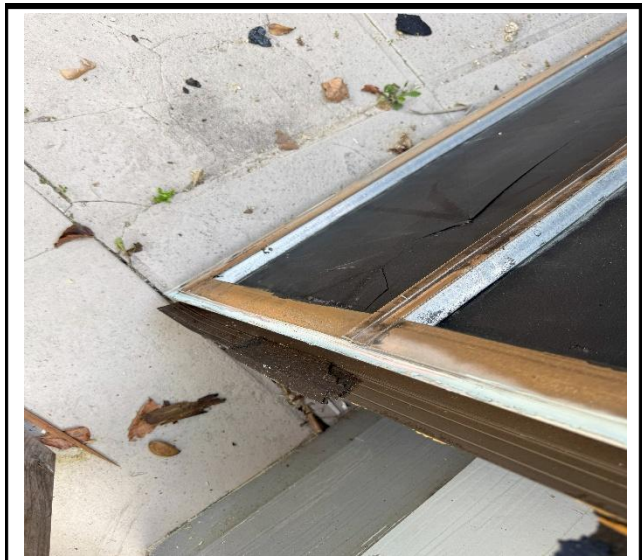
Photo 4 : Bad Frame

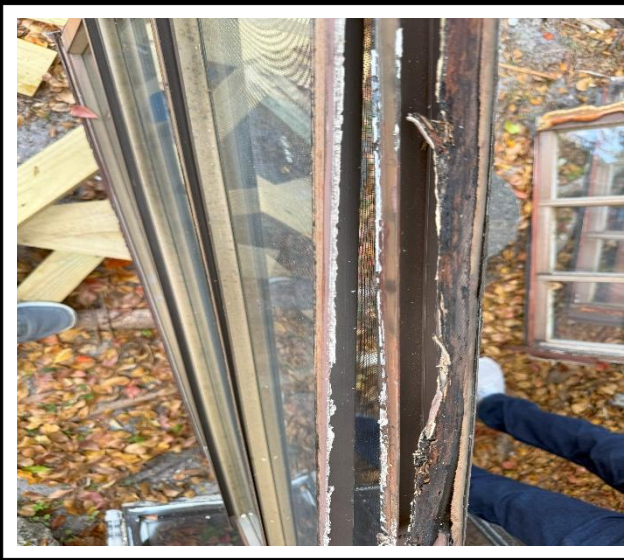
Photo 1 : Bad Frame

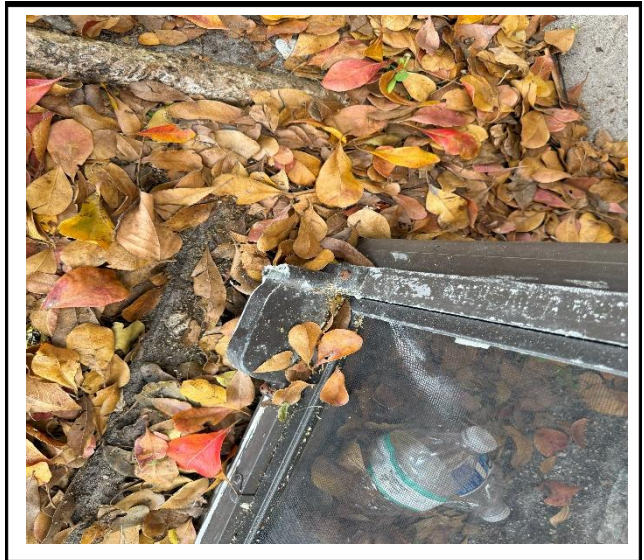
Photo 2 : Bad Latch

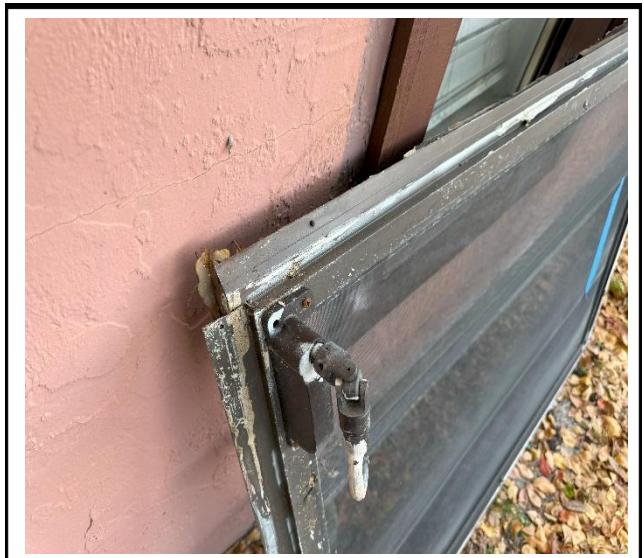
Photo 4 : Stuck Latch

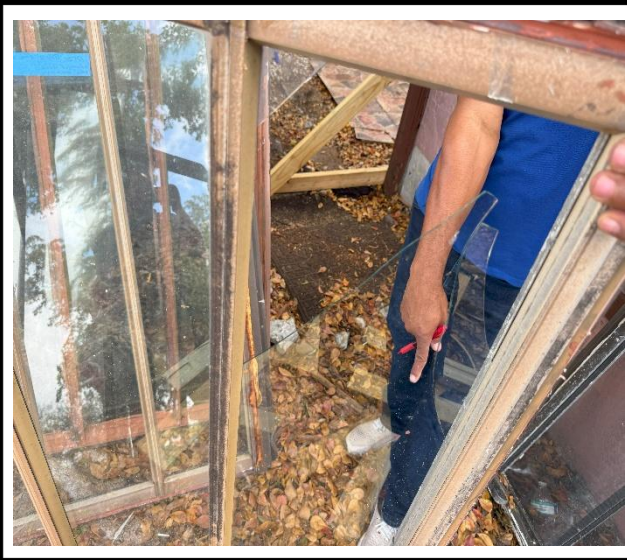
Photo 1 : Broken Glass

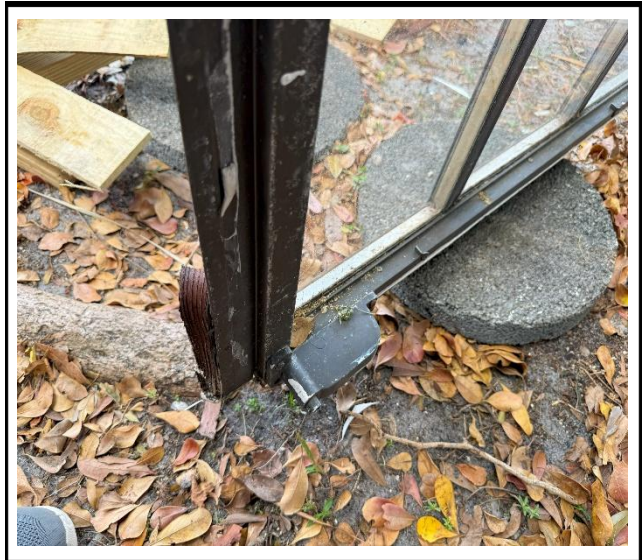
Photo 2 : Bad Frame

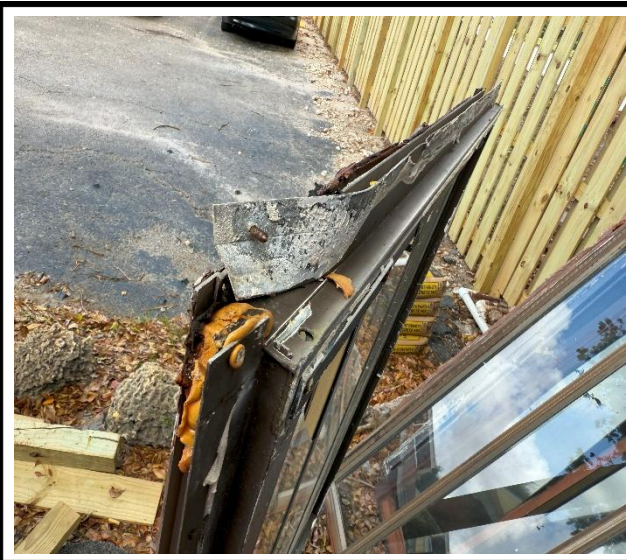
Photo 3 : Bad Frame

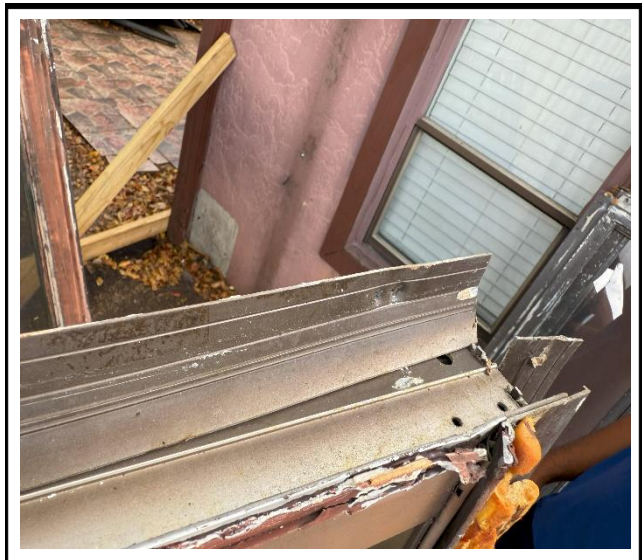
Photo 4 : Bad Frame

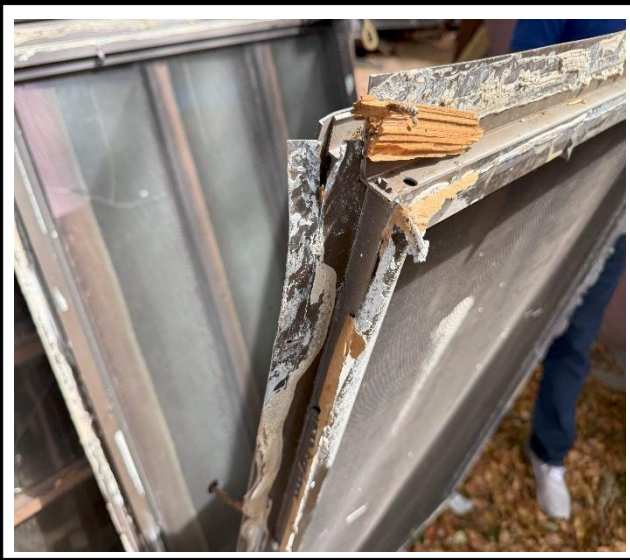
Photo 1 : Bad Frame

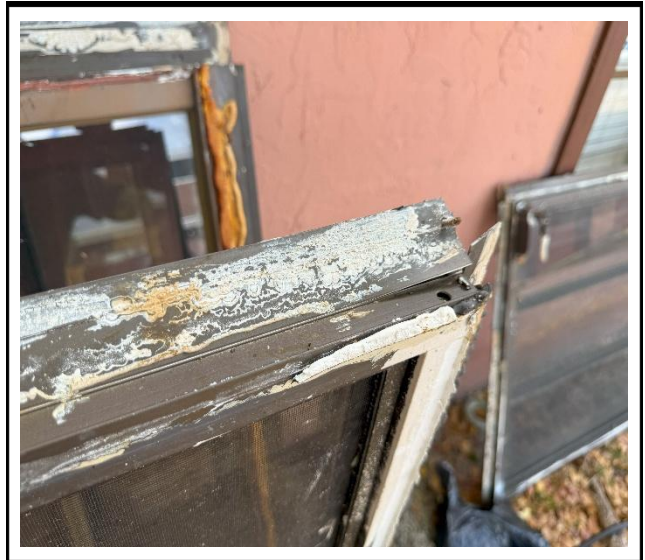
Photo 2 : Bad Frame

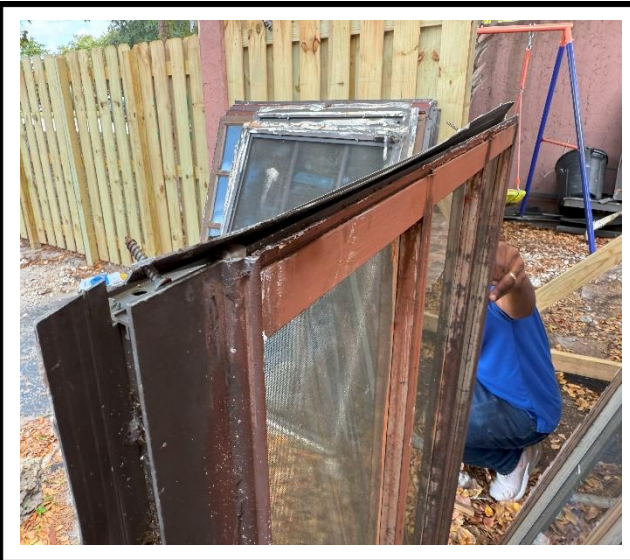
Photo 3 : Bad Frame

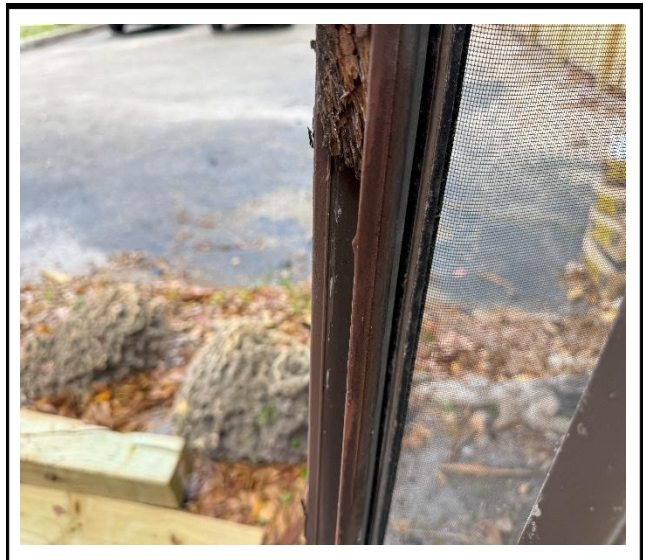
Photo 4 : Bad Weather Strip

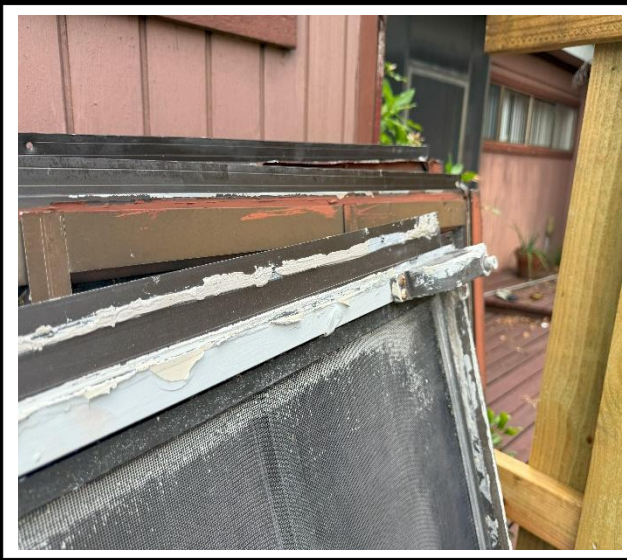
Photo 1 : Broken Latch

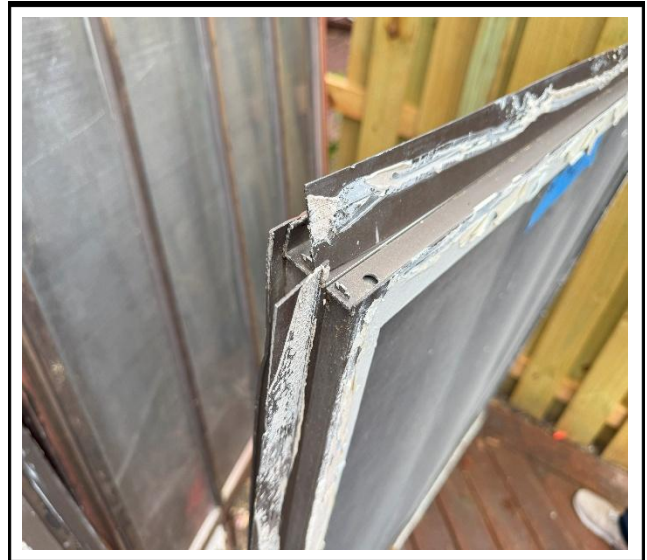
Photo 2 : Bad Frame

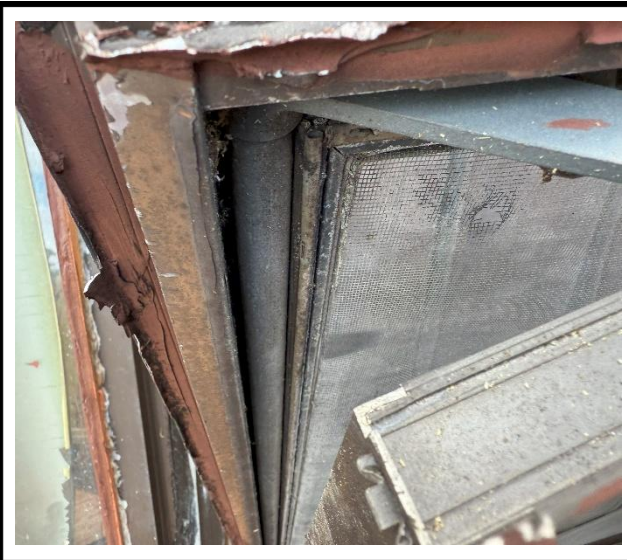
Bad Weather Strip

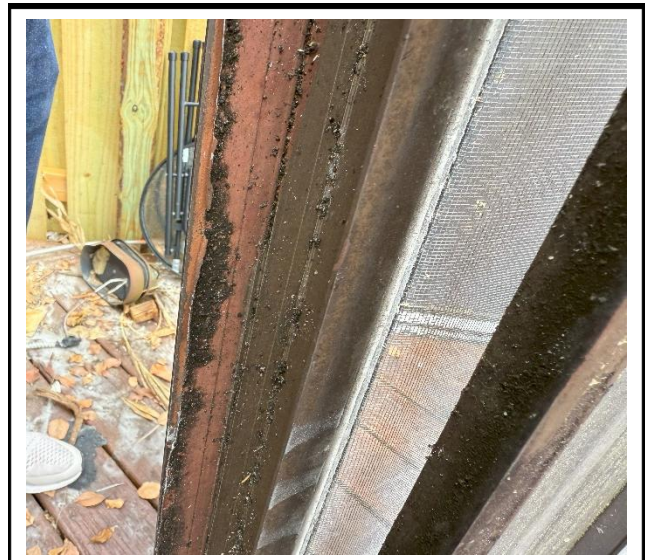
Photo 4 : Bad Weather Strip

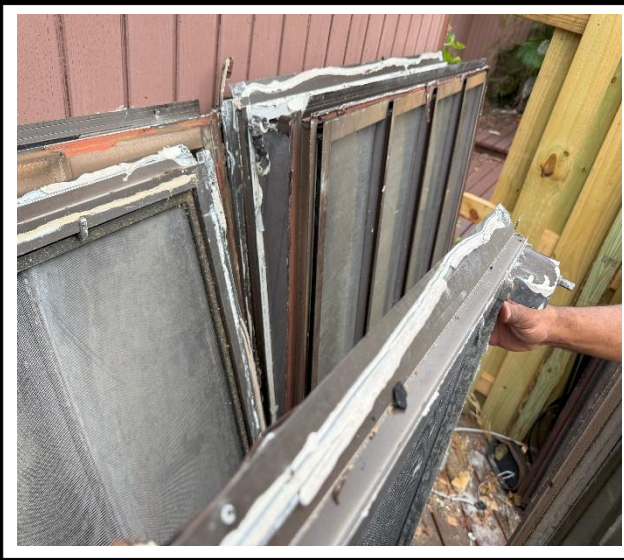
Photo 1 : Bad Frame

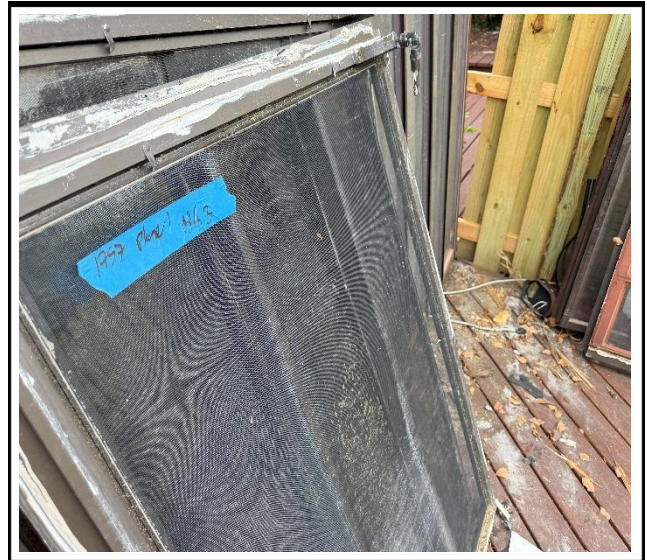
Photo 2 : Bad Frame

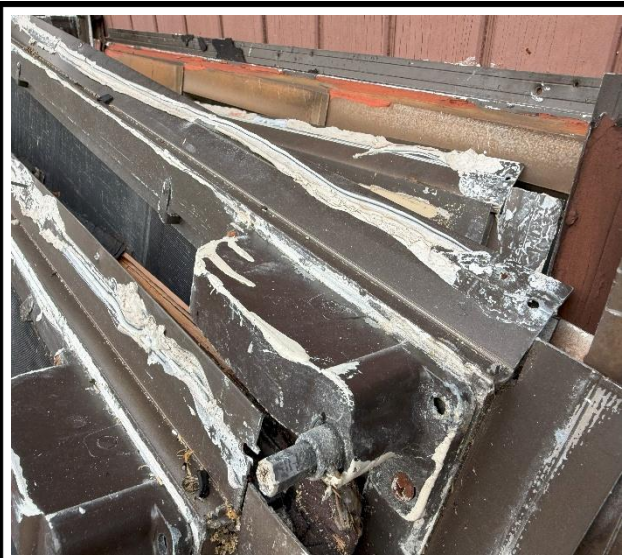
Photo 3 : Broken Latch
