# Omega Villas Condominium Association

1713 NW 72 Avenue,  
Plantation, FL 33313

## **Windows Evaluation Report** (04/03/2025)

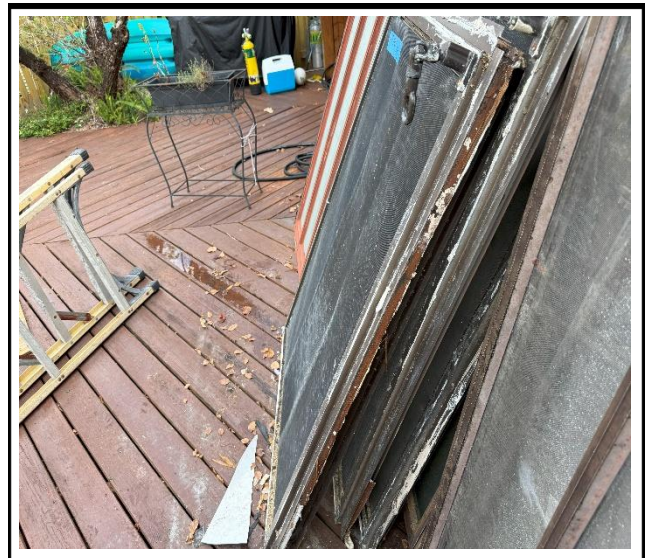
Photo 4 : Bad Frame

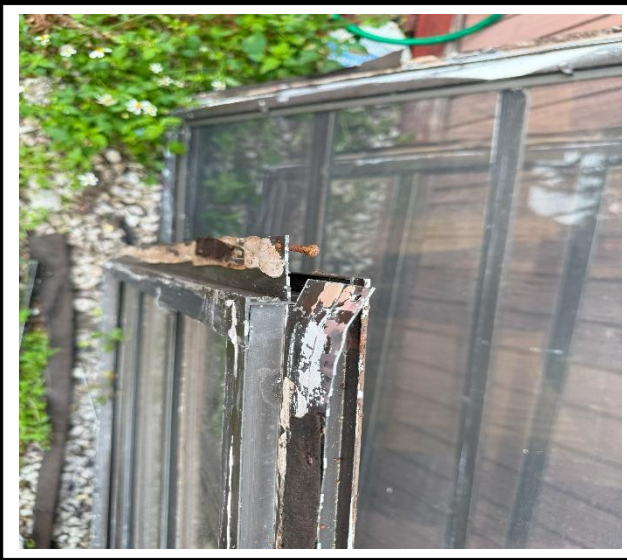
Photo 1 : Bad Frame

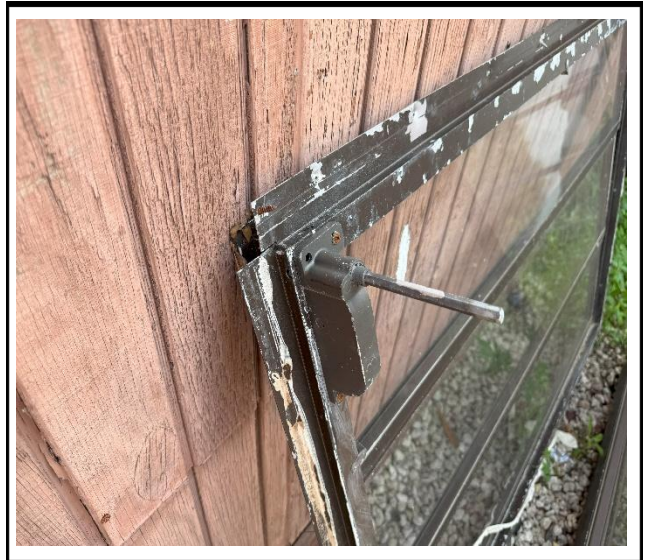
Photo 2 : Broken Latch

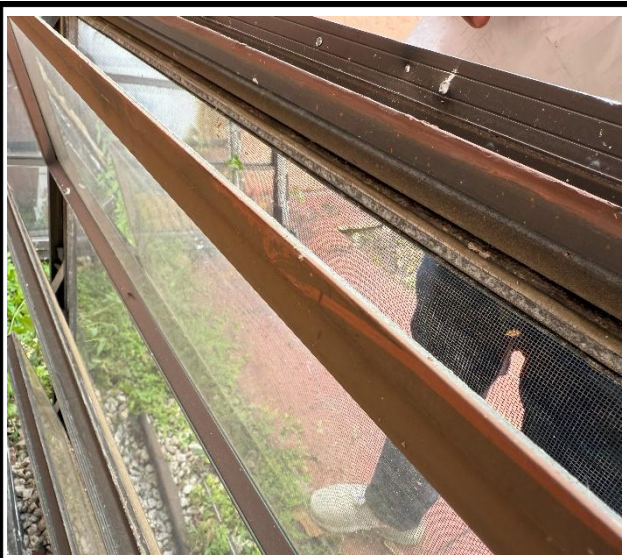
Photo 3 : Bad Weather Strip

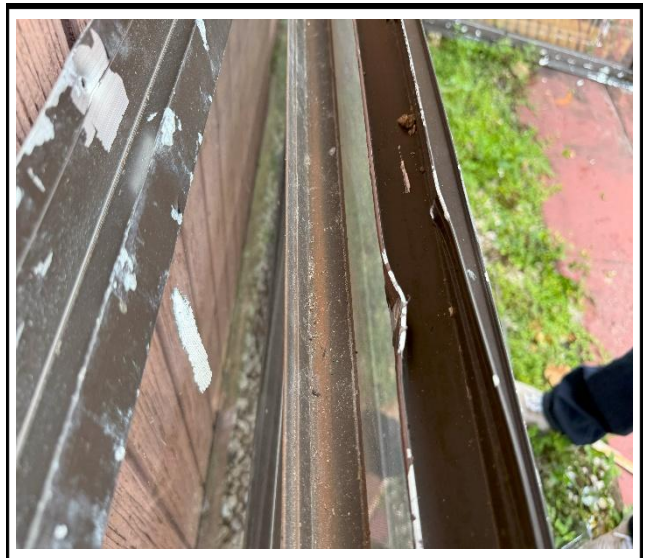
Photo 4 : Bad Frame
