Omega Villas Condominium Association

1713 NW 72 Avenue,  
Plantation, FL 33313

**Windows Evaluation Report**  
**BLDGs 1 to 15**  
(07/23/2025)

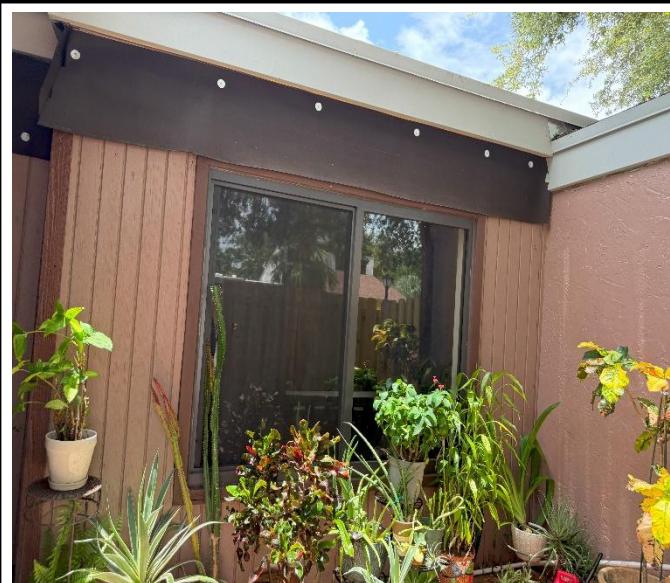
Photo 1: Existing Window

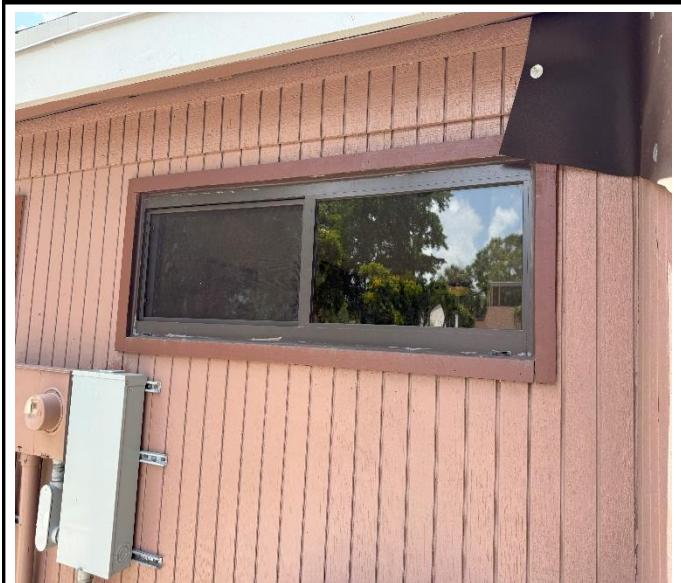
Photo 2: Existing Window

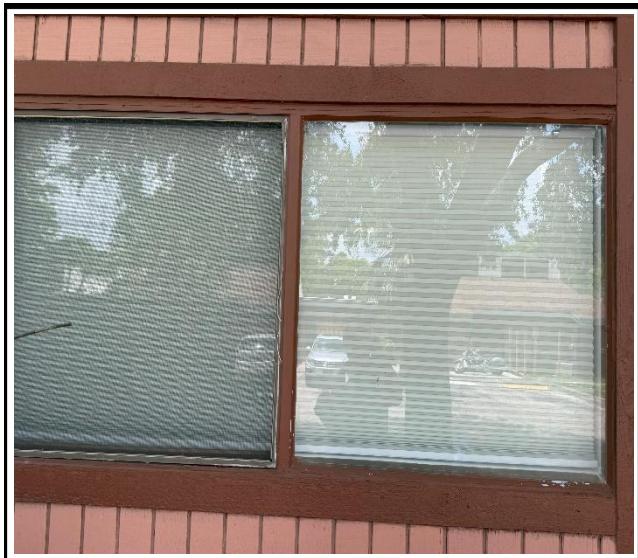
Photo 2 : Existing non-impact-rated window frame

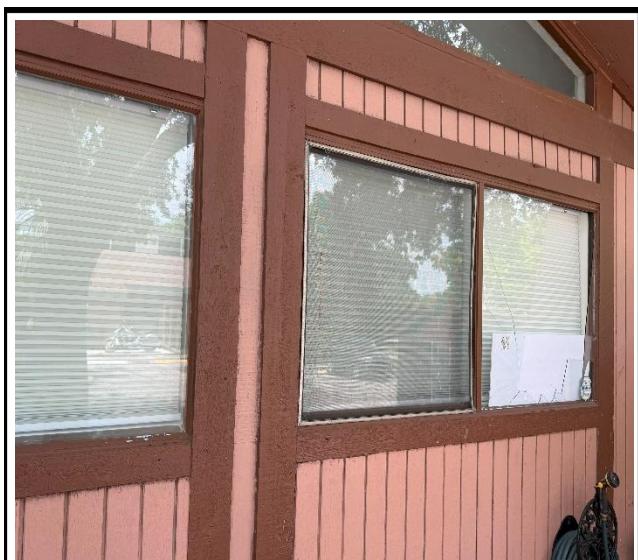
Photo 4 : Existing non-impact-rated window frame

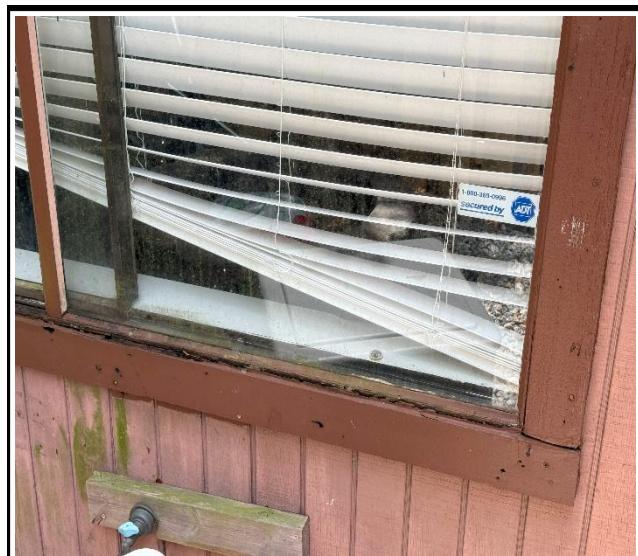
Photo 2 : Existing non-impact-rated window frame

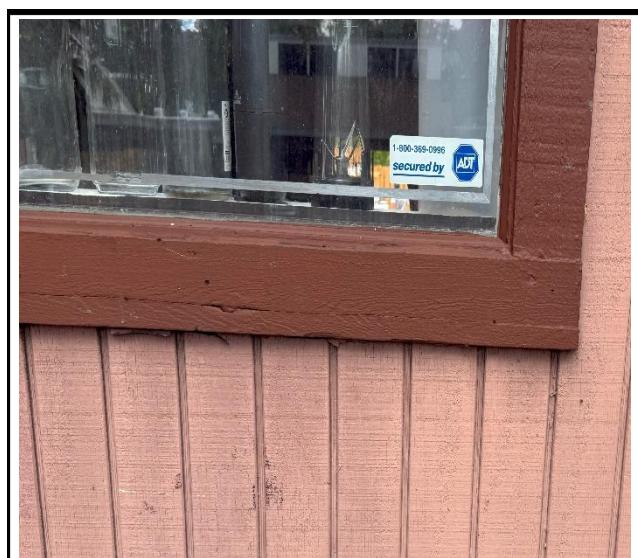
Photo 4 : Existing non-impact-rated window frame

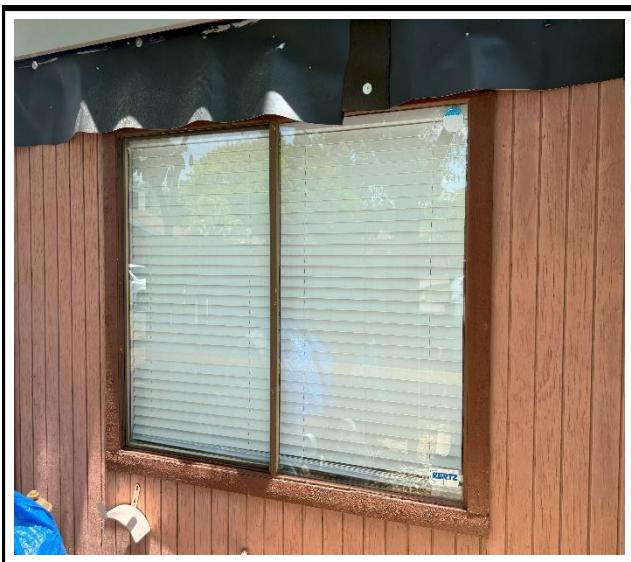
Photo 1 : Existing non-impact-rated window frame

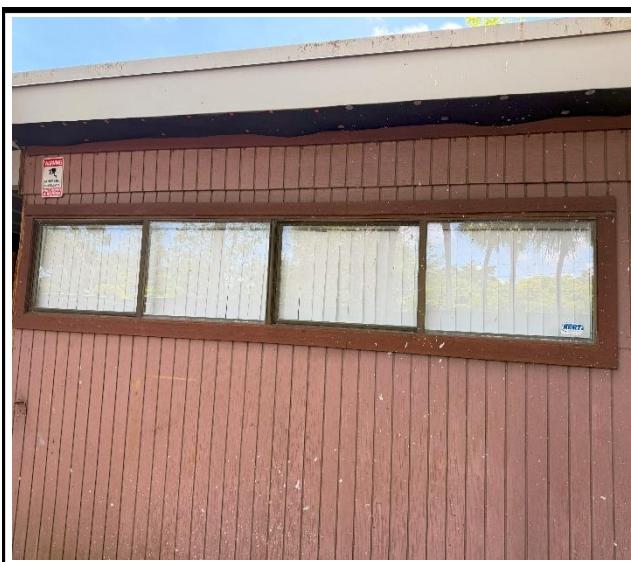
Photo 2 : Existing non-impact-rated window frame

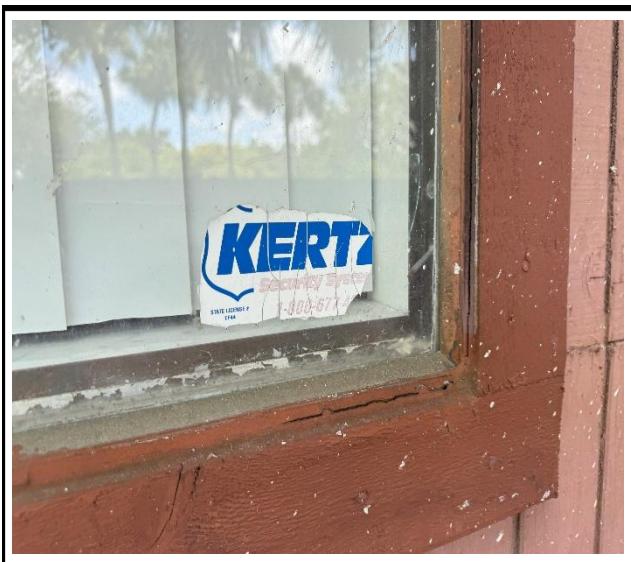
Photo 3 : Existing non-impact-rated window frame

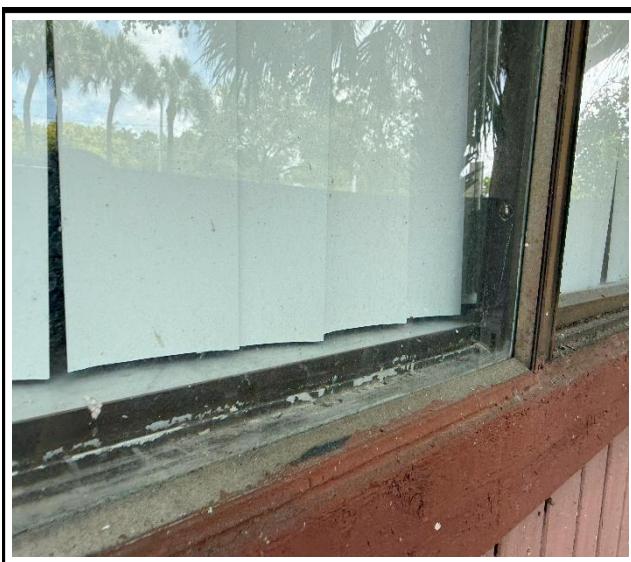
Photo 4 : Existing non-impact-rated window frame

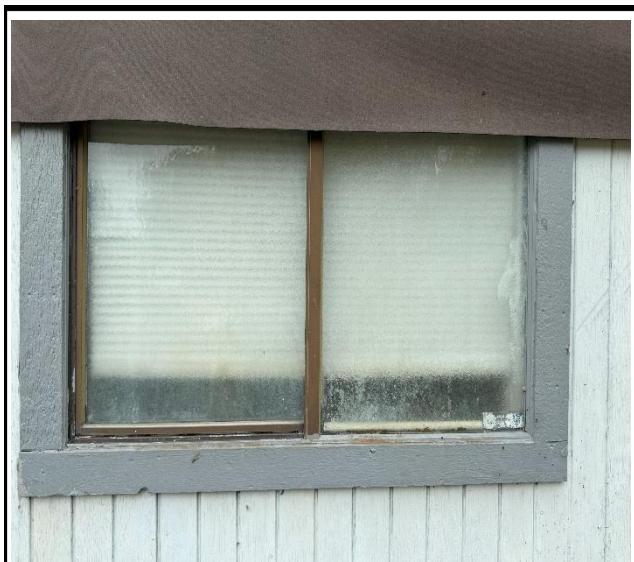
Photo 1 : Existing non-impact-rated window frame

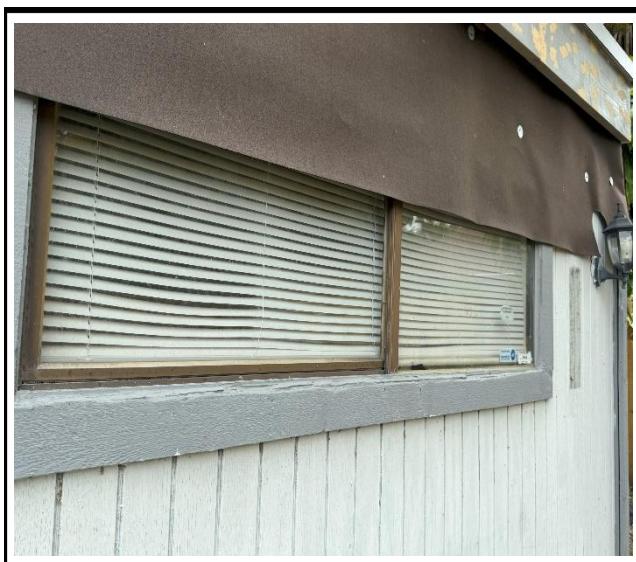
Photo 2 : Existing non-impact-rated window frame

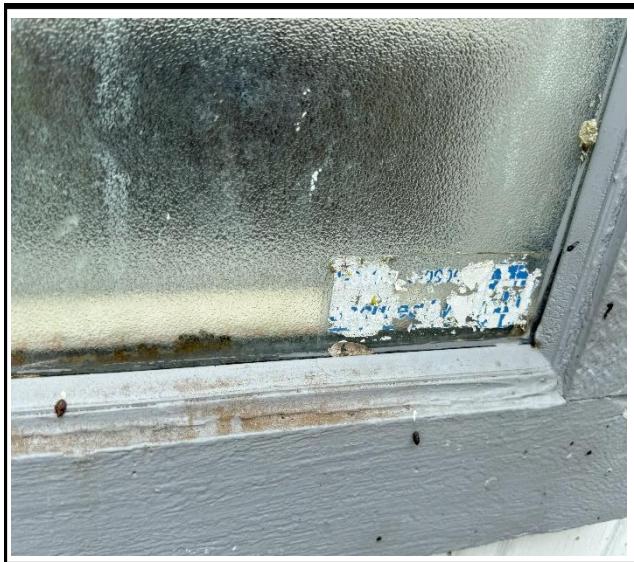
Photo 3 : Existing non-impact-rated window frame

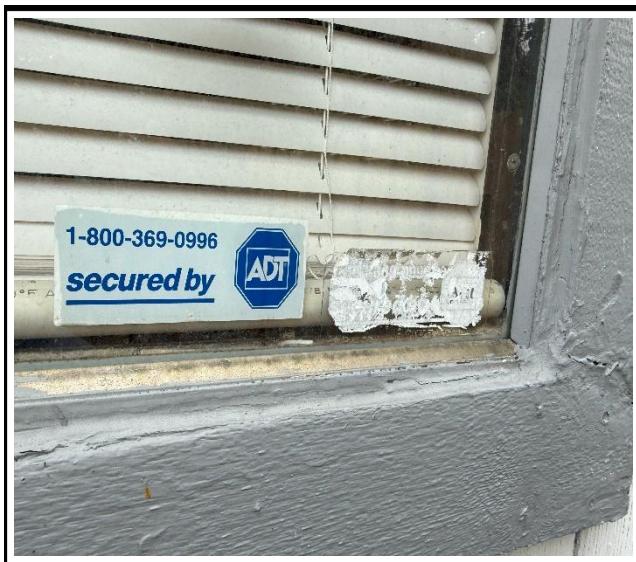
Photo 4 : Existing non-impact-rated window frame

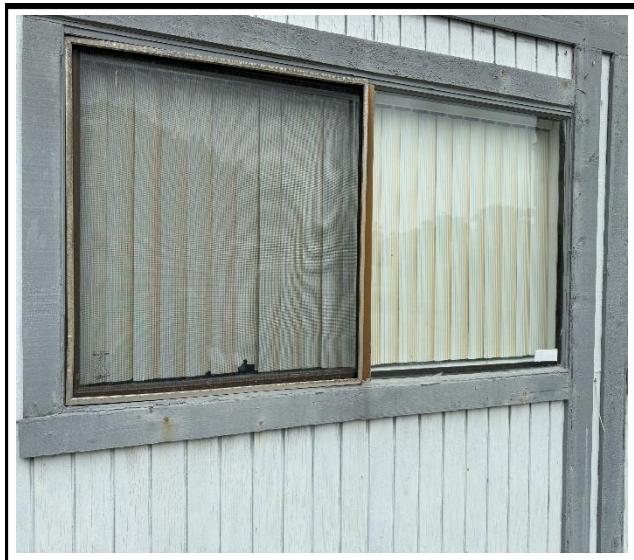
Photo 1 : Existing non-impact-rated window frame

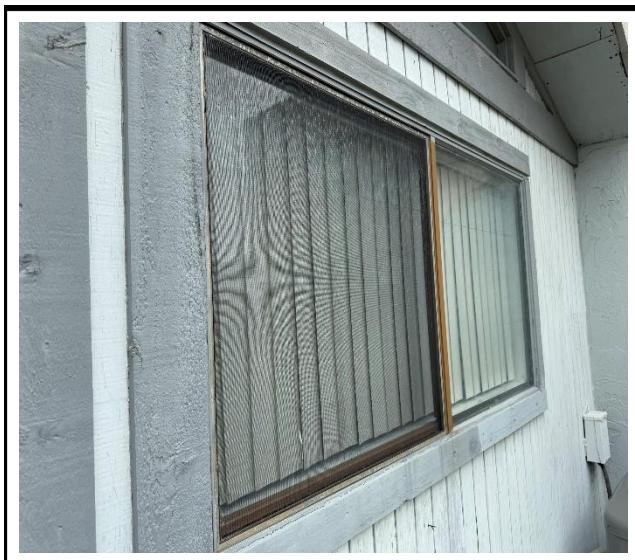
Photo 2 : Existing non-impact-rated window frame

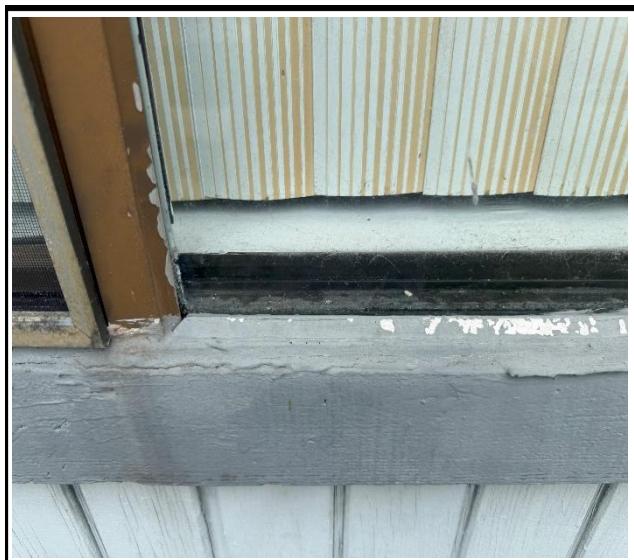
Photo 3 : Existing non-impact-rated window frame

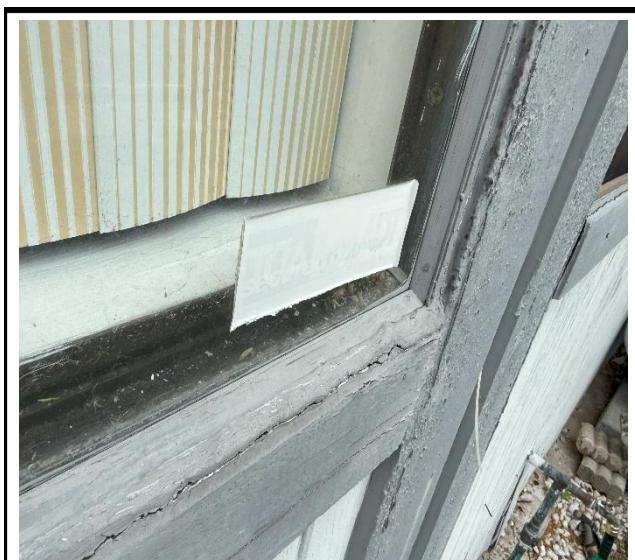
Photo 4 : Existing non-impact-rated window frame
