Omega Villas Condominium Association

1713 NW 72 Avenue,
Plantation, FL 33313

Exposed SGDs Evaluation
Report
BLDGs 1 to 15
(11/12/2025)

Exposed Sliding Glass Doors (SGDs) Evaluation Summary

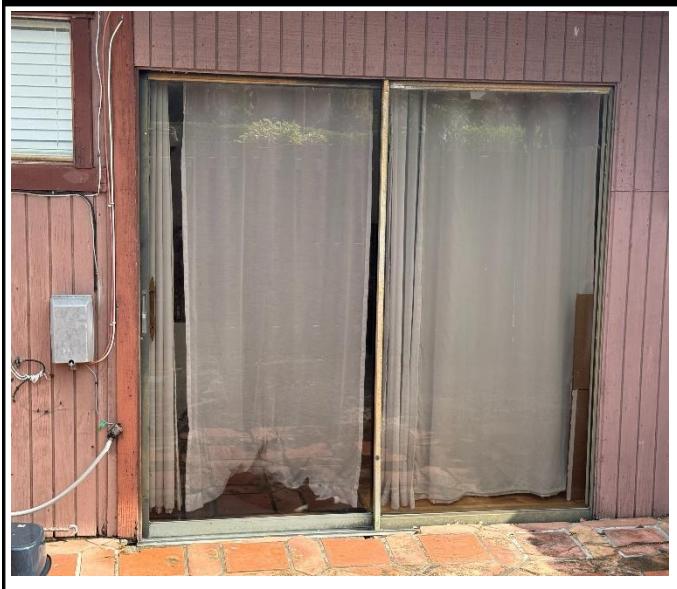
The Sliding Glass Doors are approximately 40 years old and show typical signs of aging, including potential air and water leakage, degraded seals, reduced energy efficiency, and possible corrosion and/or frame deterioration.

Photo 1 : Existing non-impact-rated Sliding Glass Door frame

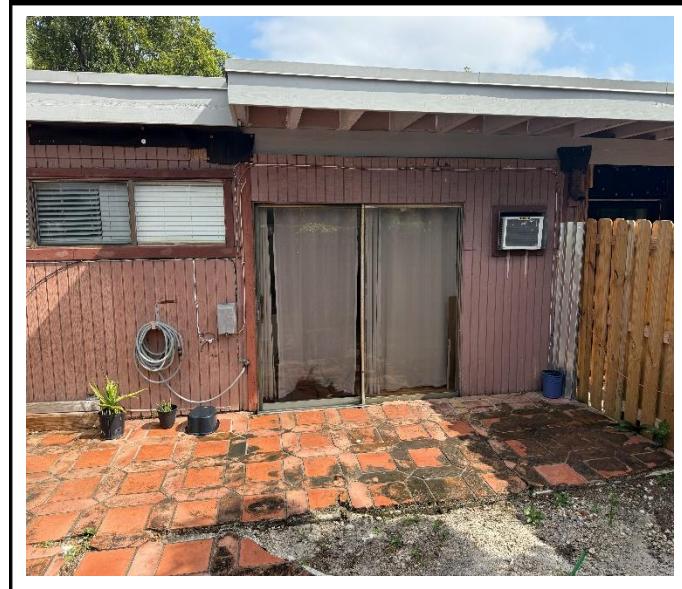
Photo 2 : Existing non-impact-rated Sliding Glass Door frame

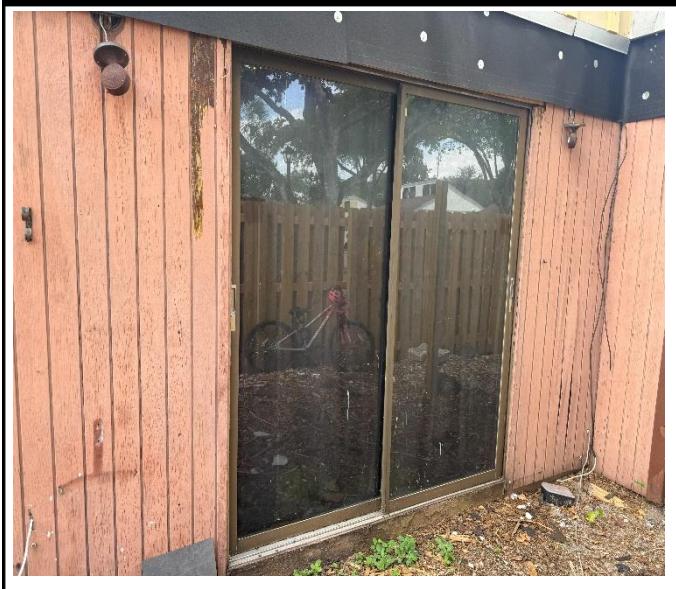
The Sliding Glass Doors are approximately 40 years old and show typical signs of aging, including potential air and water leakage, degraded seals, reduced energy efficiency, and possible corrosion and/or frame deterioration.

Photo 1 : Existing non-impact-rated Sliding Glass Door frame

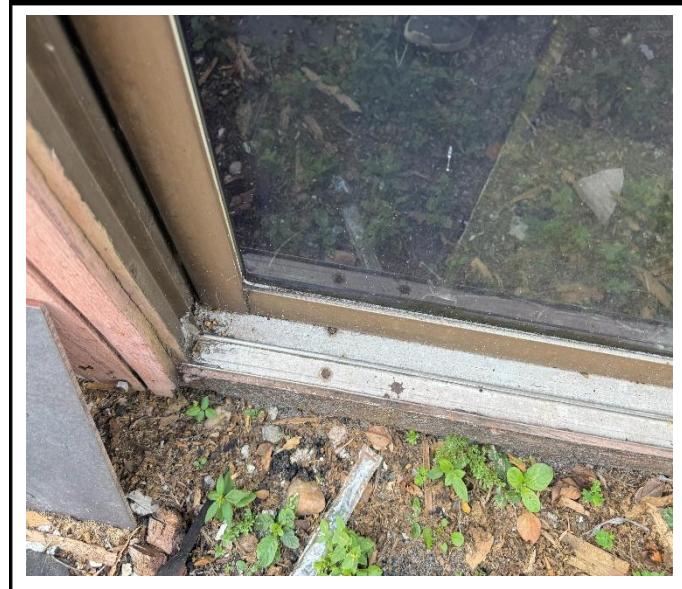
Photo 2 : Existing non-impact-rated Sliding Glass Door frame

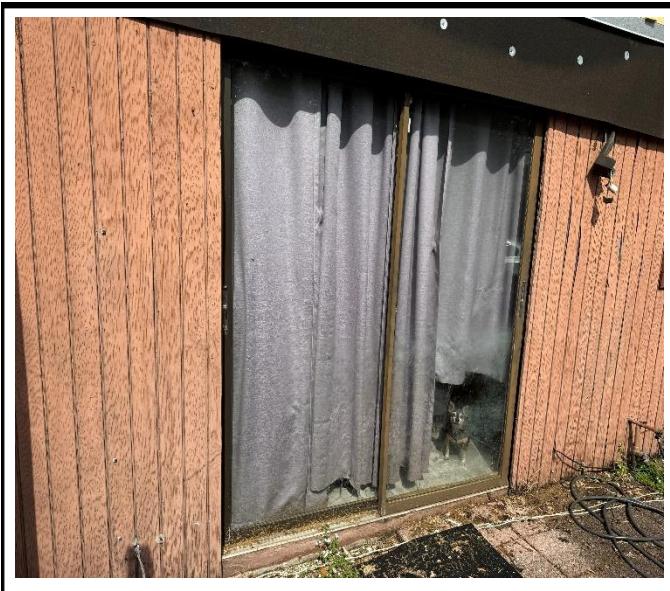
The Sliding Glass Doors are approximately 40 years old and show typical signs of aging, including potential air and water leakage, degraded seals, reduced energy efficiency, and possible corrosion and/or frame deterioration.

Photo 1 : Existing non-impact-rated Sliding Glass Door frame

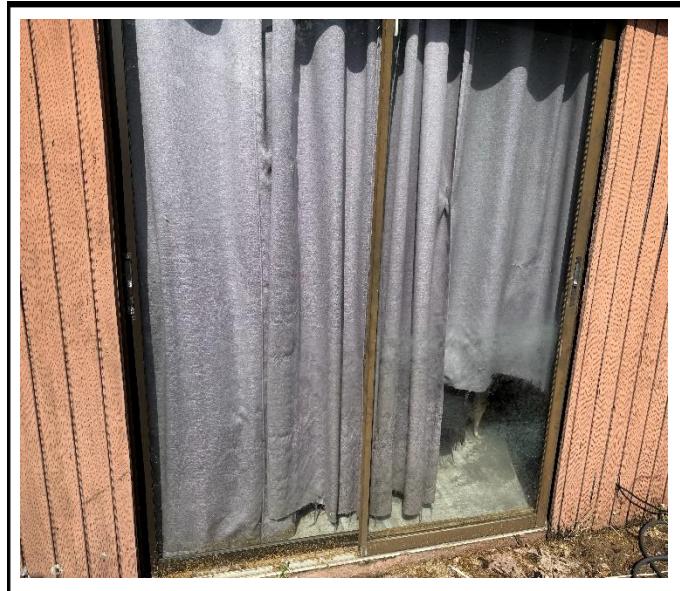
Photo 2 : Existing non-impact-rated Sliding Glass Door frame

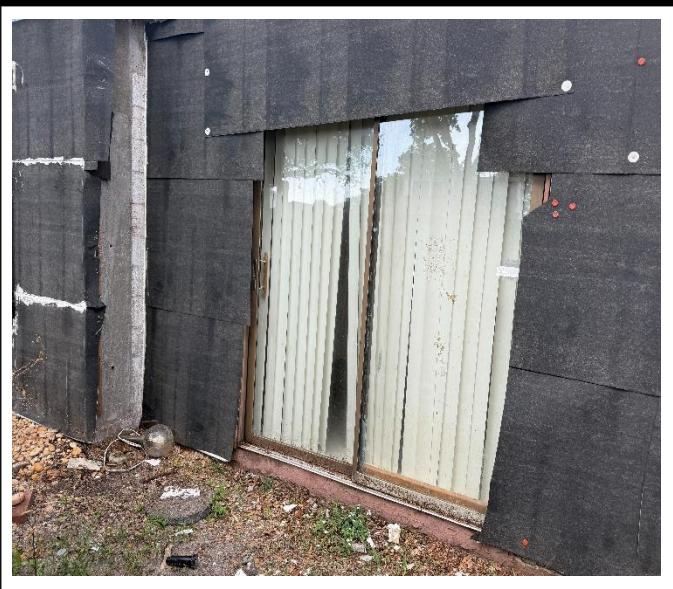
The Sliding Glass Doors are approximately 40 years old and show typical signs of aging, including potential air and water leakage, degraded seals, reduced energy efficiency, and possible corrosion and/or frame deterioration.

Photo 1 : Existing non-impact-rated Sliding Glass Door frame

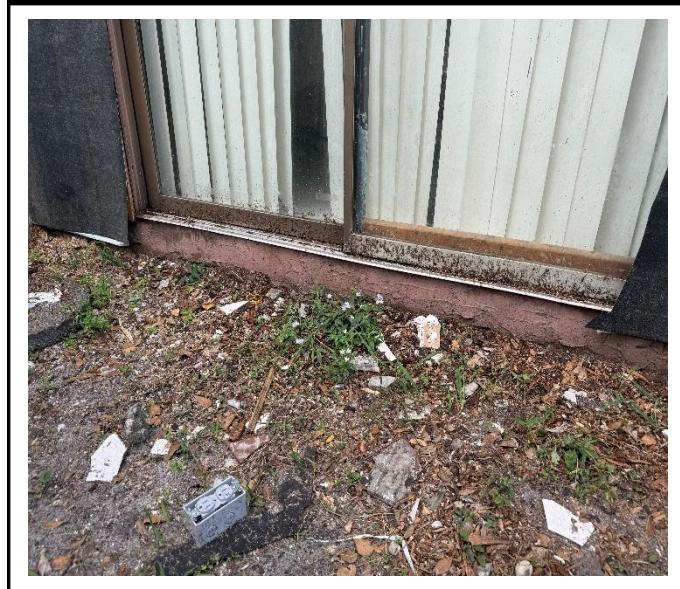
Photo 2 : Existing non-impact-rated Sliding Glass Door frame

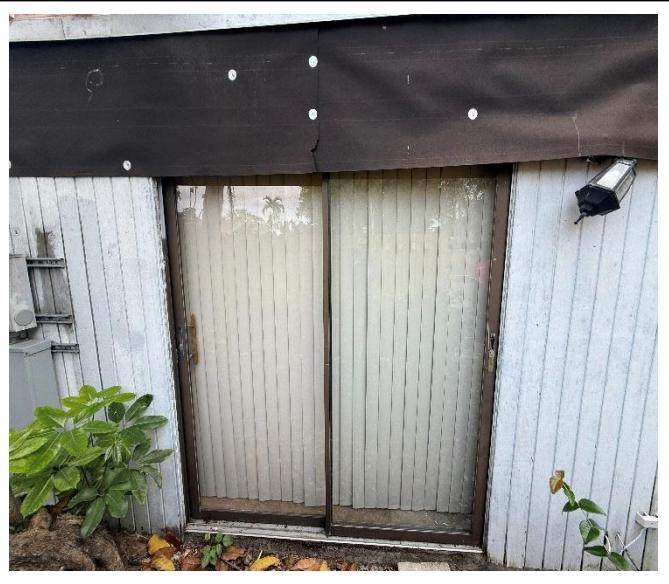
The Sliding Glass Doors are approximately 40 years old and show typical signs of aging, including potential air and water leakage, degraded seals, reduced energy efficiency, and possible corrosion and/or frame deterioration.

Photo 1 : Existing non-impact-rated Sliding Glass Door frame

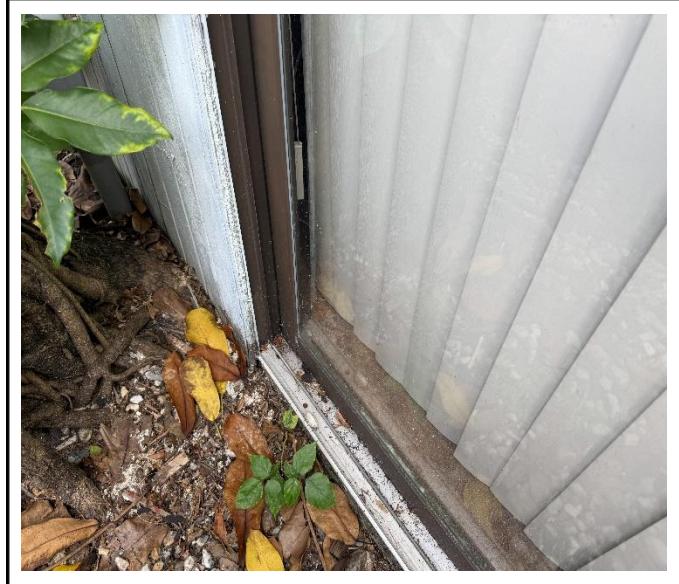
Photo 2 : Existing non-impact-rated Sliding Glass Door frame

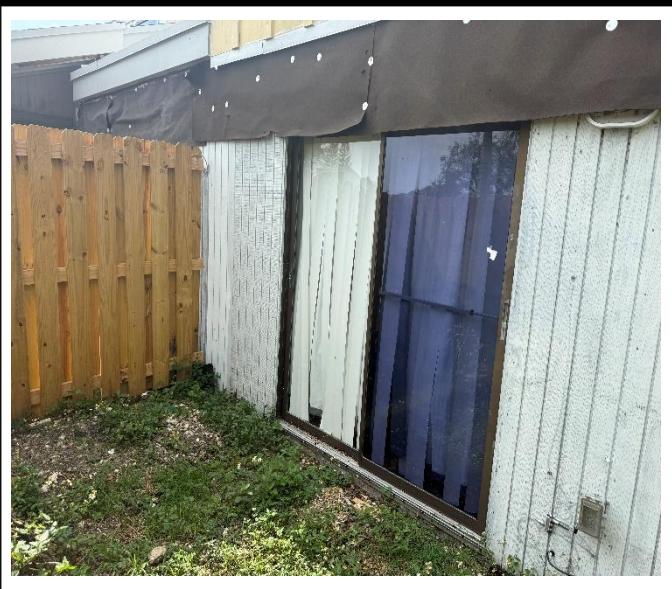
The Sliding Glass Doors are approximately 40 years old and show typical signs of aging, including potential air and water leakage, degraded seals, reduced energy efficiency, and possible corrosion and/or frame deterioration.

Photo 1 : Existing non-impact-rated Sliding Glass Door frame

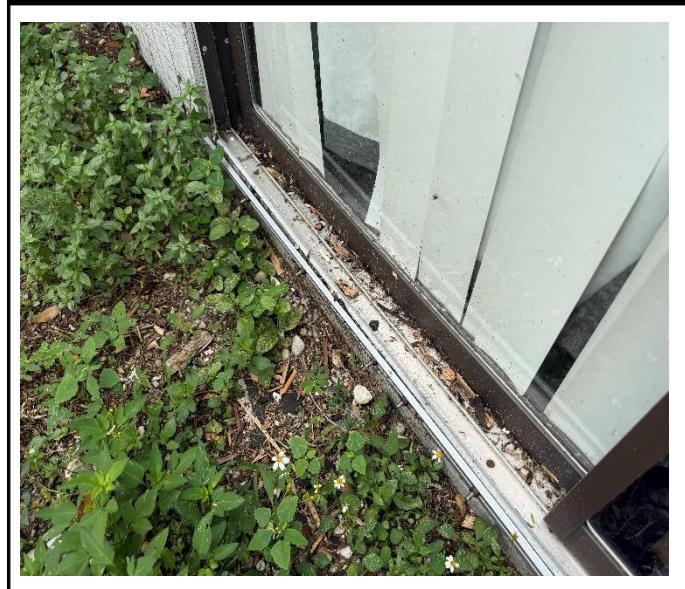
Photo 2 : Existing non-impact-rated Sliding Glass Door frame

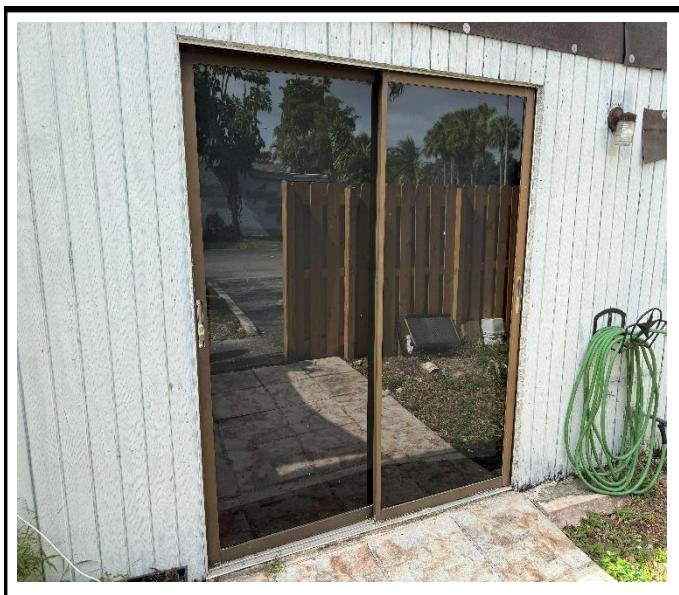
The Sliding Glass Doors are approximately 40 years old and show typical signs of aging, including potential air and water leakage, degraded seals, reduced energy efficiency, and possible corrosion and/or frame deterioration.

Photo 1 : Existing non-impact-rated Sliding Glass Door frame

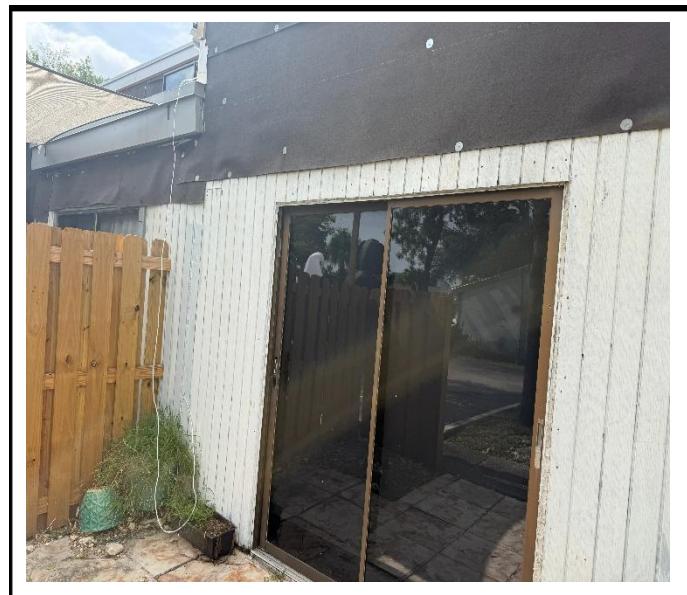
Photo 2 : Existing non-impact-rated Sliding Glass Door frame

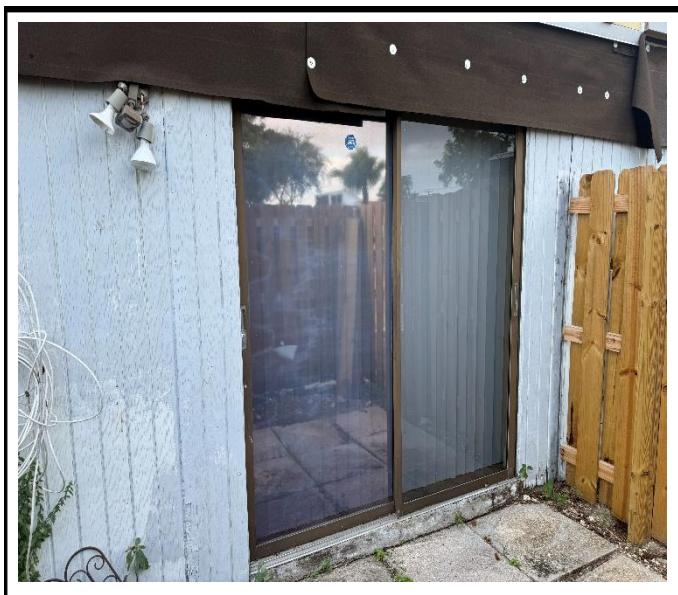
The Sliding Glass Doors are approximately 40 years old and show typical signs of aging, including potential air and water leakage, degraded seals, reduced energy efficiency, and possible corrosion and/or frame deterioration.

Photo 1 : Existing non-impact-rated Sliding Glass Door frame

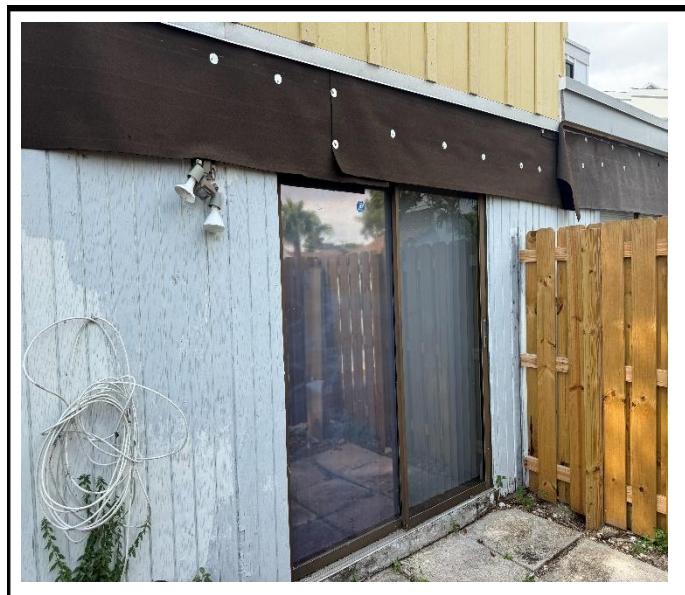
Photo 2 : Existing non-impact-rated Sliding Glass Door frame

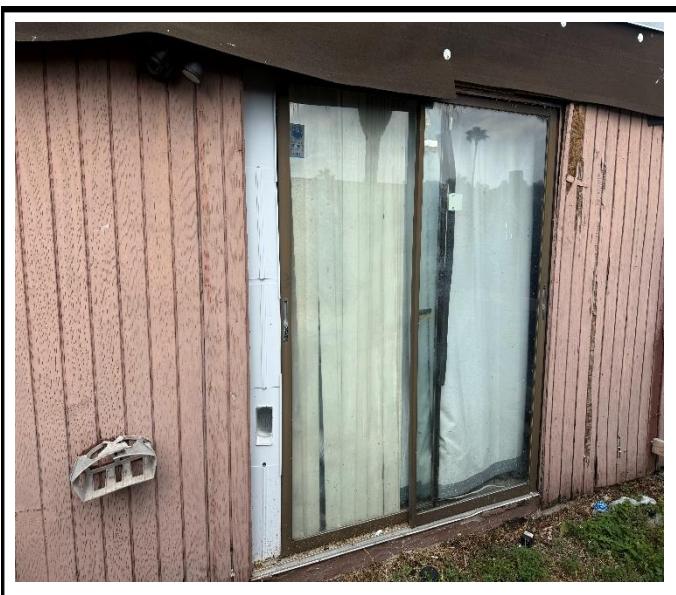
The Sliding Glass Doors are approximately 40 years old and show typical signs of aging, including potential air and water leakage, degraded seals, reduced energy efficiency, and possible corrosion and/or frame deterioration.

Photo 1 : Existing non-impact-rated Sliding Glass Door frame

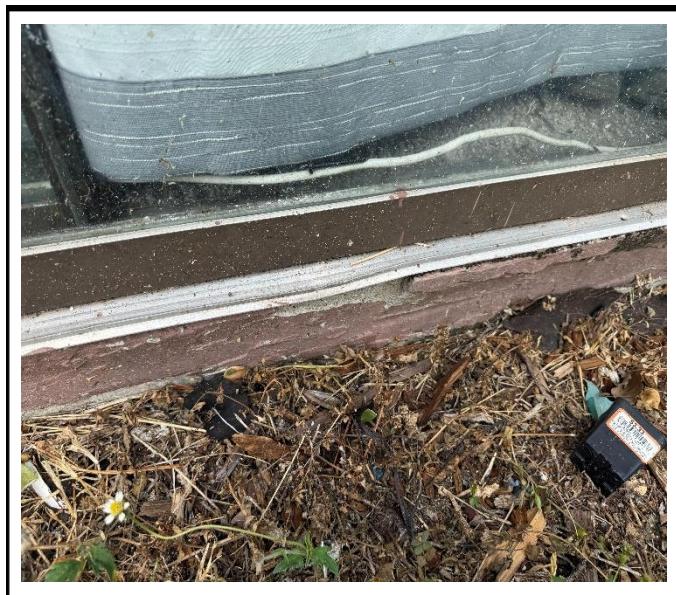
Photo 2 : Existing non-impact-rated Sliding Glass Door frame

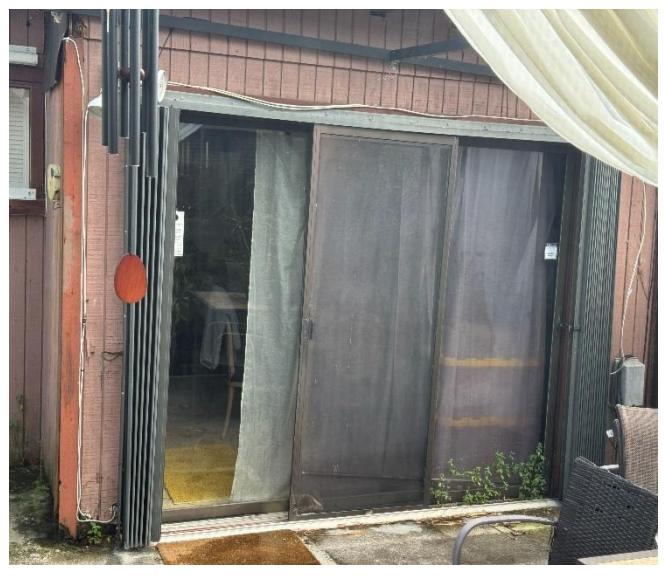
The Sliding Glass Doors are approximately 40 years old and show typical signs of aging, including potential air and water leakage, degraded seals, reduced energy efficiency, and possible corrosion and/or frame deterioration.

Photo 1 : Existing non-impact-rated Sliding Glass Door frame

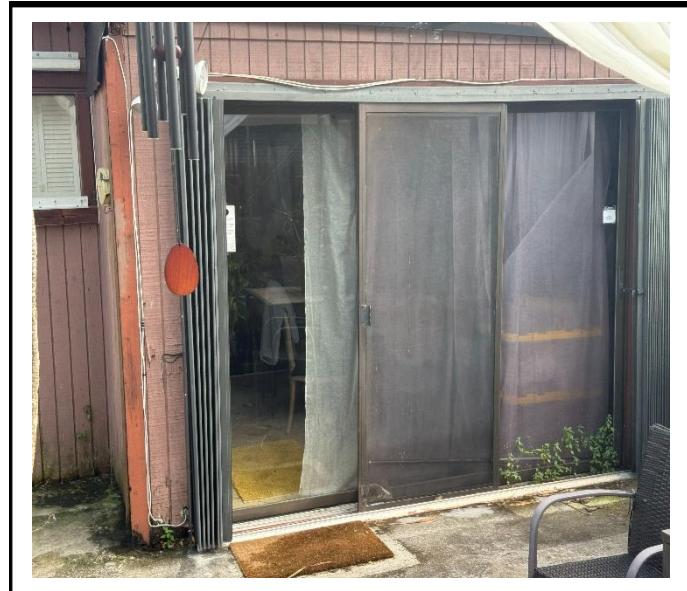
Photo 2 : Existing non-impact-rated Sliding Glass Door frame

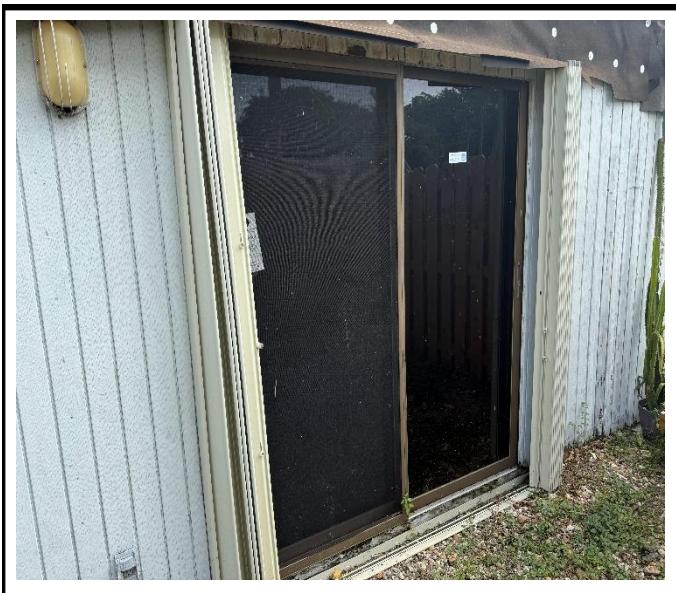
The Sliding Glass Doors are approximately 40 years old and show typical signs of aging, including potential air and water leakage, degraded seals, reduced energy efficiency, and possible corrosion and/or frame deterioration.

Photo 1 : Existing non-impact-rated Sliding Glass Door frame

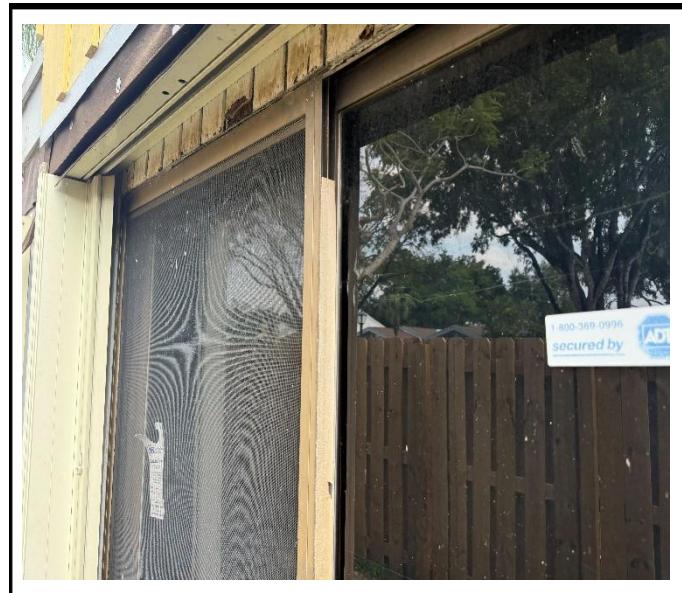
Photo 2 : Existing non-impact-rated Sliding Glass Door frame

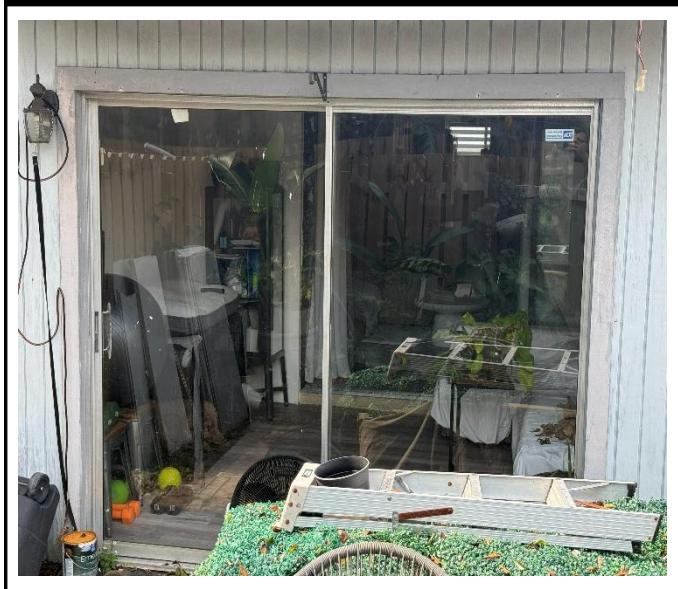
The Sliding Glass Doors are approximately 40 years old and show typical signs of aging, including potential air and water leakage, degraded seals, reduced energy efficiency, and possible corrosion and/or frame deterioration.

Photo 1 : Existing non-impact-rated Sliding Glass Door frame

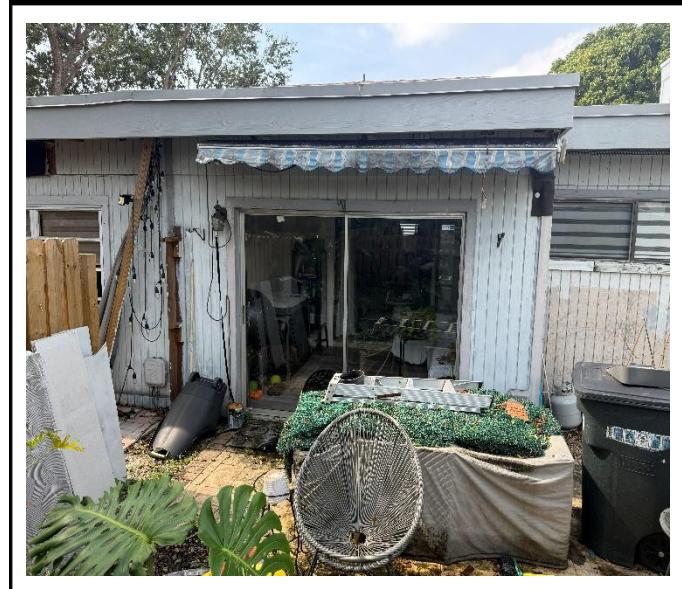
Photo 2 : Existing non-impact-rated Sliding Glass Door frame

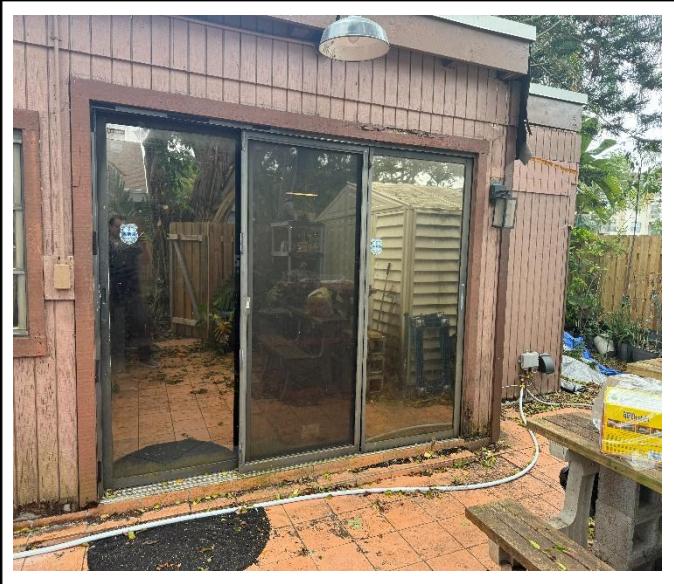
The Sliding Glass Doors are approximately 40 years old and show typical signs of aging, including potential air and water leakage, degraded seals, reduced energy efficiency, and possible corrosion and/or frame deterioration.

Photo 1 : Existing non-impact-rated Sliding Glass Door frame

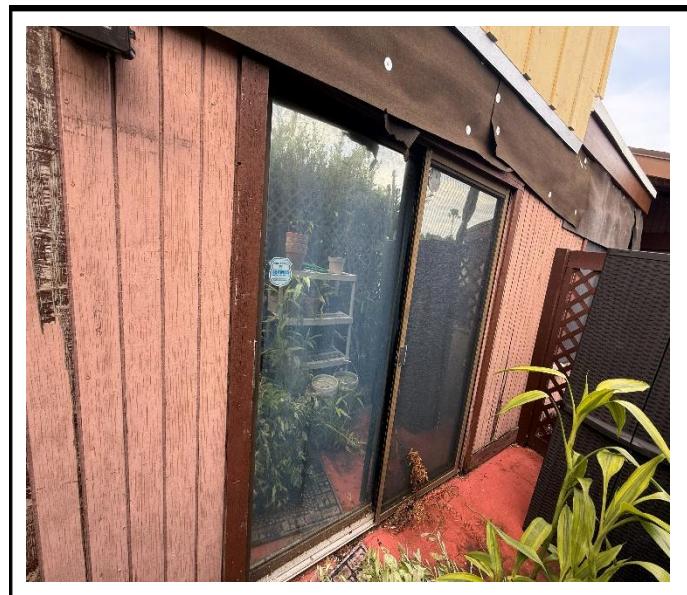
Photo 2 : Existing non-impact-rated Sliding Glass Door frame

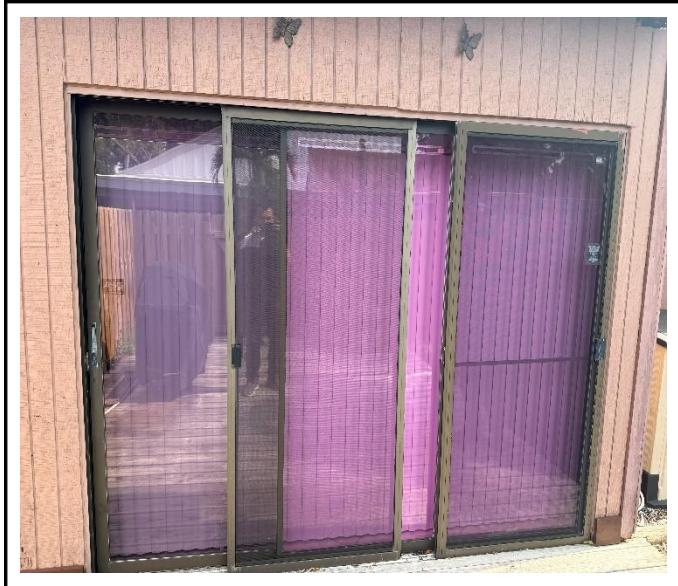
The Sliding Glass Doors are approximately 40 years old and show typical signs of aging, including potential air and water leakage, degraded seals, reduced energy efficiency, and possible corrosion and/or frame deterioration.

Photo 1 : Existing non-impact-rated Sliding Glass Door frame

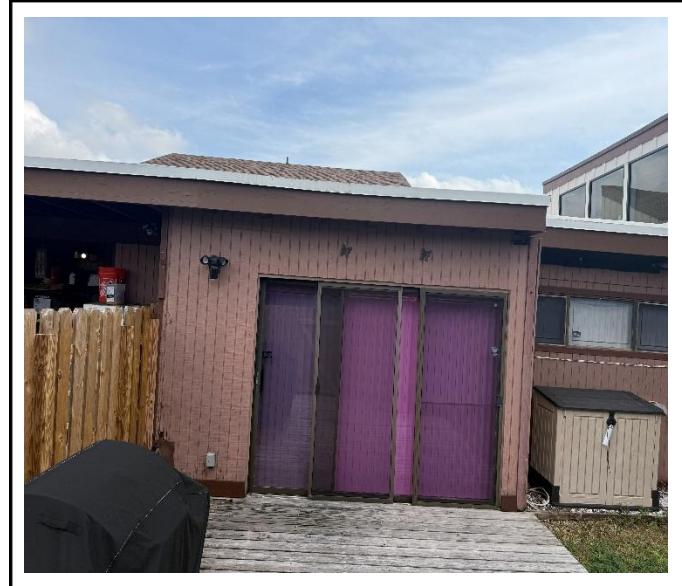
Photo 2 : Existing non-impact-rated Sliding Glass Door frame
