# Omega Villas Condominium Association

1713 NW 72 Avenue,  
Plantation, FL 33313

## **Windows Evaluation Report** (04/03/2025)

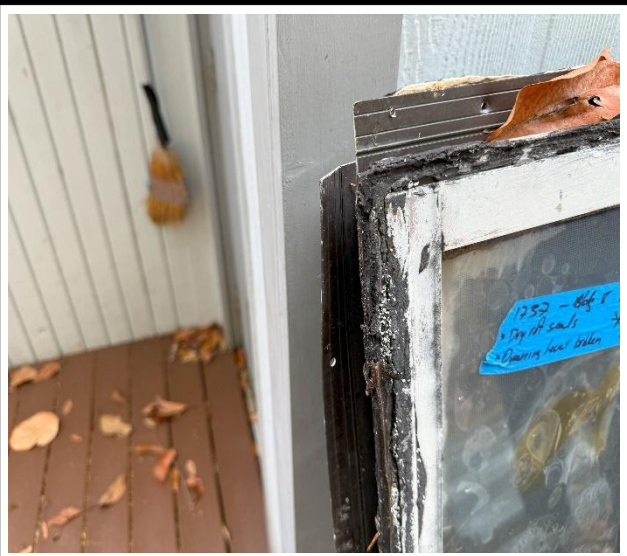
Photo 3 : Bad Window Frame
