# Omega Villas Condominium Association

1713 NW 72 Avenue,  
Plantation, FL 33313

## **Windows Evaluation Report** (04/03/2025)

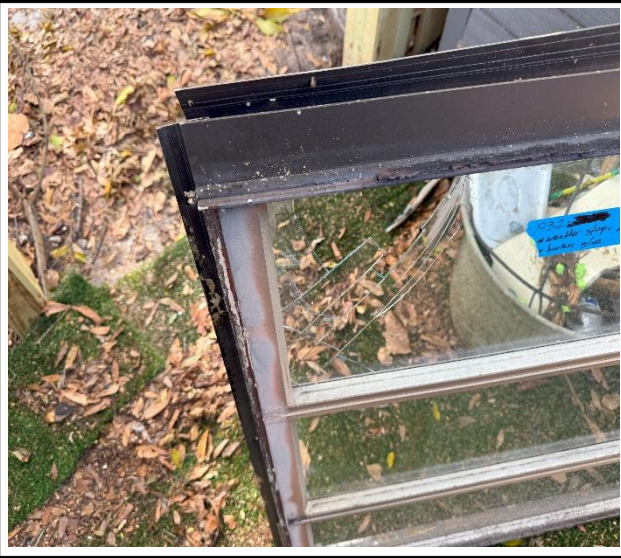
Photo 1 : Bad Frame

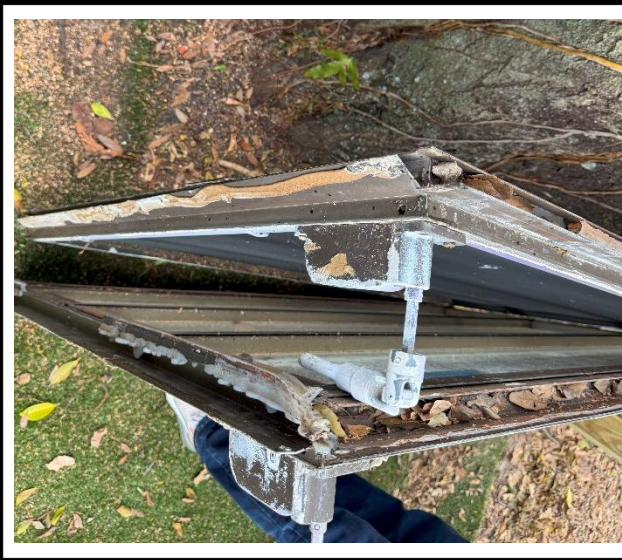
Photo 1 : Stuck Latch

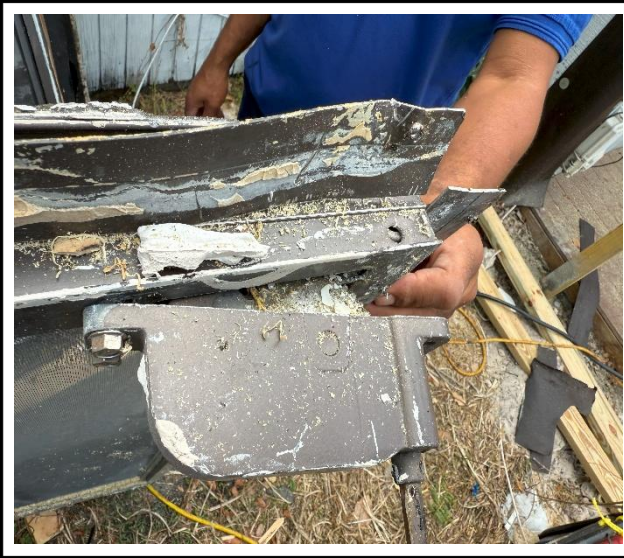
Photo 1 : Bad Latch

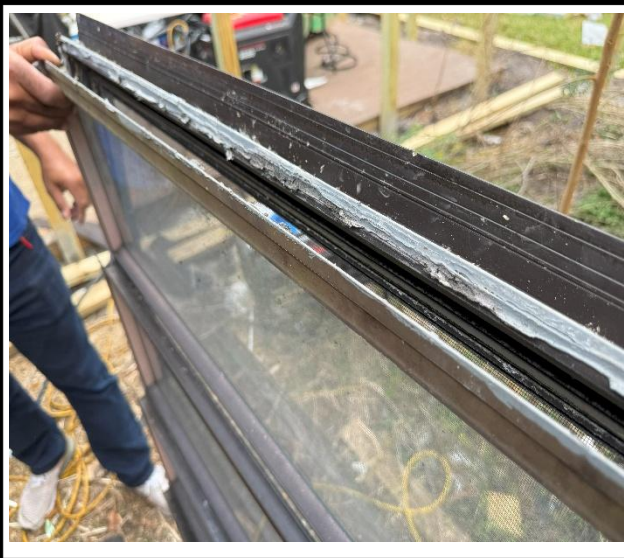
Photo 3 : Bad Weather Strip

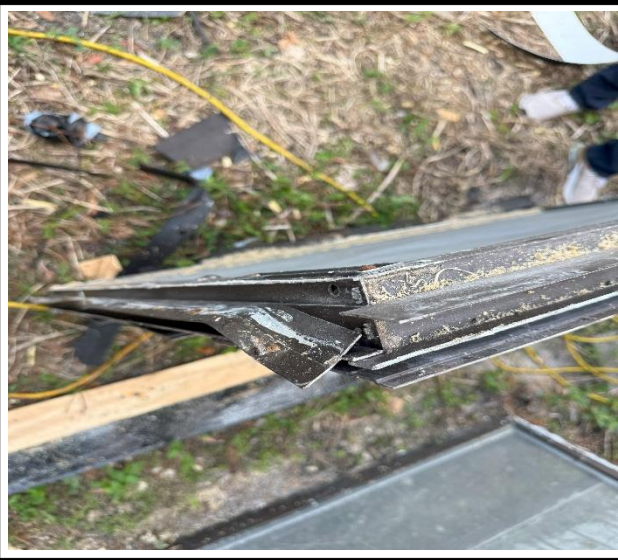
Photo 1 : Bad Frame

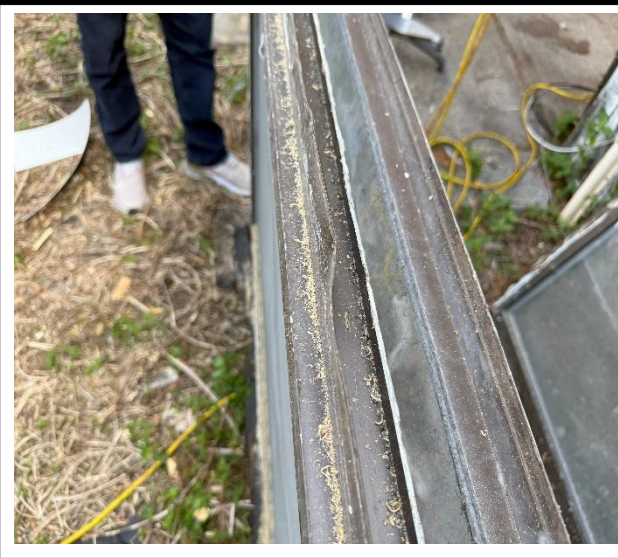
Photo 3 : Bad Freme
