Omega Villas Condominium Association

1713 NW 72 Avenue,  
Plantation, FL 33313

**Windows Evaluation Report**  
**BLDGs 1 to 15**  
(07/23/2025)

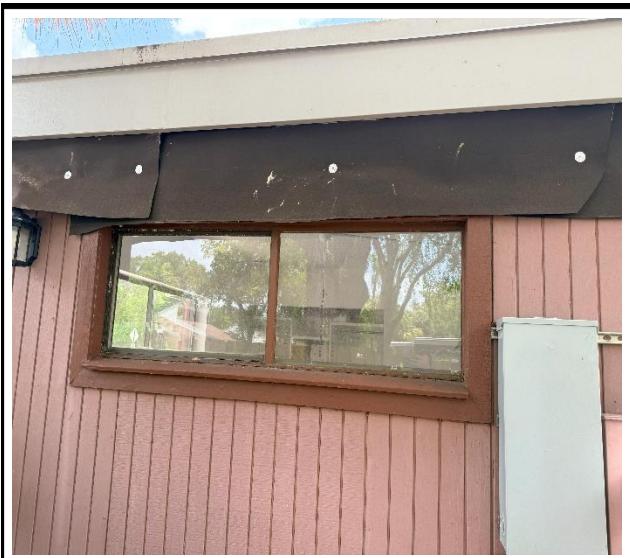
The windows are approximately 40 years old and show typical signs of aging, including potential air and water leakage, degraded seals, reduced energy efficiency, and possible corrosion and/or frame deterioration.

Photo 1 : Existing non-impact-rated window frame

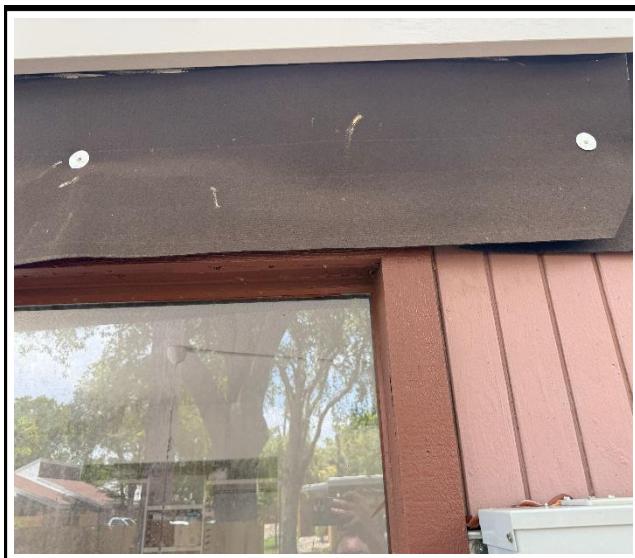
Photo 2 : Existing non-impact-rated window frame

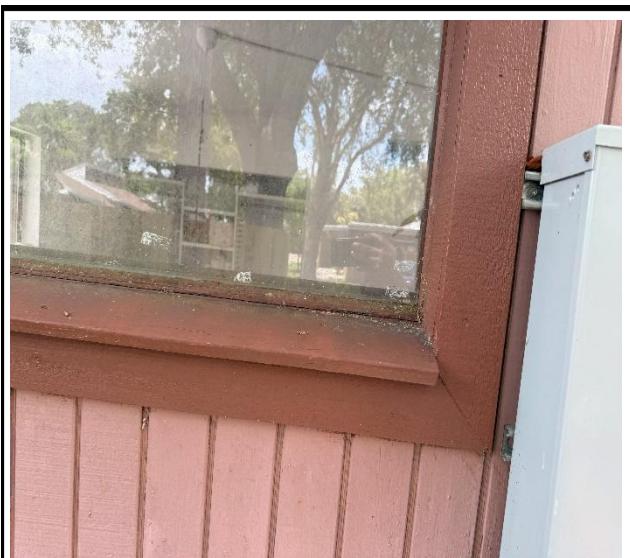
Photo 3 : Existing non-impact-rated window frame

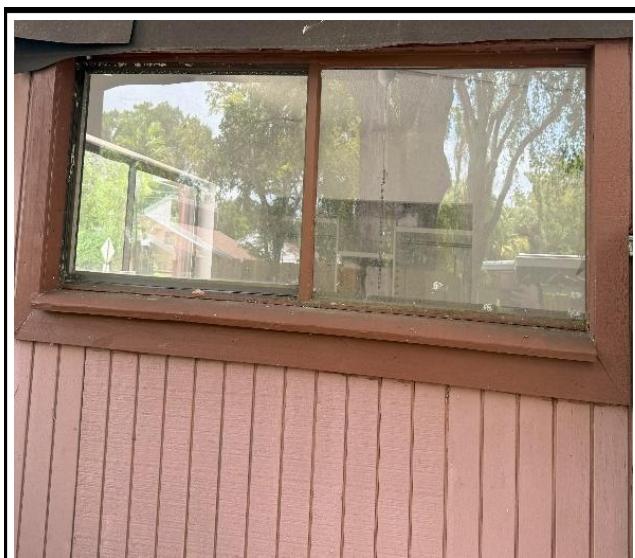
Photo 4 : Existing non-impact-rated window frame

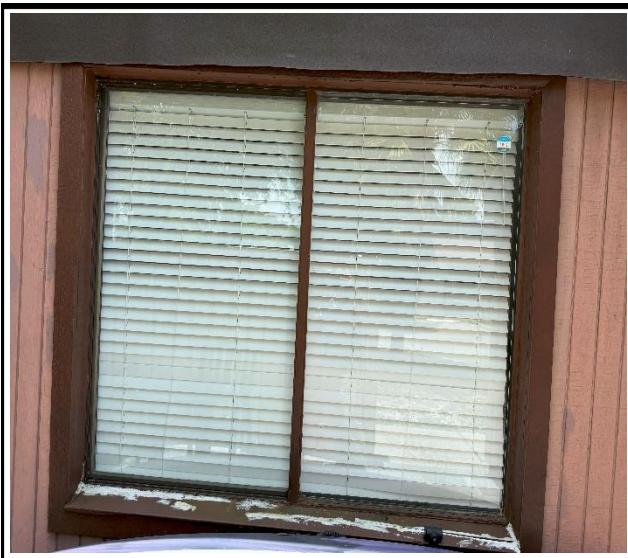
The windows are approximately 40 years old and show typical signs of aging, including potential air and water leakage, degraded seals, reduced energy efficiency, and possible corrosion and/or frame deterioration.

Photo 1 : Existing non-impact-rated window frame

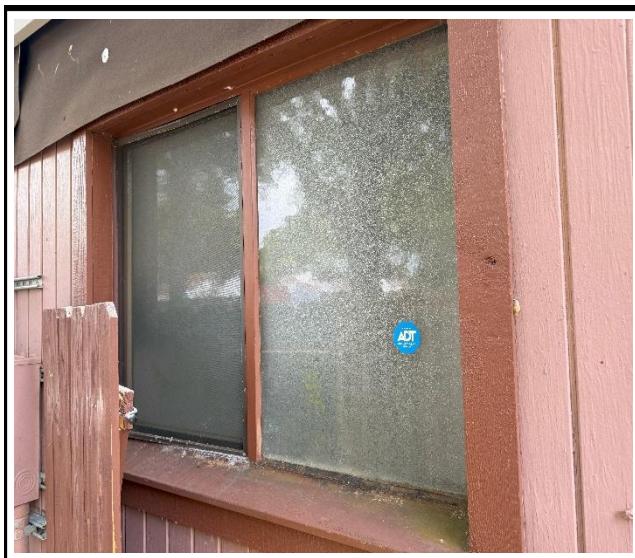
Photo 2 : Existing non-impact-rated window frame

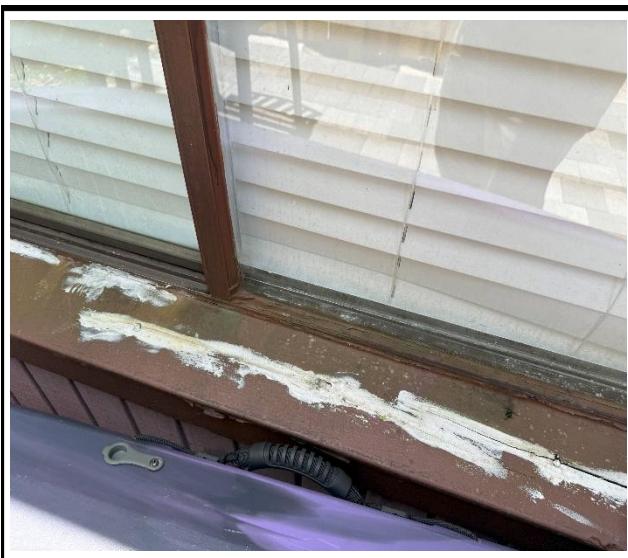
Photo 3 : Existing non-impact-rated window frame

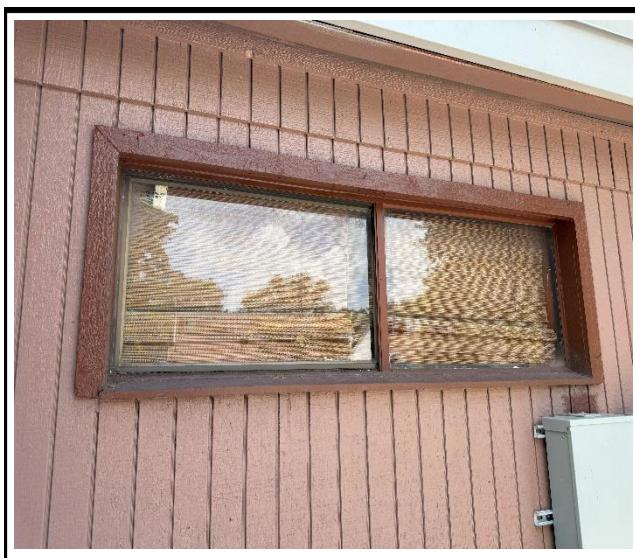
Photo 4 : Existing non-impact-rated window frame

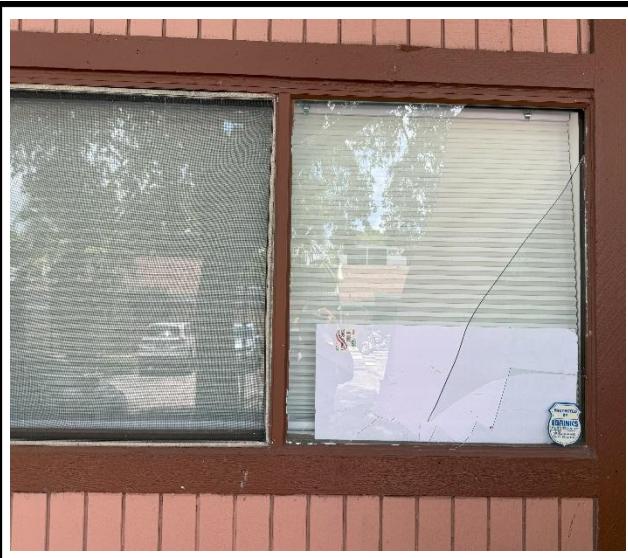
The windows are approximately 40 years old and show typical signs of aging, including potential air and water leakage, degraded seals, reduced energy efficiency, and possible corrosion and/or frame deterioration.

Photo 1 : Existing non-impact-rated window frame

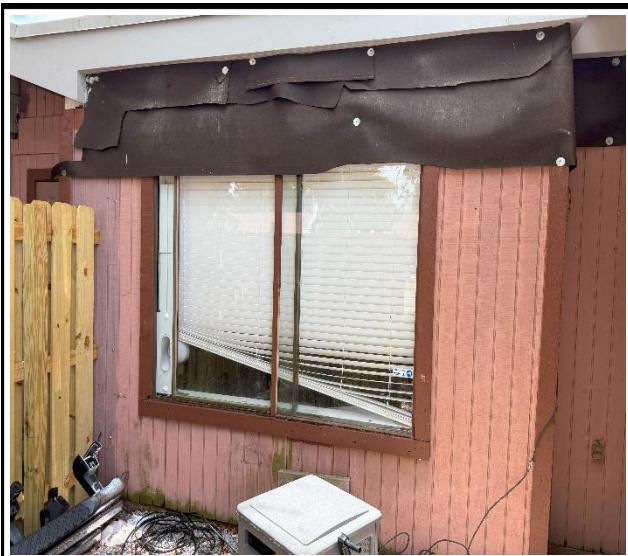
The windows are approximately 40 years old and show typical signs of aging, including potential air and water leakage, degraded seals, reduced energy efficiency, and possible corrosion and/or frame deterioration.

Photo 1 : Existing non-impact-rated window frame

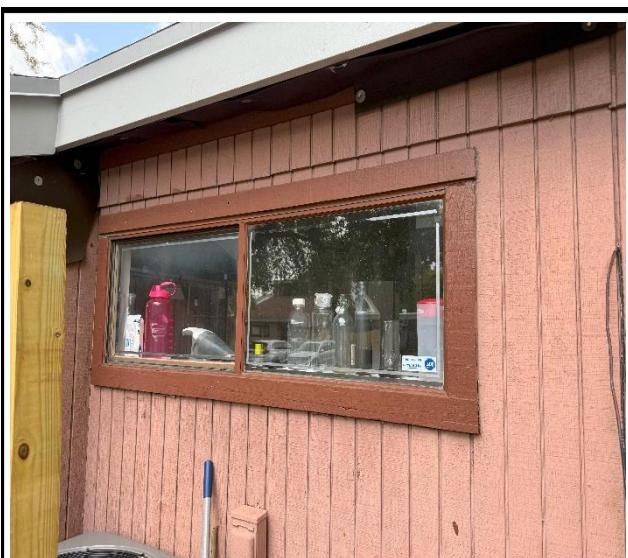
Photo 3 : Existing non-impact-rated window frame

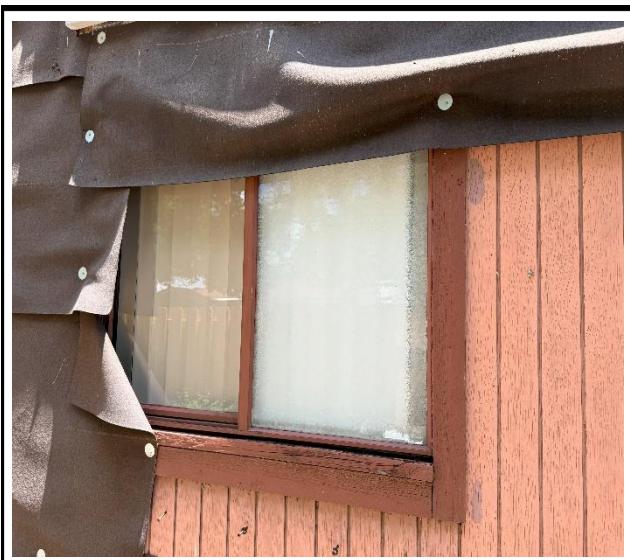
The windows are approximately 40 years old and show typical signs of aging, including potential air and water leakage, degraded seals, reduced energy efficiency, and possible corrosion and/or frame deterioration.

Photo 1 : Existing non-impact-rated window frame

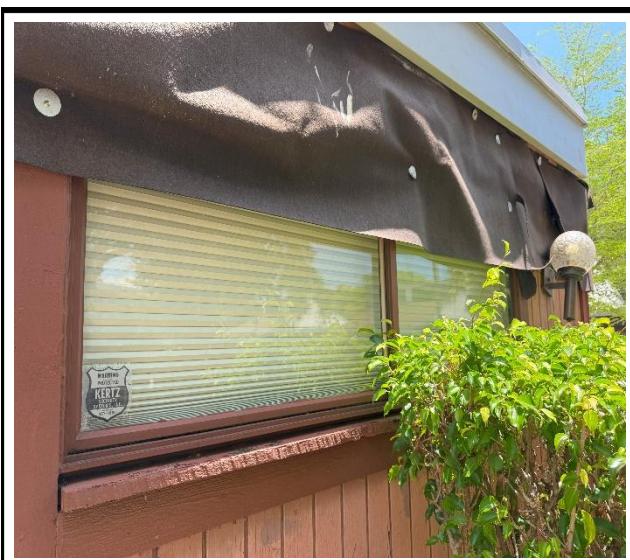
Photo 2 : Existing non-impact-rated window frame

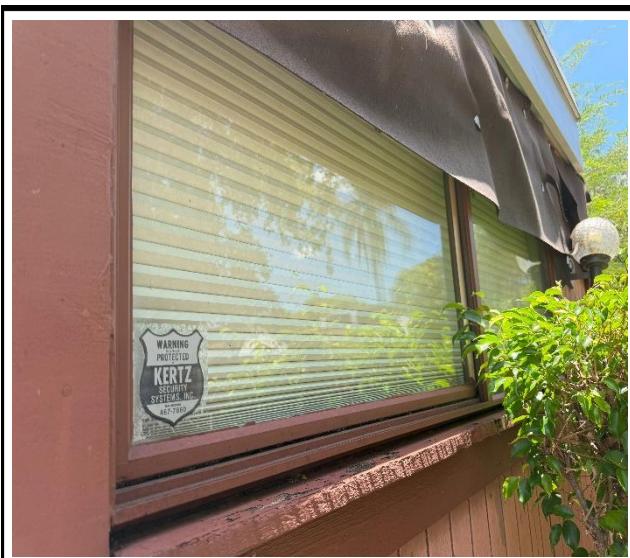
Photo 3 : Existing non-impact-rated window frame

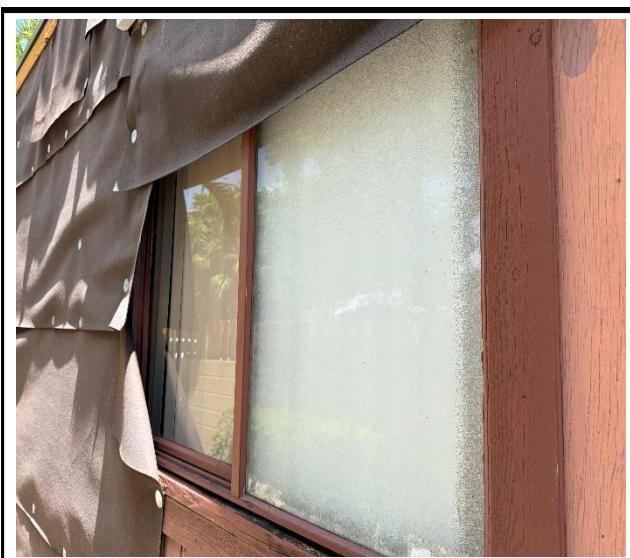
Photo 4 : Existing non-impact-rated window frame

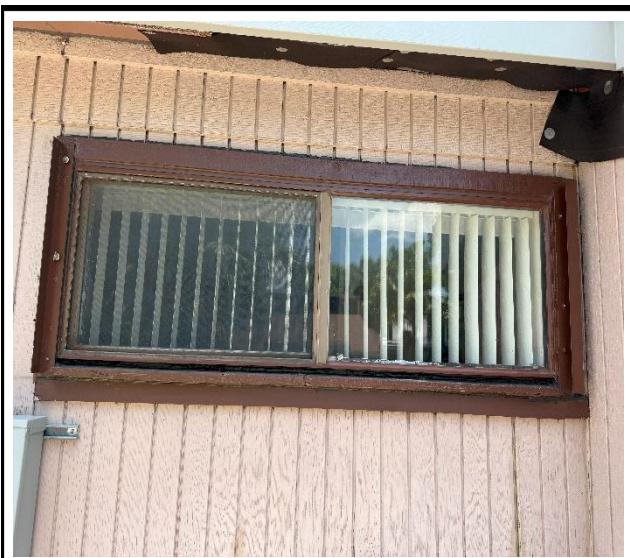
The windows are approximately 40 years old and show typical signs of aging, including potential air and water leakage, degraded seals, reduced energy efficiency, and possible corrosion and/or frame deterioration.

Photo 1 : Existing non-impact-rated window frame

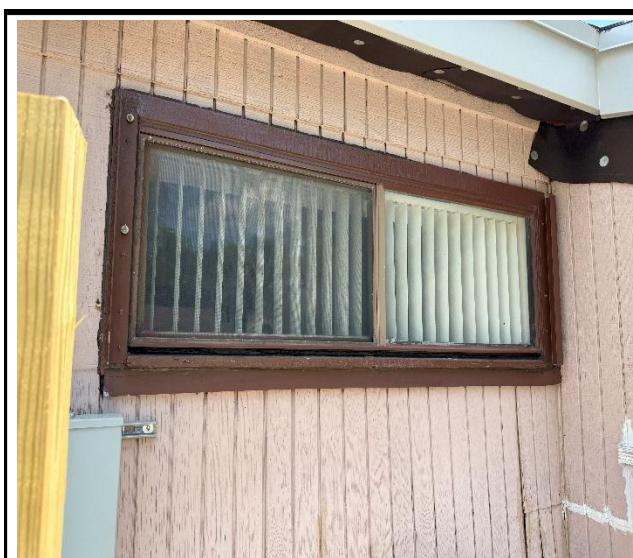
Photo 4 : Existing non-impact-rated window frame

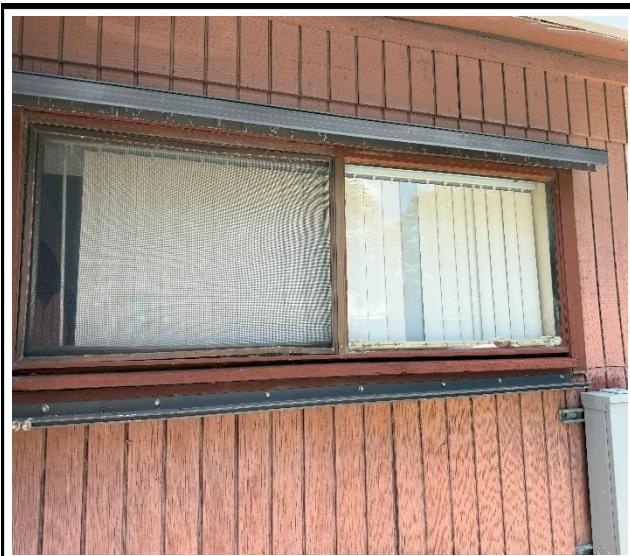
The windows are approximately 40 years old and show typical signs of aging, including potential air and water leakage, degraded seals, reduced energy efficiency, and possible corrosion and/or frame deterioration.

Photo 1 : Existing non-impact-rated window frame

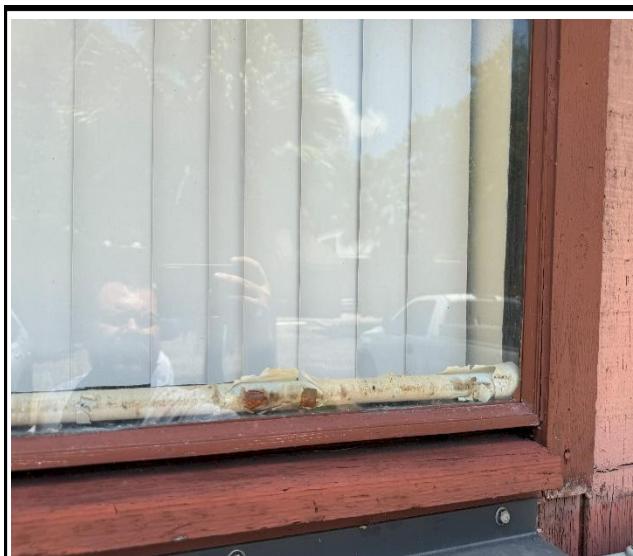
Photo 2 : Existing non-impact-rated window frame

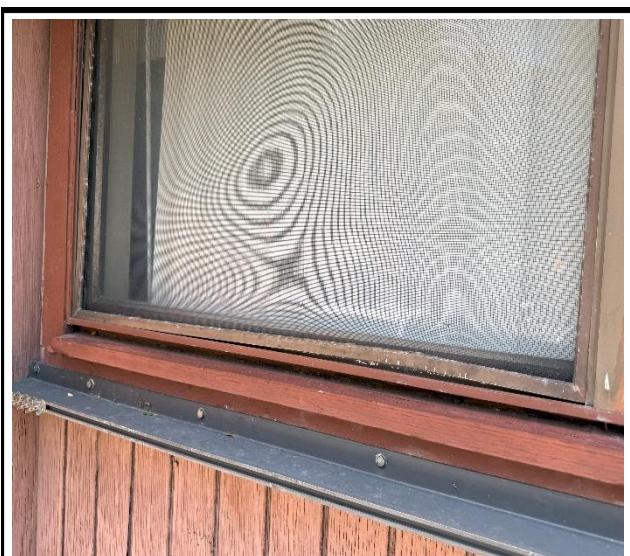
Photo 3 : Existing non-impact-rated window frame

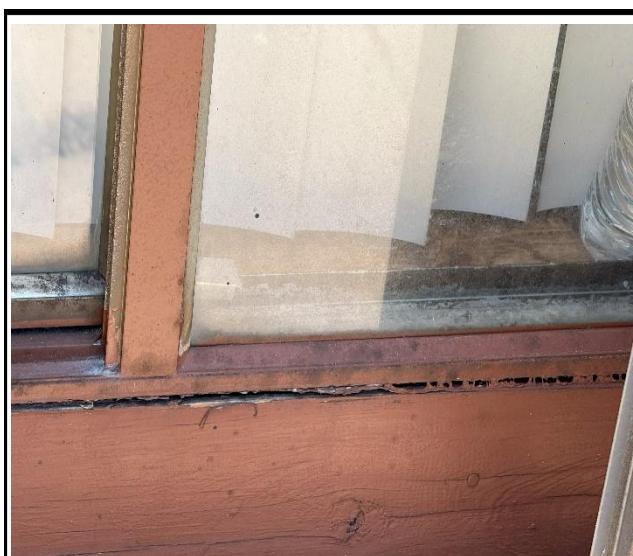
Photo 4 : Existing non-impact-rated window frame

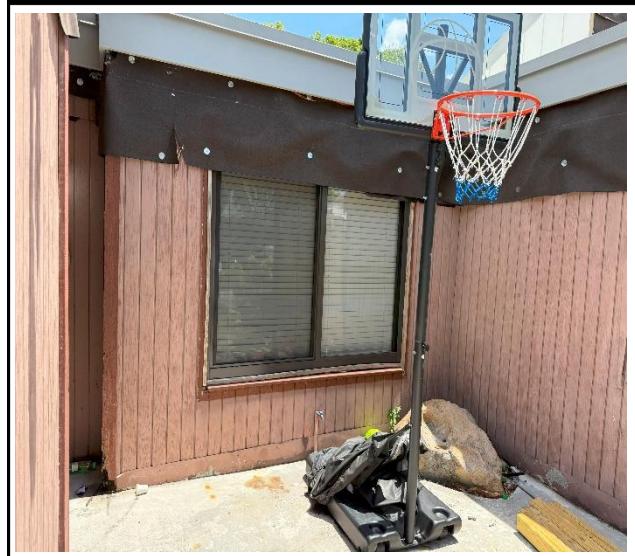
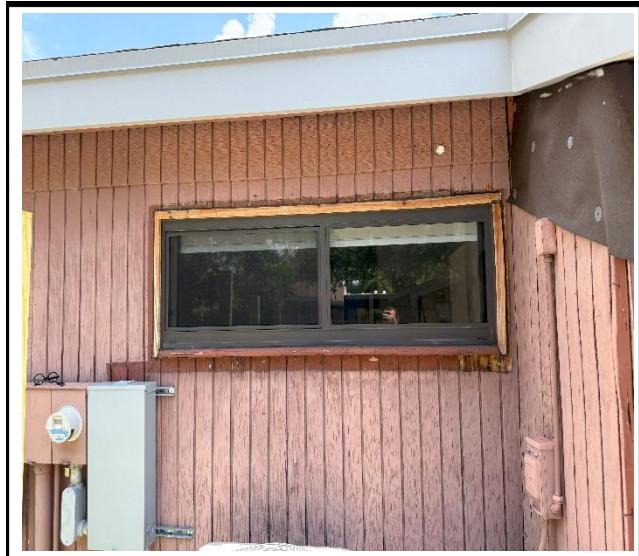
Component Decision	Good	Bad	Unknown
Window Frame	✗		
Latch			✗
Weather Strip	✗		
Sill	✗		
Glass	✗

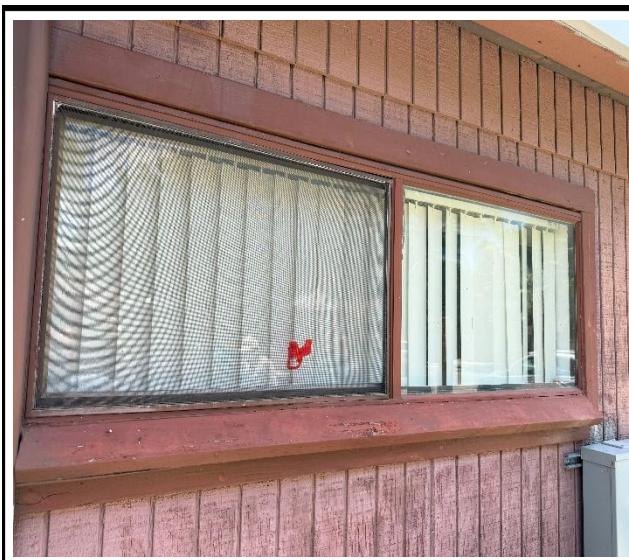
The windows are approximately 40 years old and show typical signs of aging, including potential air and water leakage, degraded seals, reduced energy efficiency, and possible corrosion and/or frame deterioration.

Photo 1 : Existing non-impact-rated window frame

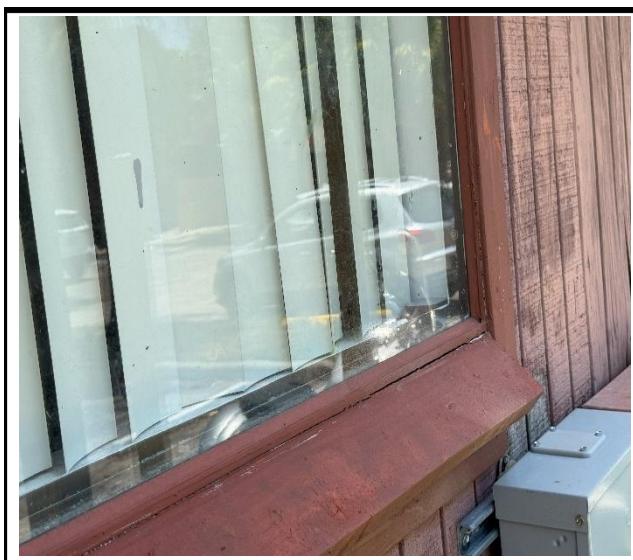
Photo 2 : Existing non-impact-rated window frame

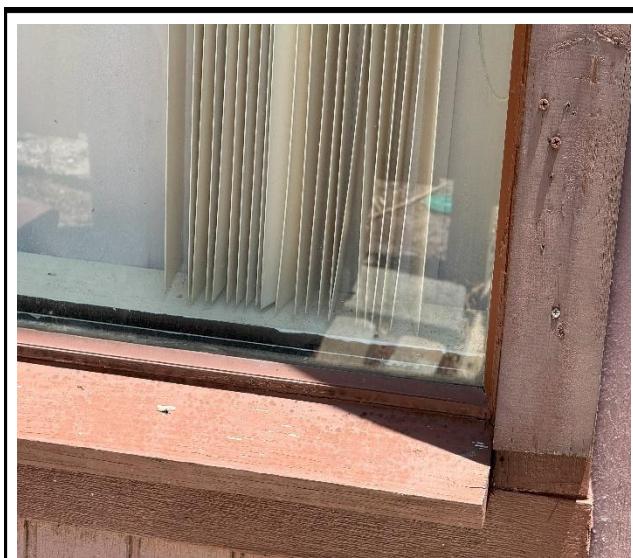
Photo 4 : Existing non-impact-rated window frame

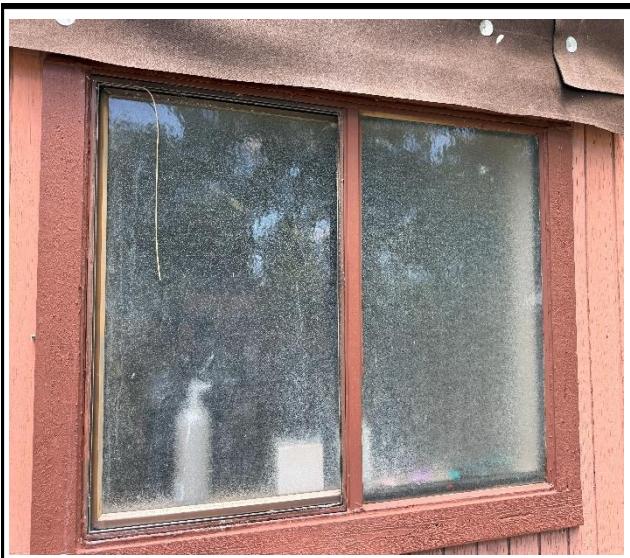
The windows are approximately 40 years old and show typical signs of aging, including potential air and water leakage, degraded seals, reduced energy efficiency, and possible corrosion and/or frame deterioration.

Photo 1 : Existing non-impact-rated window frame

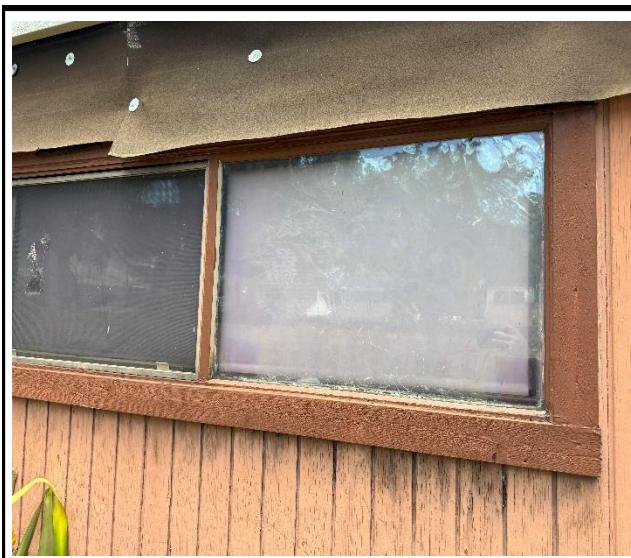
Photo 2 : Existing non-impact-rated window frame

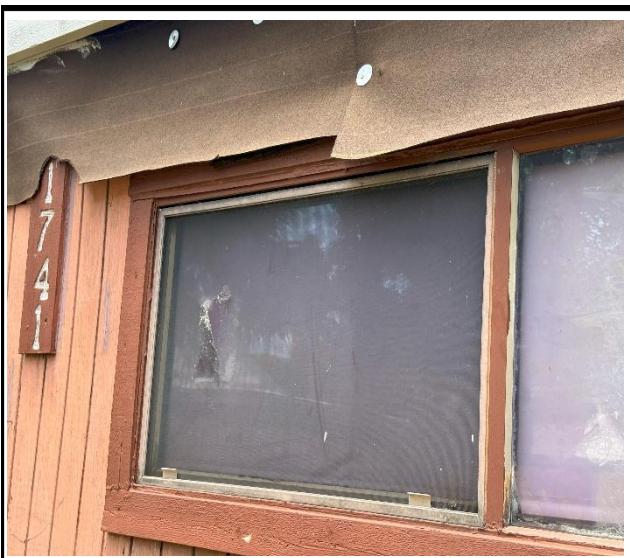
Photo 3 : Existing non-impact-rated window frame

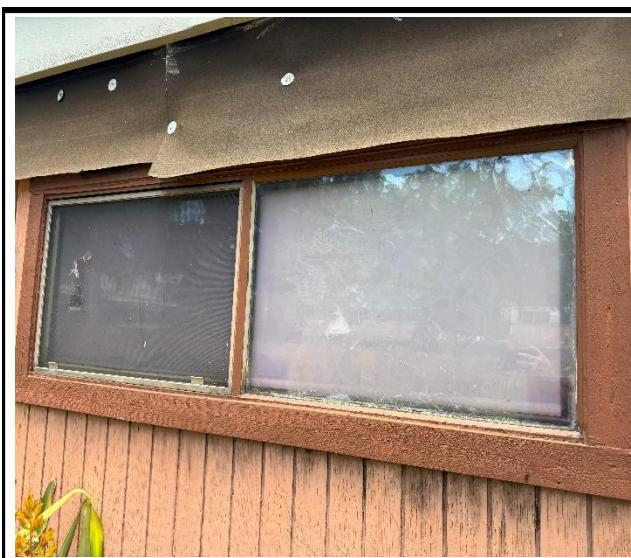
Photo 4 : Existing non-impact-rated window frame

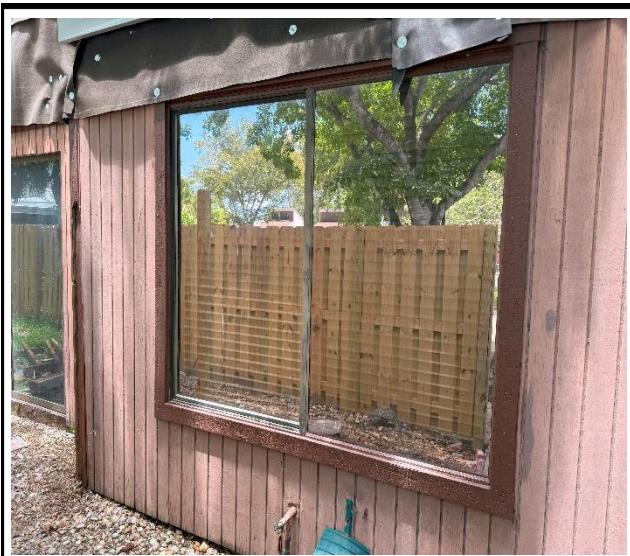
The windows are approximately 40 years old and show typical signs of aging, including potential air and water leakage, degraded seals, reduced energy efficiency, and possible corrosion and/or frame deterioration.

Photo 1 : Existing non-impact-rated window frame

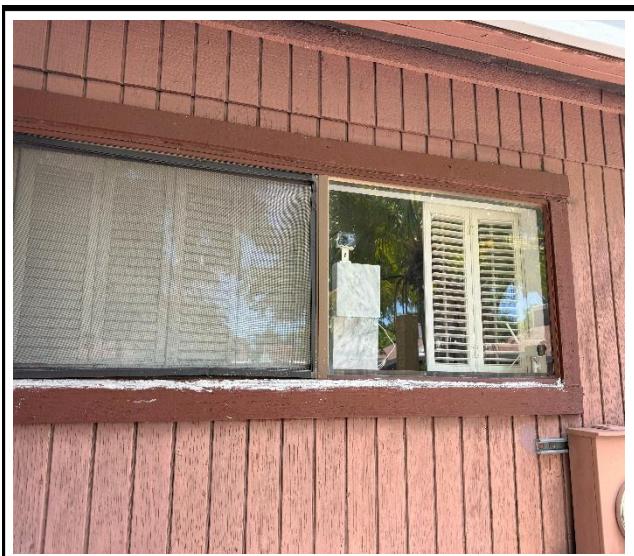
Photo 2 : Existing non-impact-rated window frame

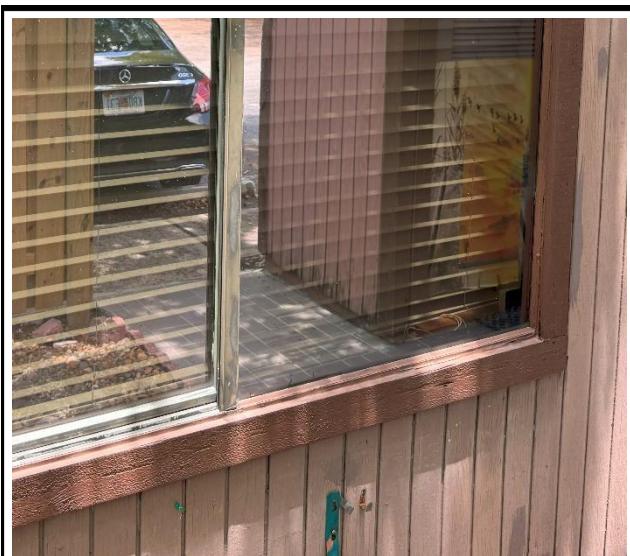
Photo 3 : Existing non-impact-rated window frame

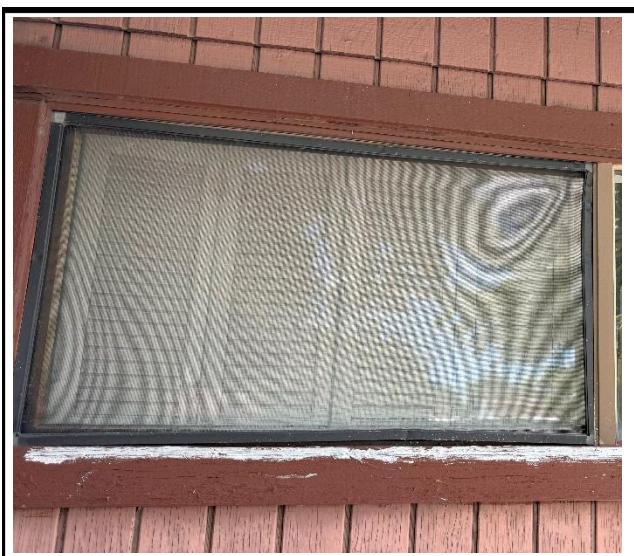
Photo 4 : Existing non-impact-rated window frame

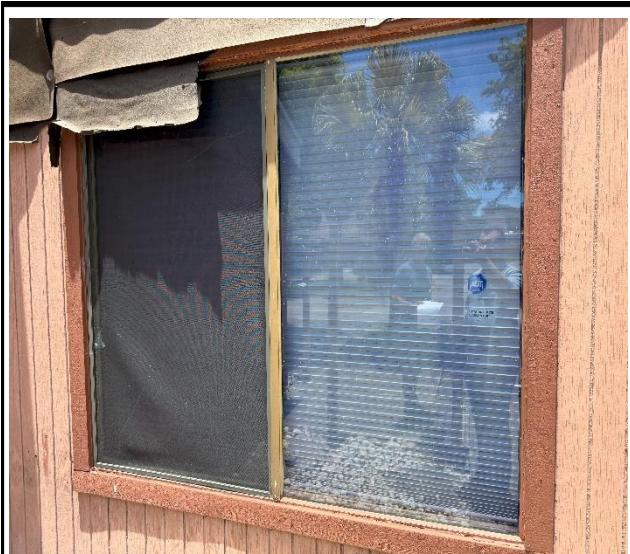
The windows are approximately 40 years old and show typical signs of aging, including potential air and water leakage, degraded seals, reduced energy efficiency, and possible corrosion and/or frame deterioration.

Photo 1 : Existing non-impact-rated window frame

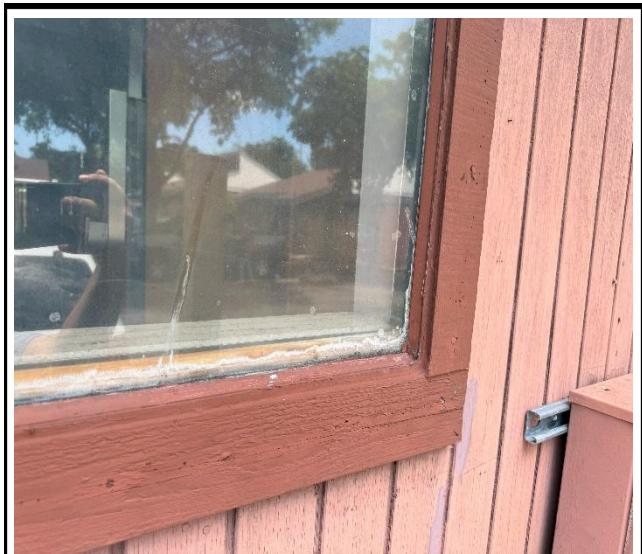
Photo 2 : Existing non-impact-rated window frame

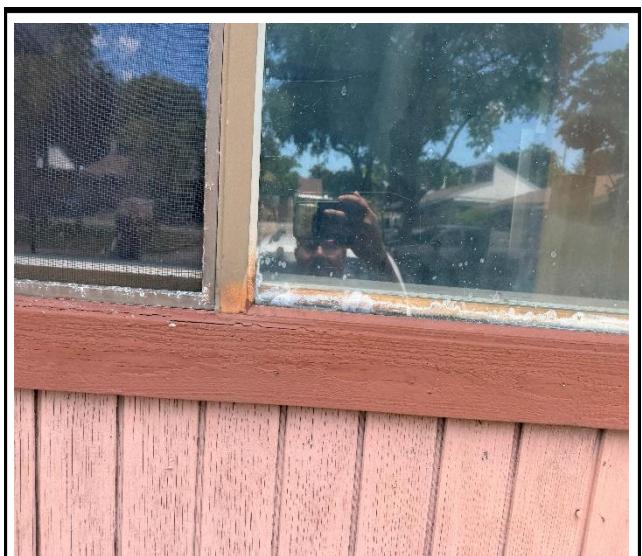
Photo 4 : Existing non-impact-rated window frame

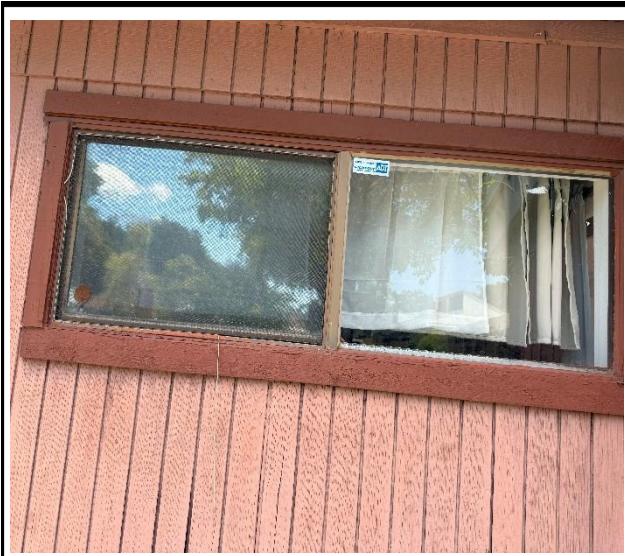
The windows are approximately 40 years old and show typical signs of aging, including potential air and water leakage, degraded seals, reduced energy efficiency, and possible corrosion and/or frame deterioration.

Photo 1 : Existing non-impact-rated window frame

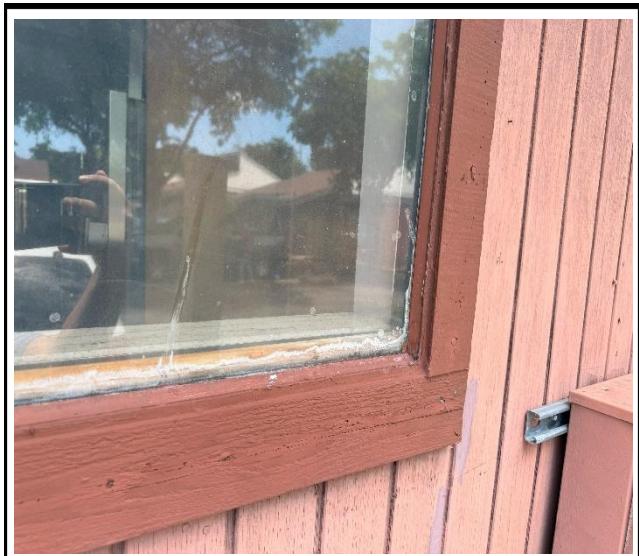
Photo 2 : Existing non-impact-rated window frame

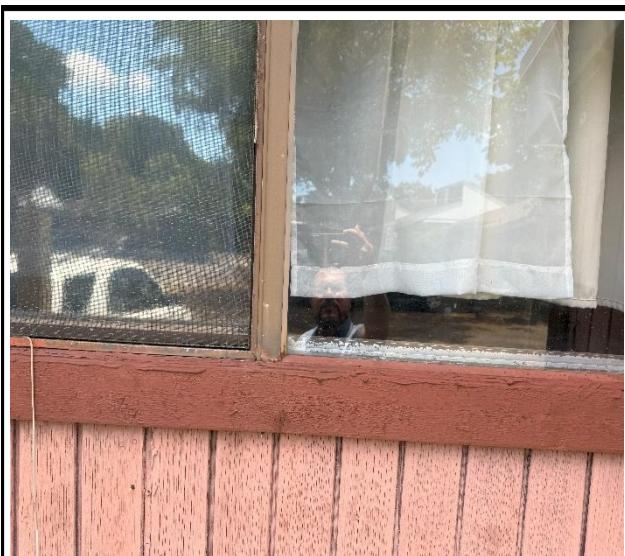
Photo 3 : Existing non-impact-rated window frame

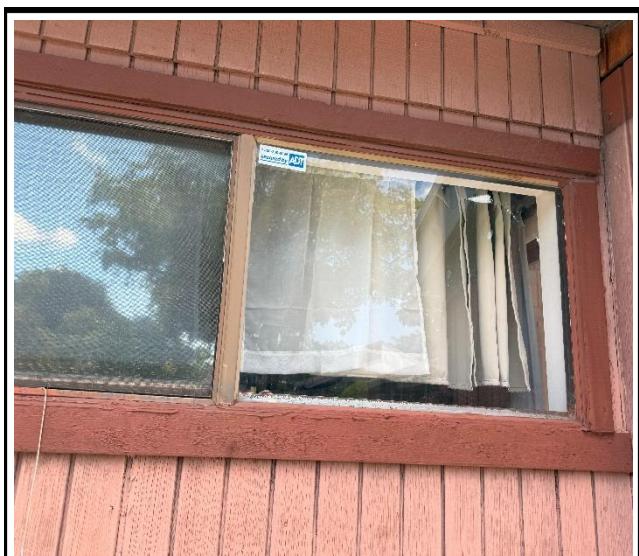
Photo 4 : Existing non-impact-rated window frame

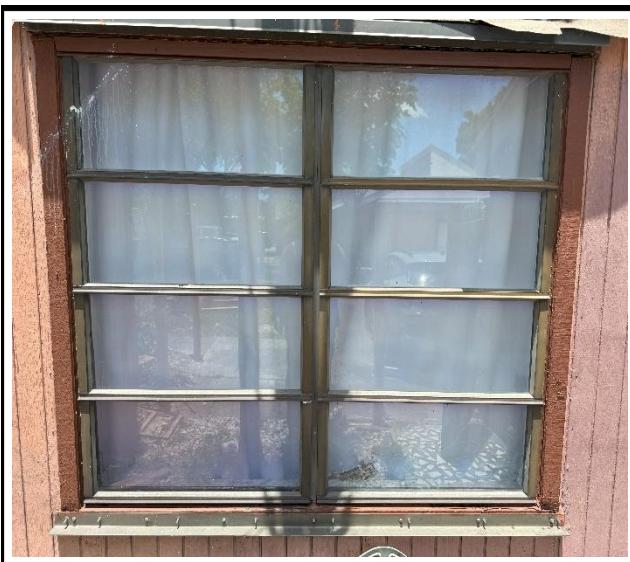
The windows are approximately 40 years old and show typical signs of aging, including potential air and water leakage, degraded seals, reduced energy efficiency, and possible corrosion and/or frame deterioration.

Photo 1 : Existing non-impact-rated window frame

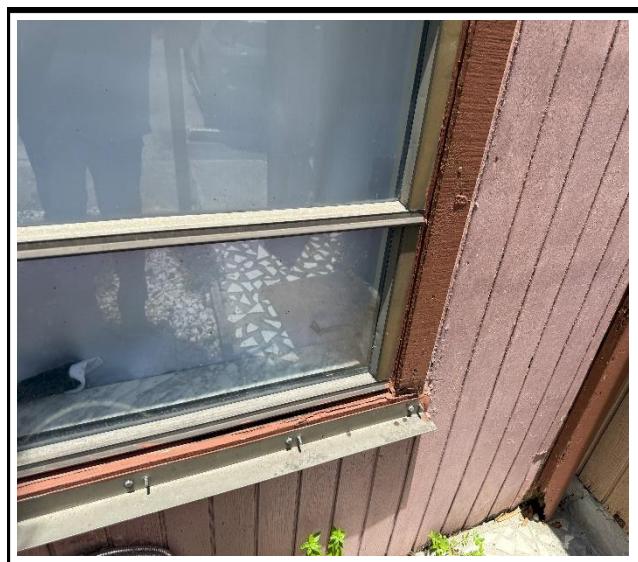
Photo 2 : Existing non-impact-rated window frame

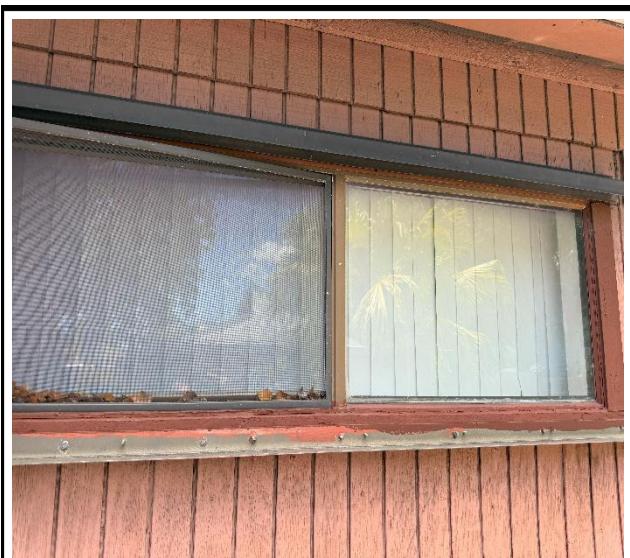
Photo 3 : Existing non-impact-rated window frame

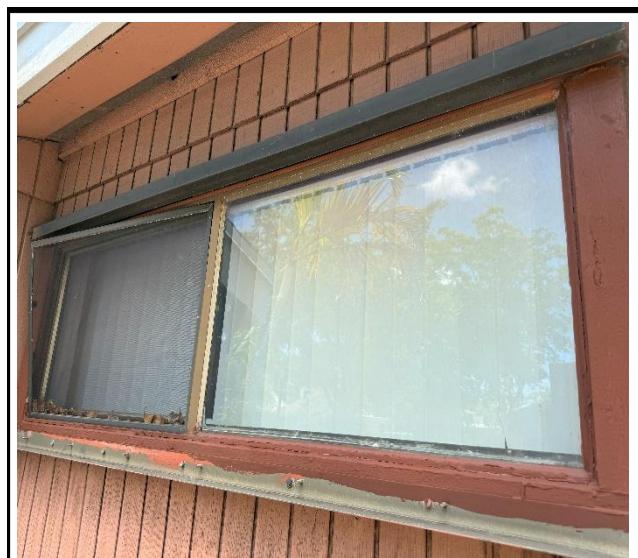
Photo 4 : Existing non-impact-rated window frame

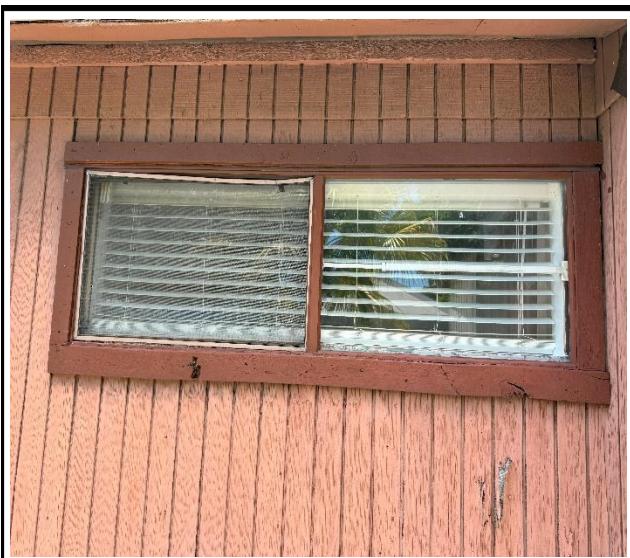
The windows are approximately 40 years old and show typical signs of aging, including potential air and water leakage, degraded seals, reduced energy efficiency, and possible corrosion and/or frame deterioration.

Photo 1 : Existing non-impact-rated window frame

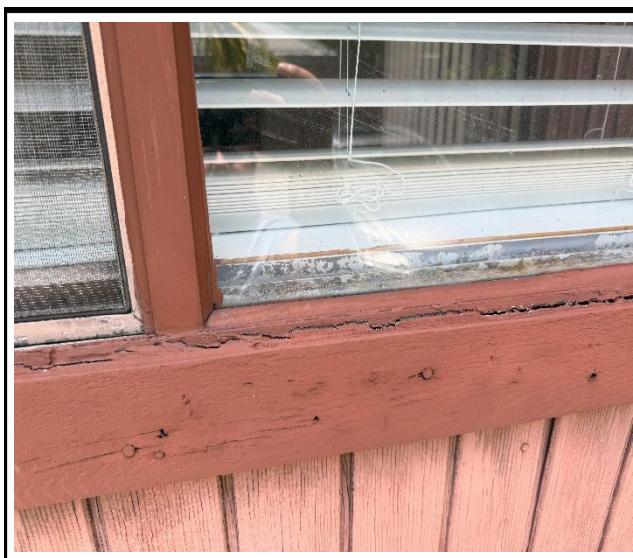
Photo 2 : Existing non-impact-rated window frame

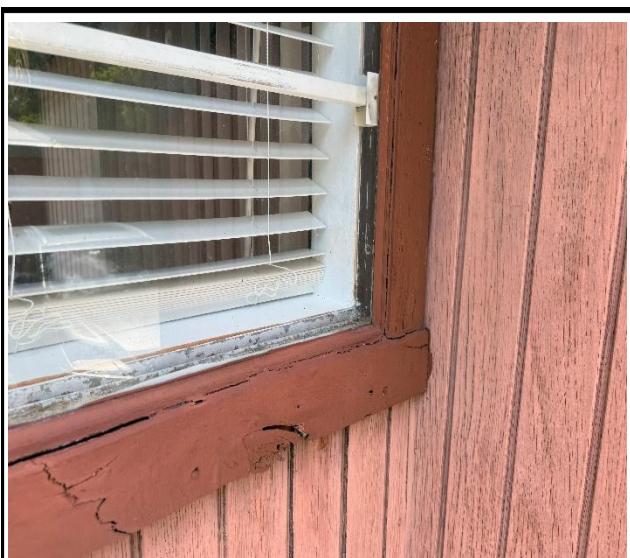
Photo 3 : Existing non-impact-rated window frame

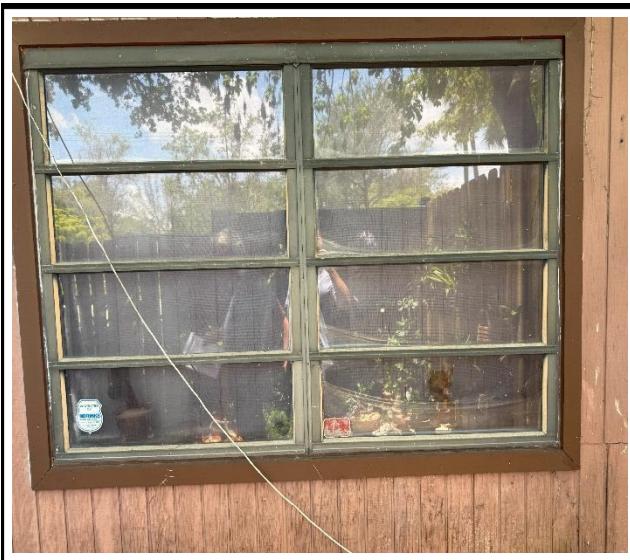
The windows are approximately 40 years old and show typical signs of aging, including potential air and water leakage, degraded seals, reduced energy efficiency, and possible corrosion and/or frame deterioration.

Photo 1 : Existing non-impact-rated window frame

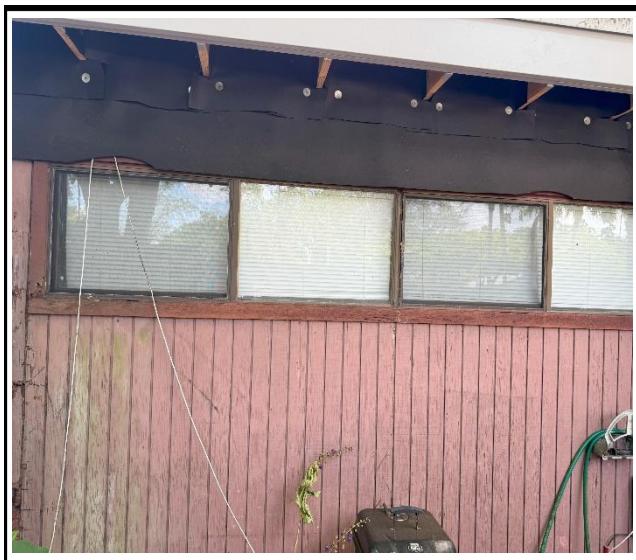
Photo 2 : Existing non-impact-rated window frame

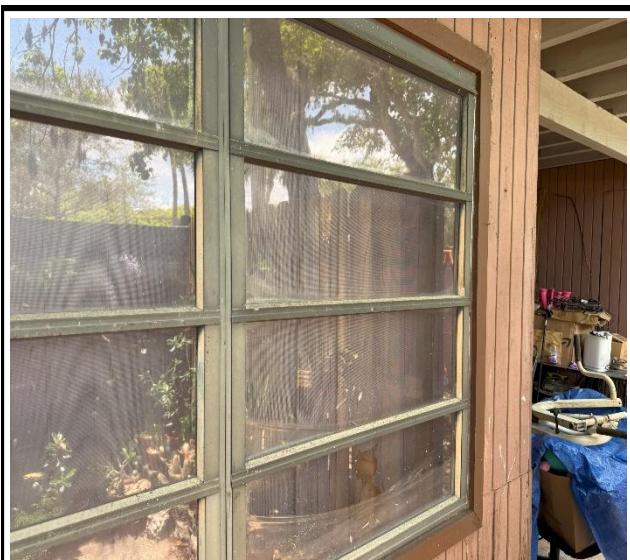
Photo 3 : Existing non-impact-rated window frame

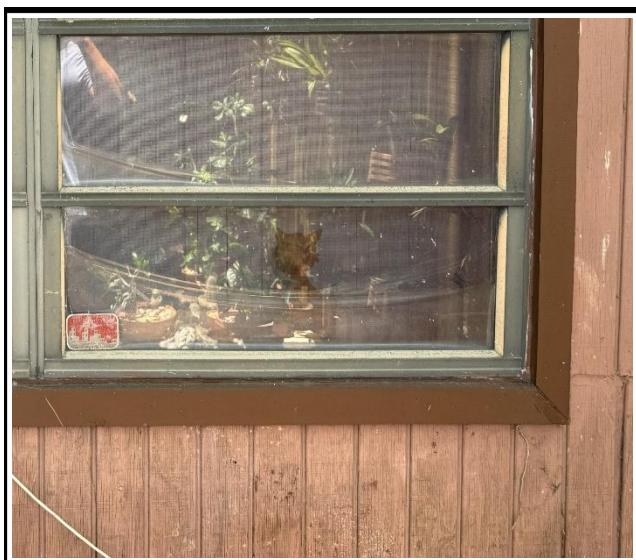
Photo 4 : Existing non-impact-rated window frame

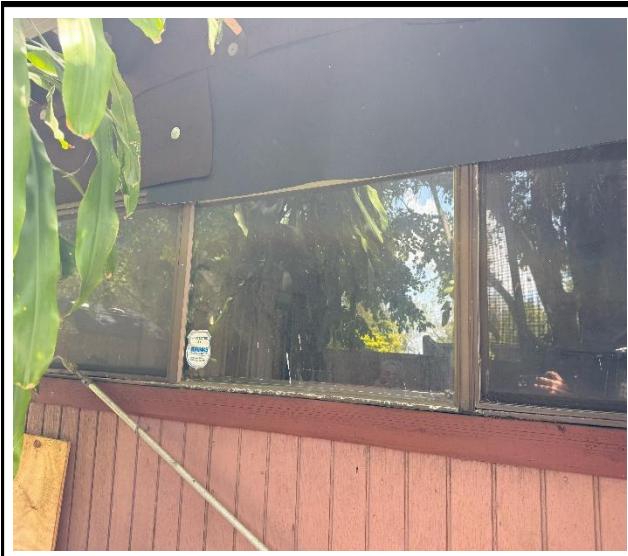
The windows are approximately 40 years old and show typical signs of aging, including potential air and water leakage, degraded seals, reduced energy efficiency, and possible corrosion and/or frame deterioration.

Photo 1 : Existing non-impact-rated window frame

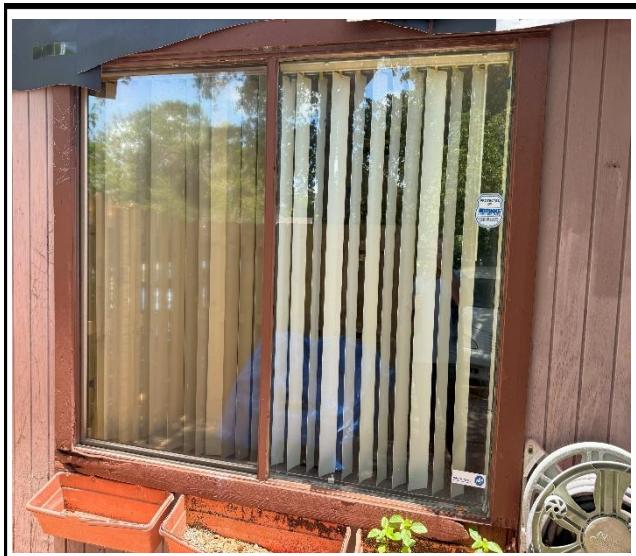
Photo 2 : Existing non-impact-rated window frame

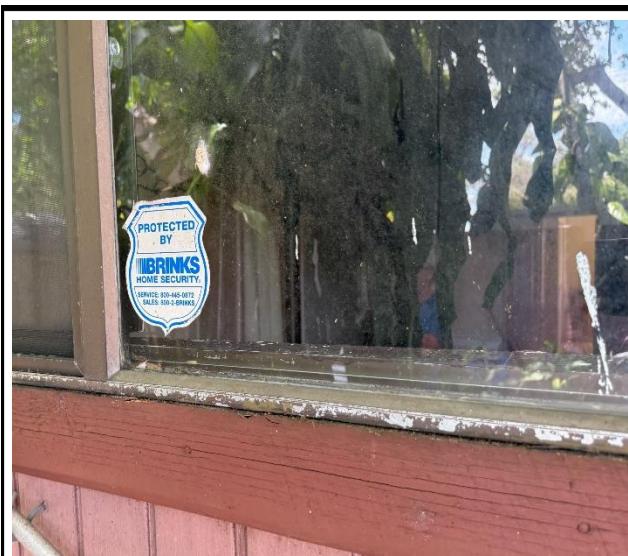
Photo 3 : Existing non-impact-rated window frame

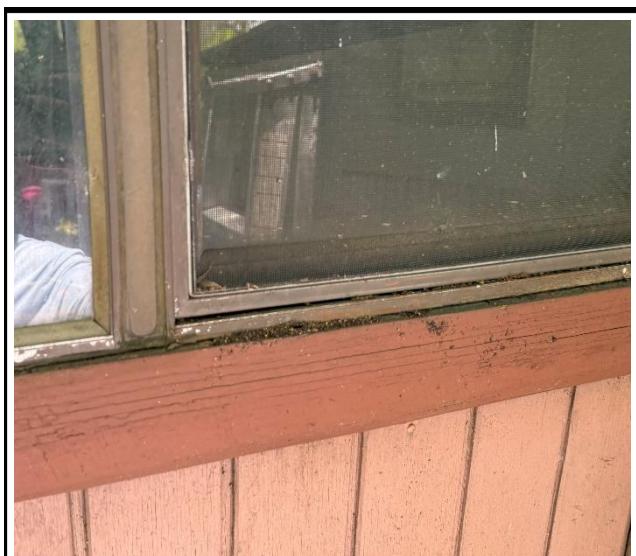
Photo 4 : Existing non-impact-rated window frame

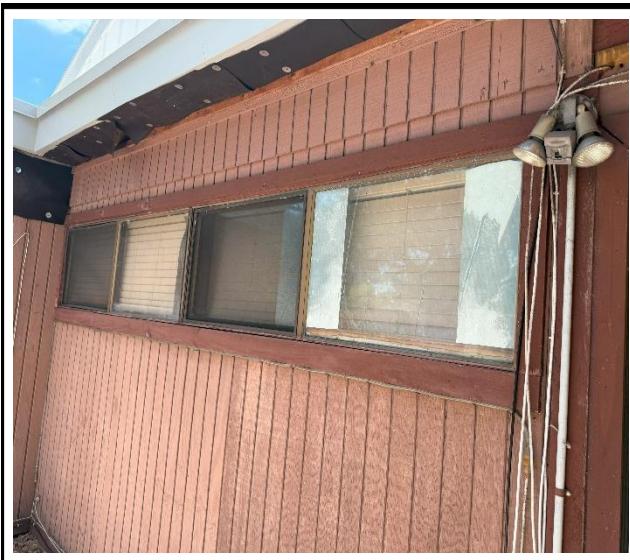
The windows are approximately 40 years old and show typical signs of aging, including potential air and water leakage, degraded seals, reduced energy efficiency, and possible corrosion and/or frame deterioration.

Photo 1 : Existing non-impact-rated window frame

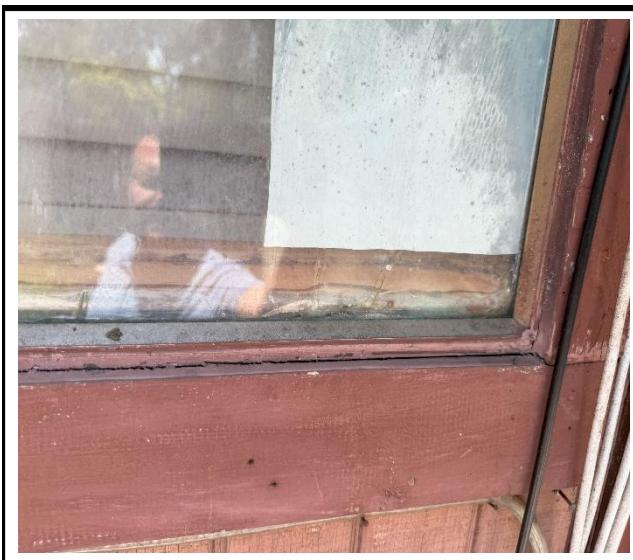
Photo 2 : Existing non-impact-rated window frame

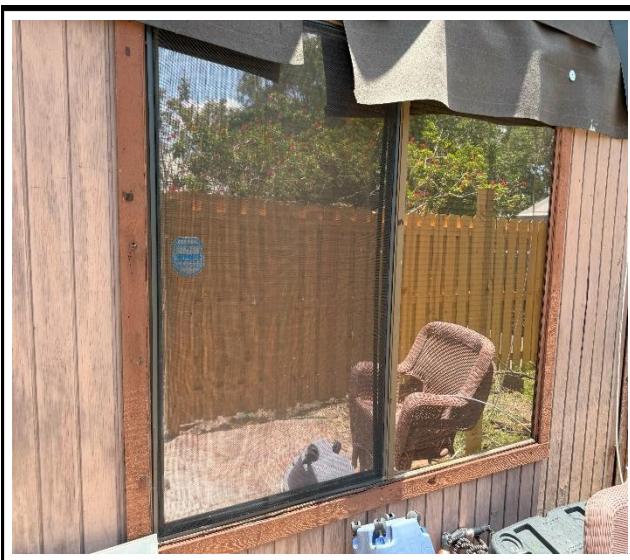
Photo 3 : Existing non-impact-rated window frame

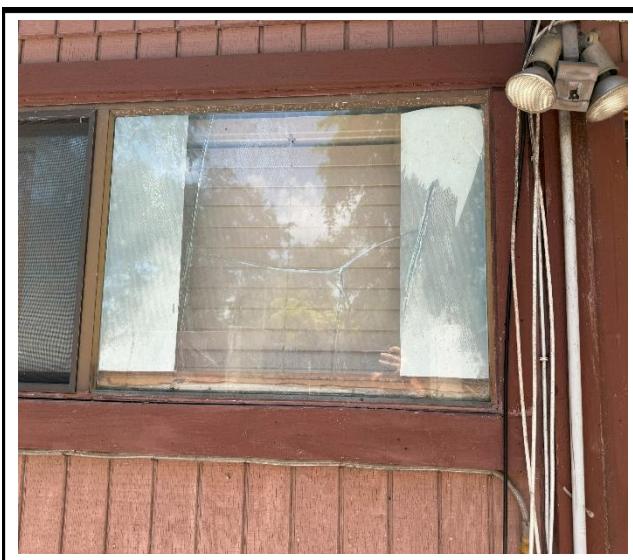
Photo 4 : Existing non-impact-rated window frame
