Omega Villas Condominium Association

1713 NW 72 Avenue,  
Plantation, FL 33313

**Windows Evaluation Report**  
**BLDGs 1 to 15**  
(07/23/2025)

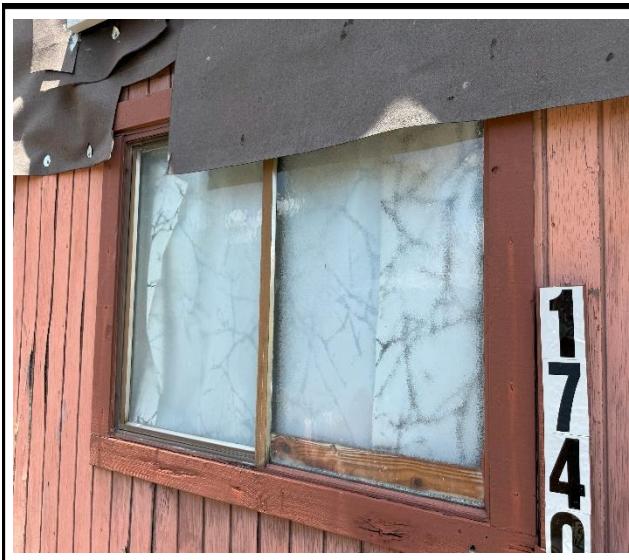
The windows are approximately 40 years old and show typical signs of aging, including potential air and water leakage, degraded seals, reduced energy efficiency, and possible corrosion and/or frame deterioration.

Photo 1 : Existing non-impact-rated window frame

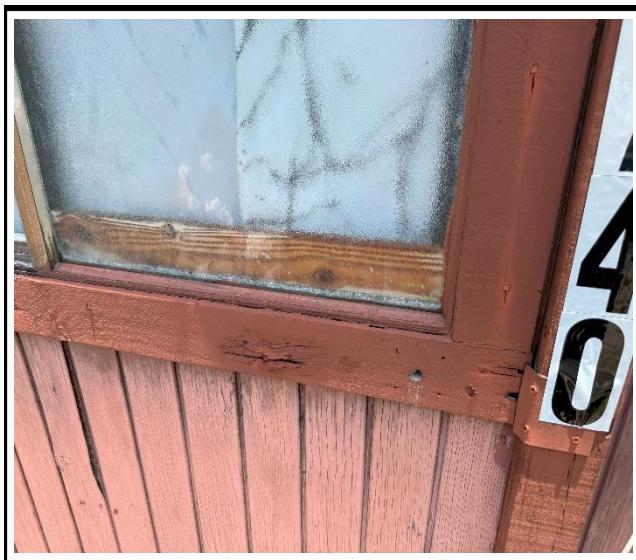
Photo 2 : Existing non-impact-rated window frame

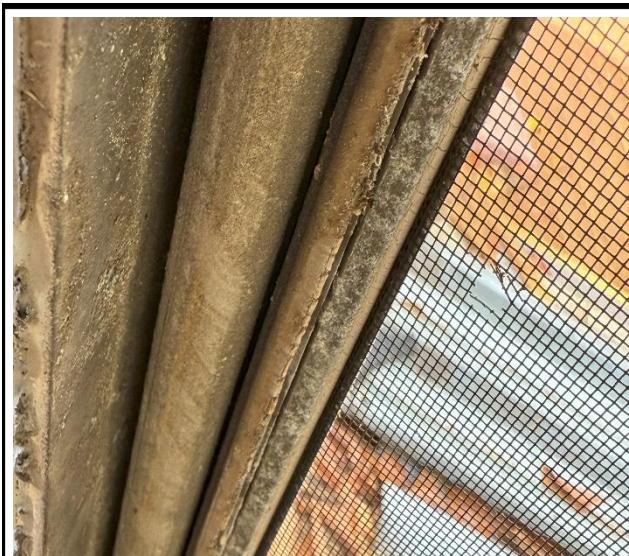
Photo 3 : Existing non-impact-rated window frame

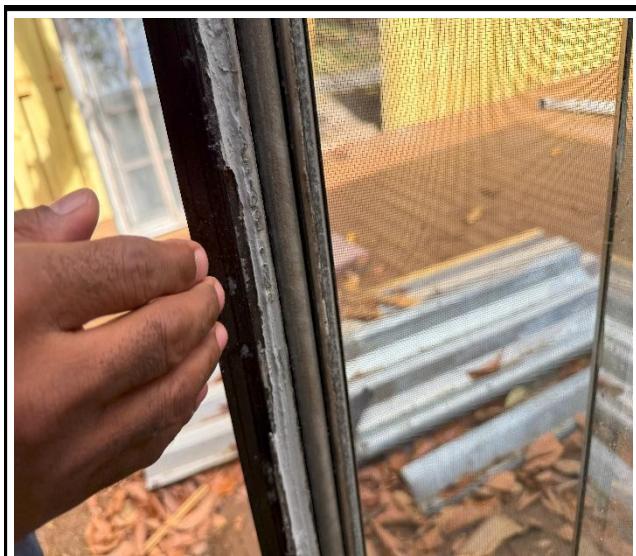
Photo 4 : Existing non-impact-rated window frame

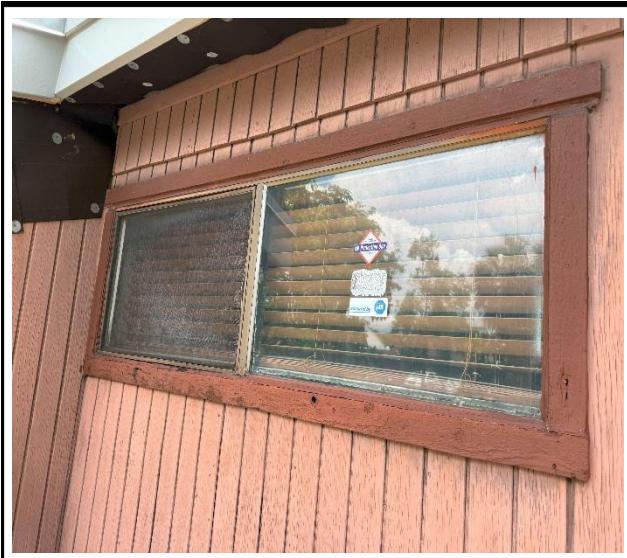
The windows are approximately 40 years old and show typical signs of aging, including potential air and water leakage, degraded seals, reduced energy efficiency, and possible corrosion and/or frame deterioration.

Photo 1 : Existing non-impact-rated window frame

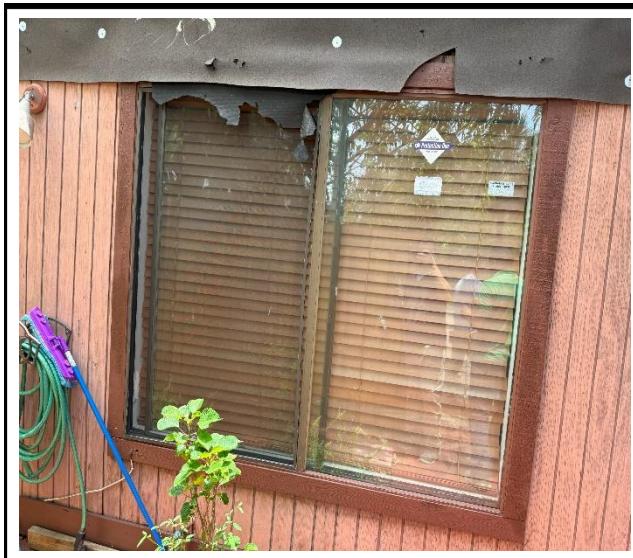
Photo 2 : Existing non-impact-rated window frame

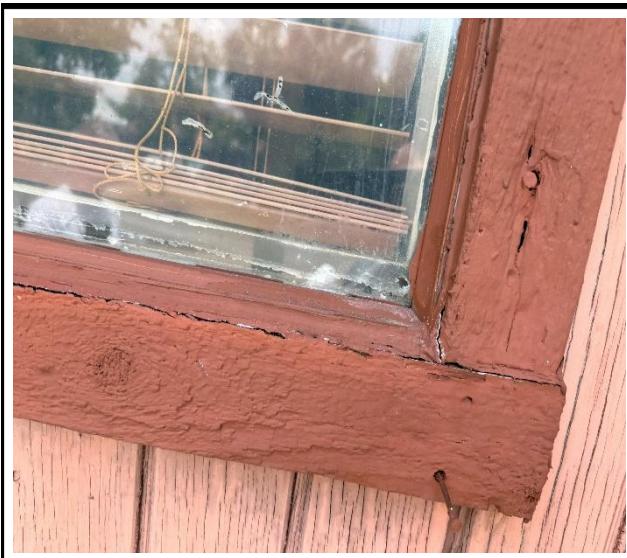
Photo 3 : Existing non-impact-rated window frame

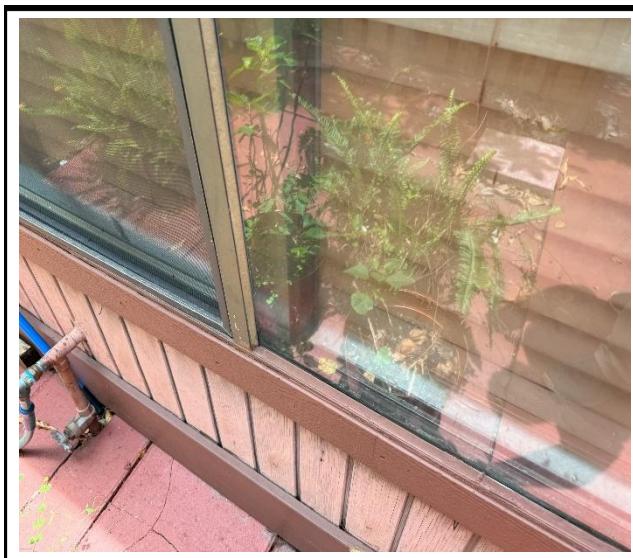
Photo 4 : Existing non-impact-rated window frame

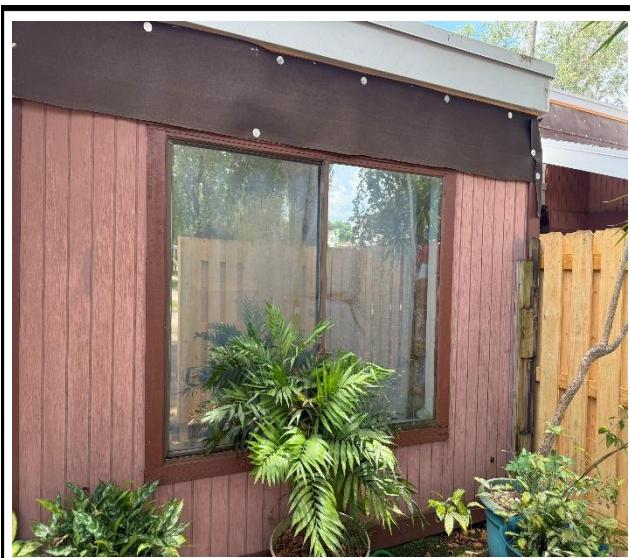
The windows are approximately 40 years old and show typical signs of aging, including potential air and water leakage, degraded seals, reduced energy efficiency, and possible corrosion and/or frame deterioration.

Photo 1 : Existing non-impact-rated window frame

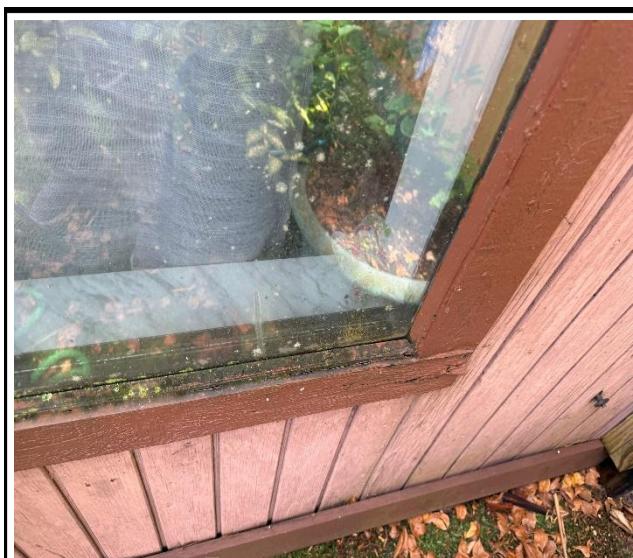
Photo 2 : Existing non-impact-rated window frame

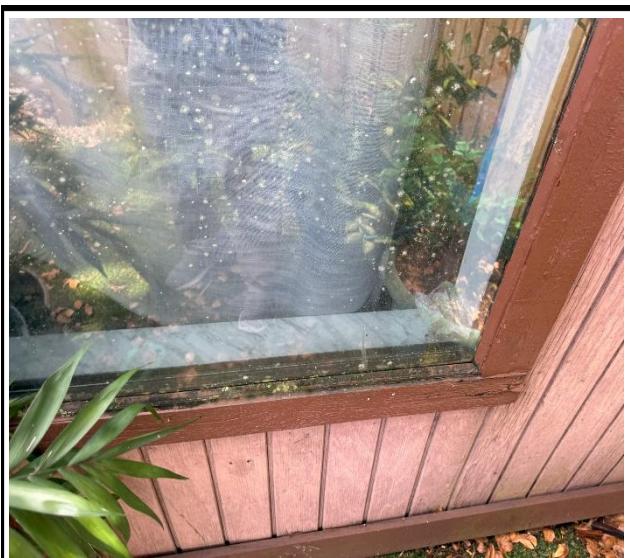
Photo 3 : Existing non-impact-rated window frame

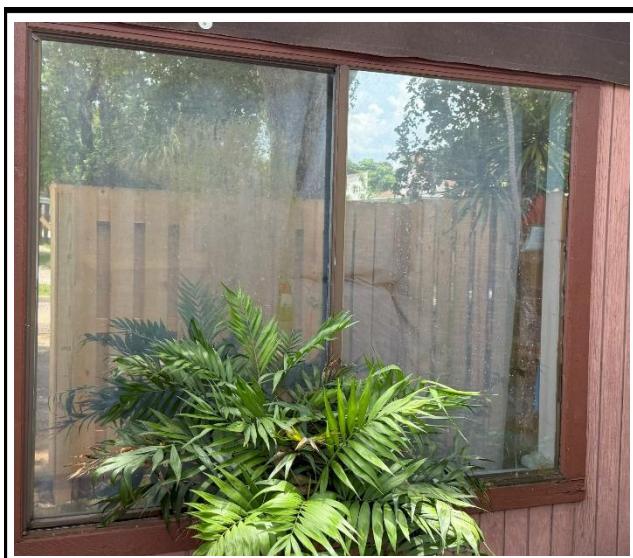
Photo 4 : Existing non-impact-rated window frame

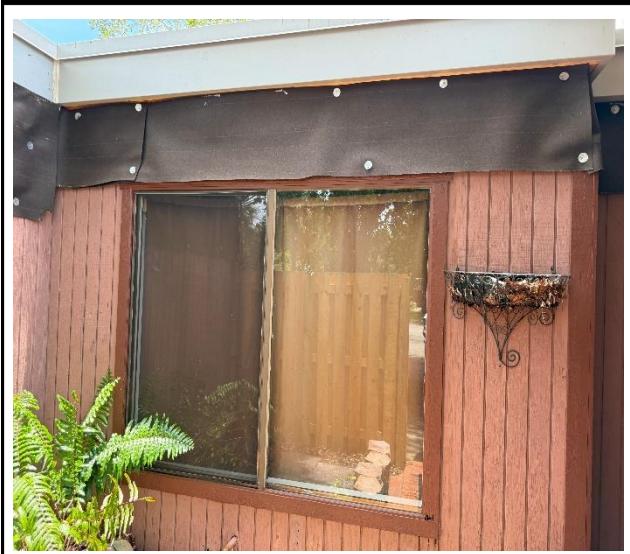
The windows are approximately 40 years old and show typical signs of aging, including potential air and water leakage, degraded seals, reduced energy efficiency, and possible corrosion and/or frame deterioration.

Photo 1 : Existing non-impact-rated window frame

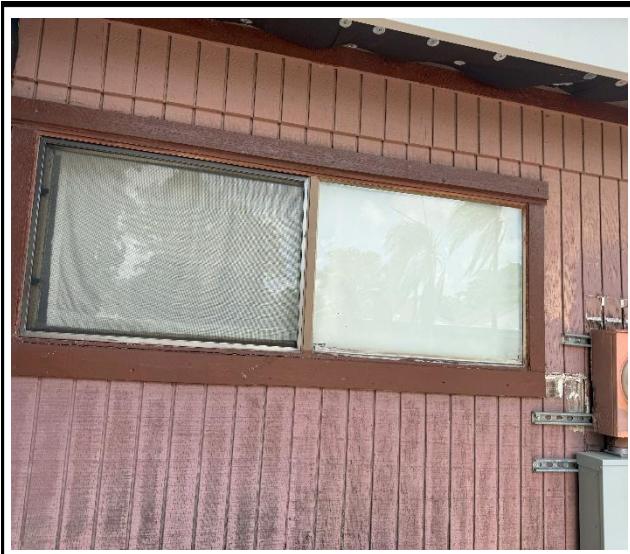
Photo 2 : Existing non-impact-rated window frame

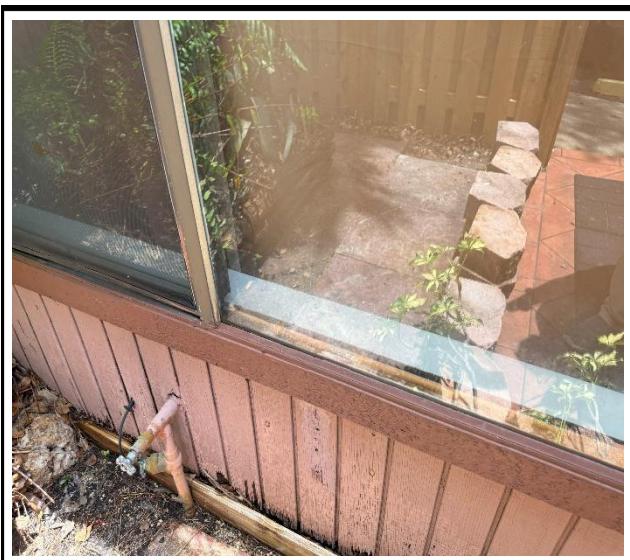
Photo 3 : Existing non-impact-rated window frame

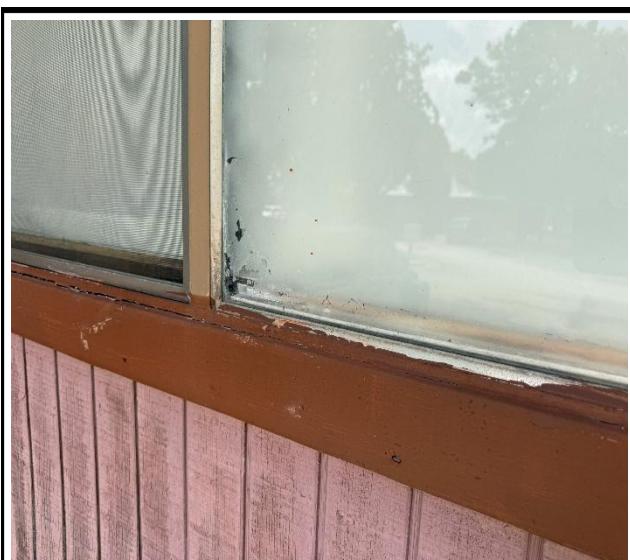
Photo 4 : Existing non-impact-rated window frame

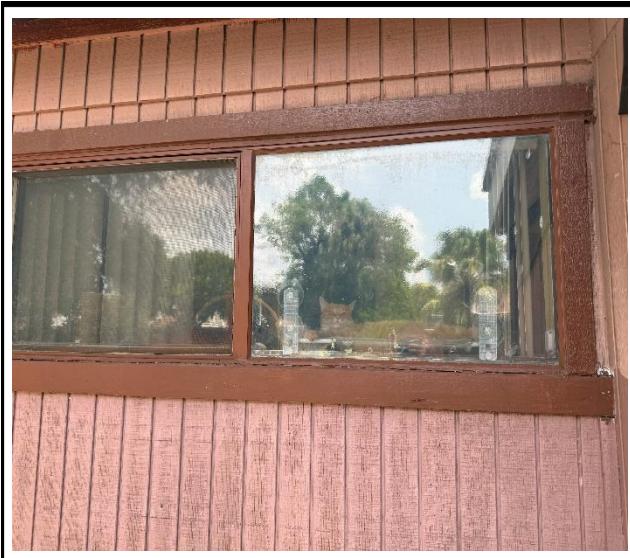
The windows are approximately 40 years old and show typical signs of aging, including potential air and water leakage, degraded seals, reduced energy efficiency, and possible corrosion and/or frame deterioration.

Photo 1 : Existing non-impact-rated window frame

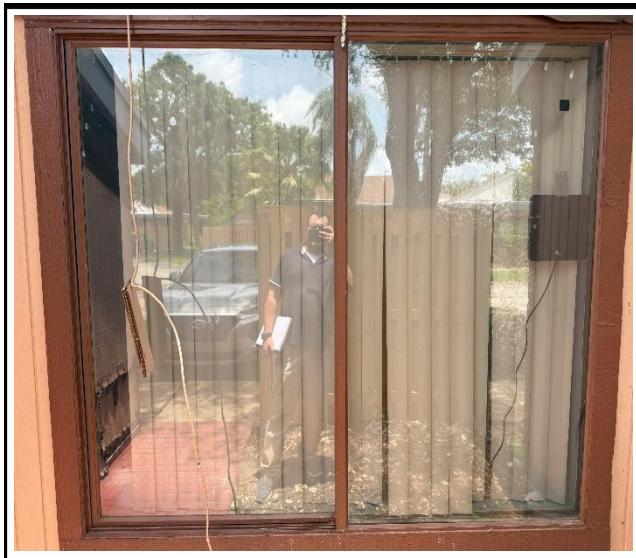
Photo 2 : Existing non-impact-rated window frame

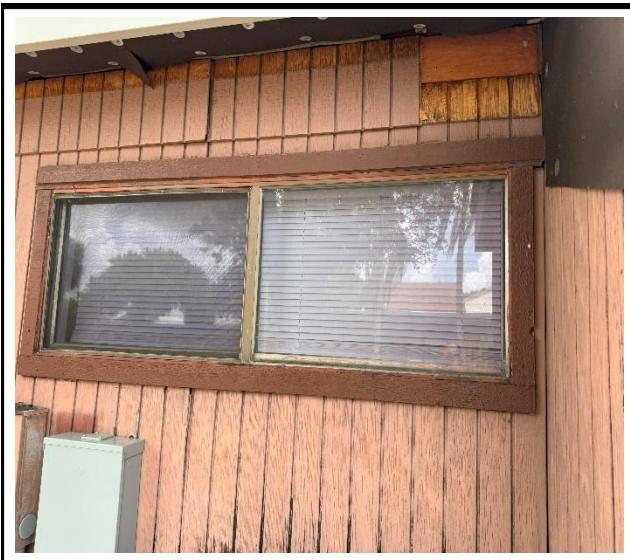
The windows are approximately 40 years old and show typical signs of aging, including potential air and water leakage, degraded seals, reduced energy efficiency, and possible corrosion and/or frame deterioration.

Photo 1 : Existing non-impact-rated window frame

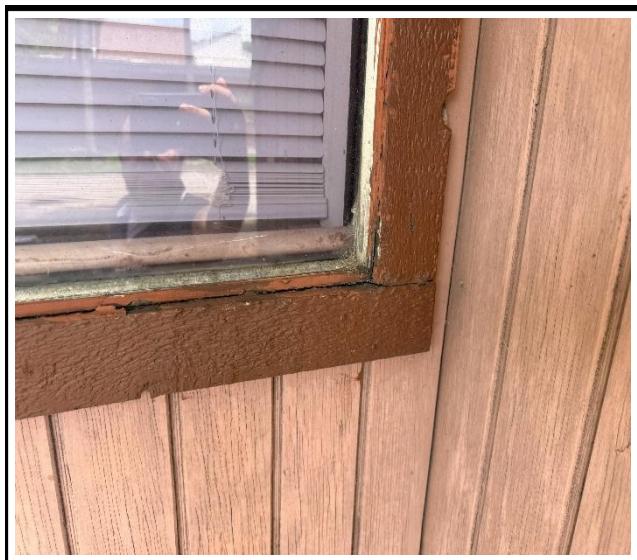
Photo 2 : Existing non-impact-rated window frame

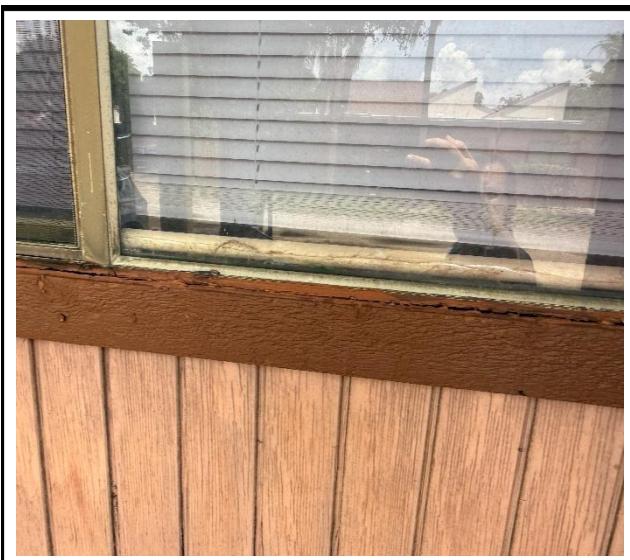
Photo 3 : Existing non-impact-rated window frame

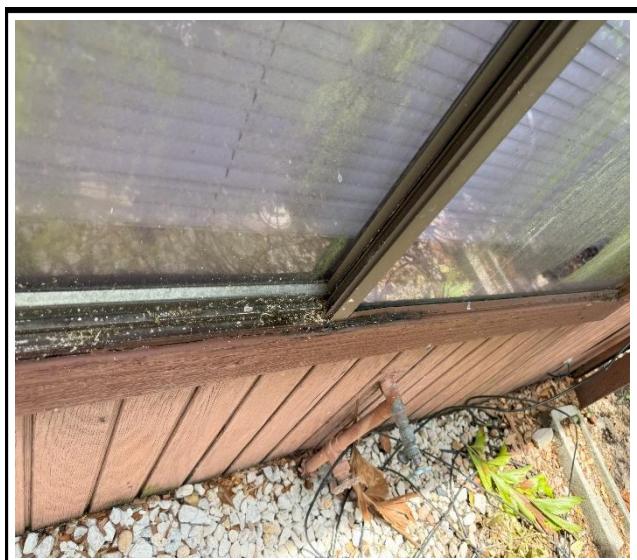
Photo 4 : Existing non-impact-rated window frame

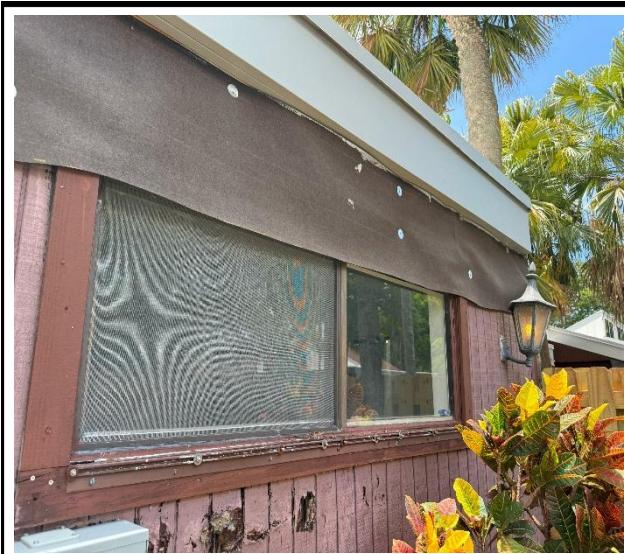
The windows are approximately 40 years old and show typical signs of aging, including potential air and water leakage, degraded seals, reduced energy efficiency, and possible corrosion and/or frame deterioration.

Photo 1 : Existing non-impact-rated window frame

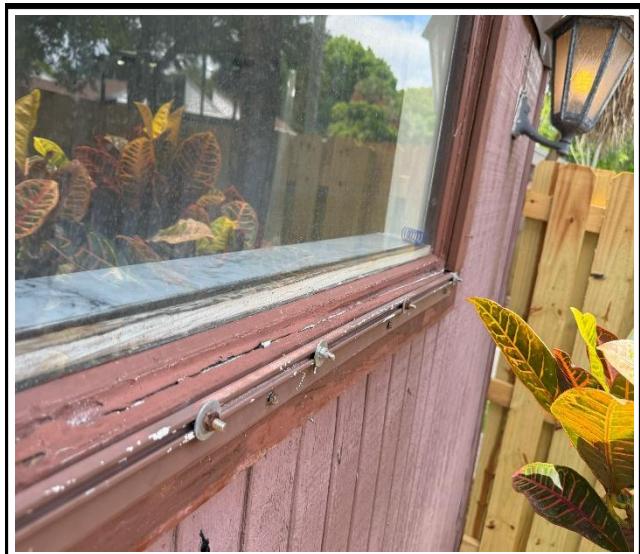
Photo 2 : Existing non-impact-rated window frame

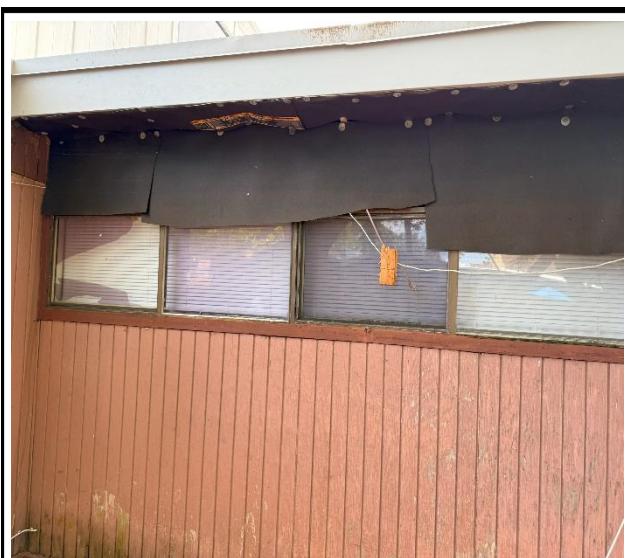
Photo 3 : Existing non-impact-rated window frame

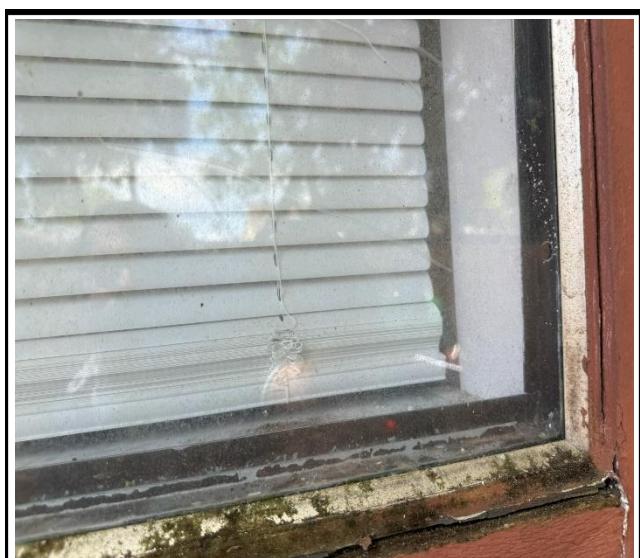
Photo 4 : Existing non-impact-rated window frame

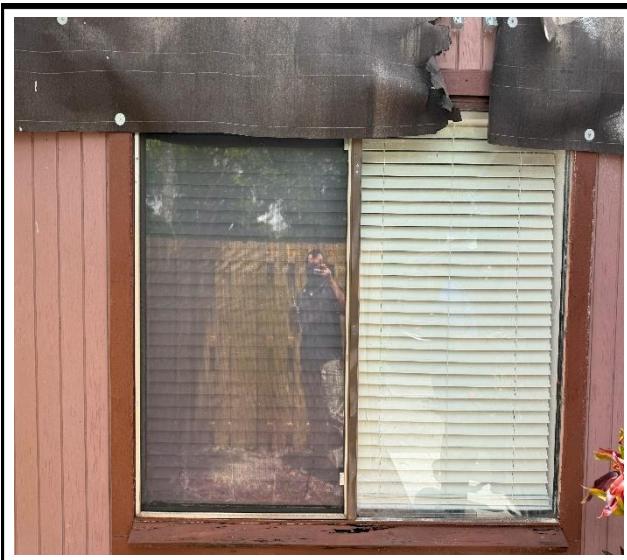
The windows are approximately 40 years old and show typical signs of aging, including potential air and water leakage, degraded seals, reduced energy efficiency, and possible corrosion and/or frame deterioration.

Photo 1 : Existing non-impact-rated window frame

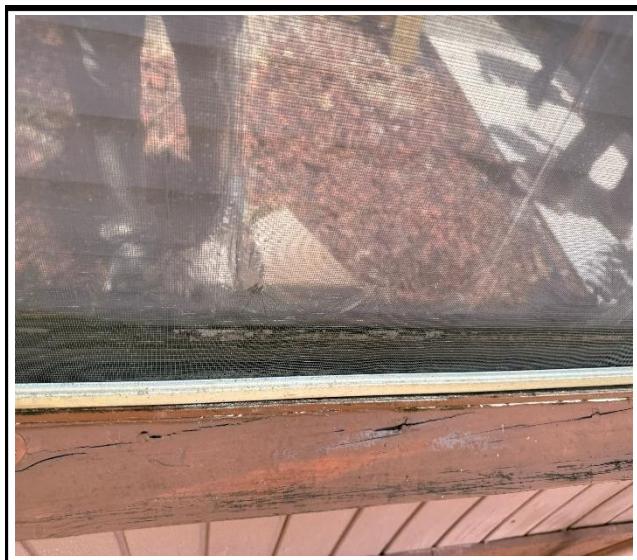
Photo 2 : Existing non-impact-rated window frame

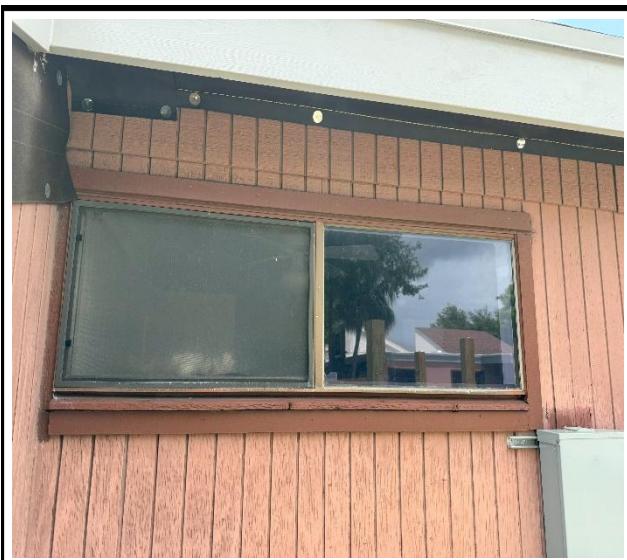
Photo 3 : Existing non-impact-rated window frame

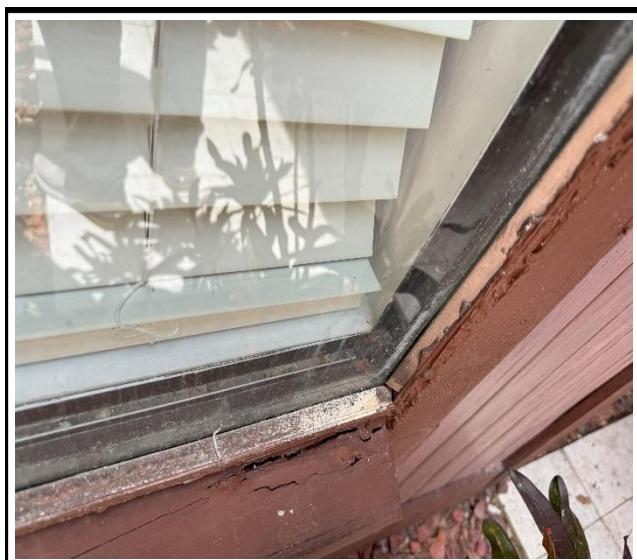
Photo 4 : Existing non-impact-rated window frame

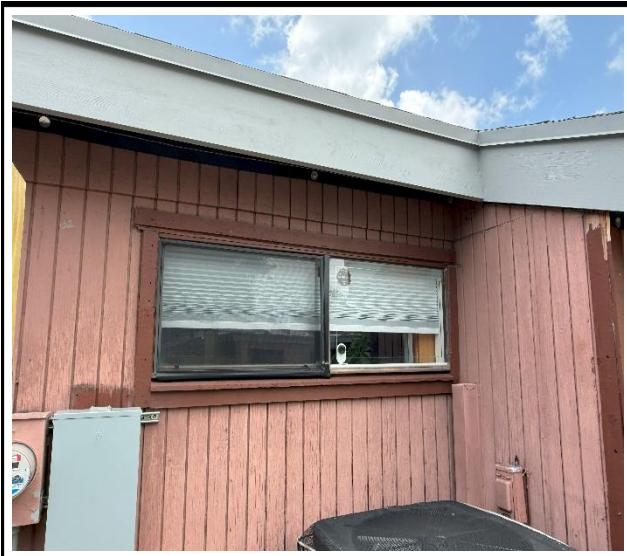
The windows are approximately 40 years old and show typical signs of aging, including potential air and water leakage, degraded seals, reduced energy efficiency, and possible corrosion and/or frame deterioration.

Photo 1 : Existing non-impact-rated window frame

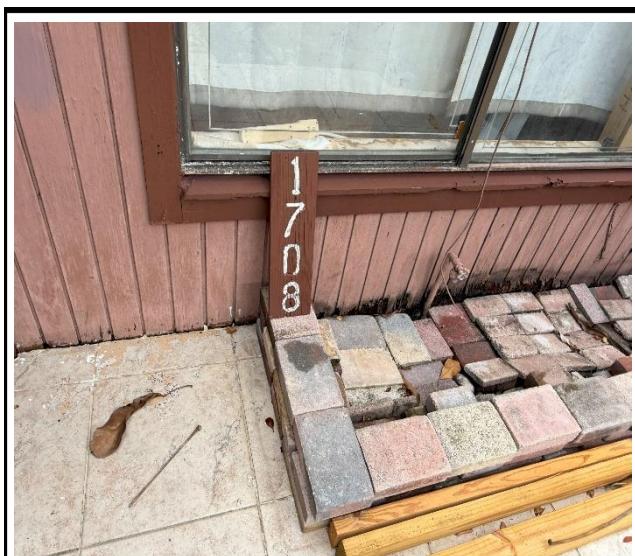
Photo 4 : Existing non-impact-rated window frame

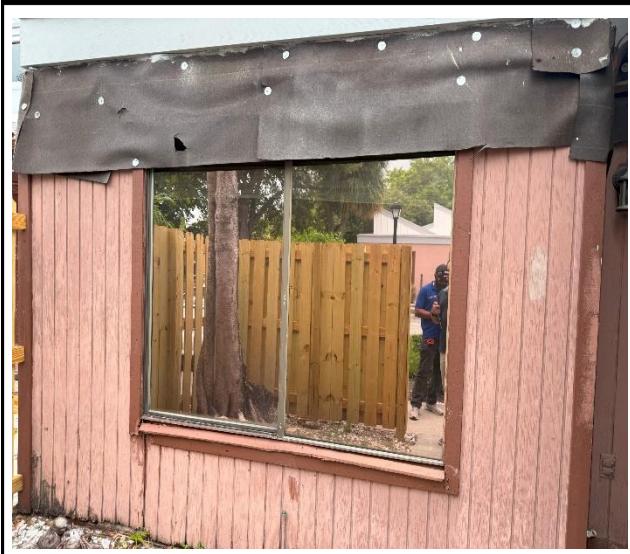
The windows are approximately 40 years old and show typical signs of aging, including potential air and water leakage, degraded seals, reduced energy efficiency, and possible corrosion and/or frame deterioration.

Photo 1 : Existing non-impact-rated window frame

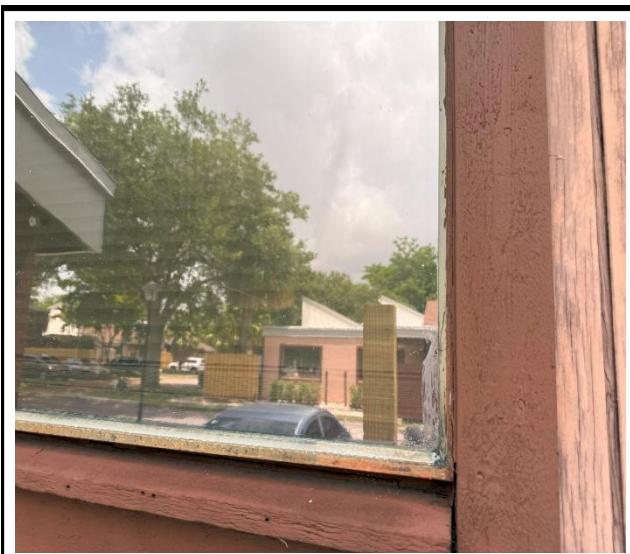
Photo 4 : Existing non-impact-rated window frame

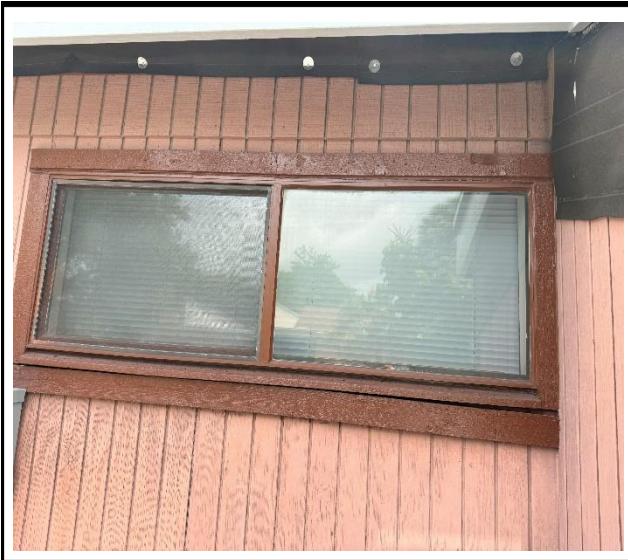
The windows are approximately 40 years old and show typical signs of aging, including potential air and water leakage, degraded seals, reduced energy efficiency, and possible corrosion and/or frame deterioration.

Photo 1 : Existing non-impact-rated window frame

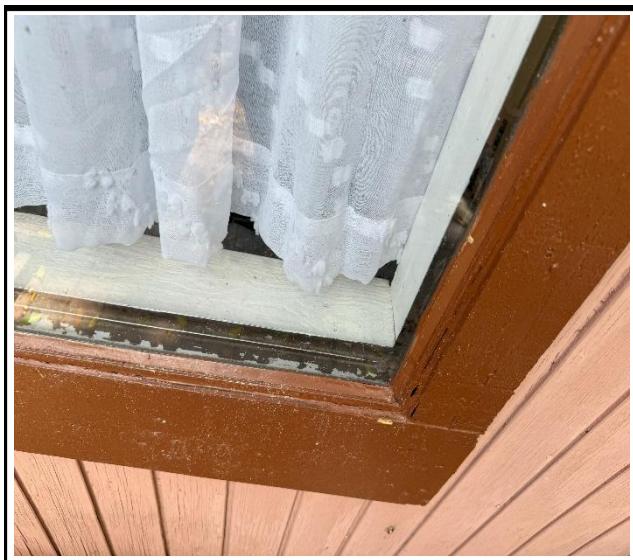
Photo 4 : Existing non-impact-rated window frame

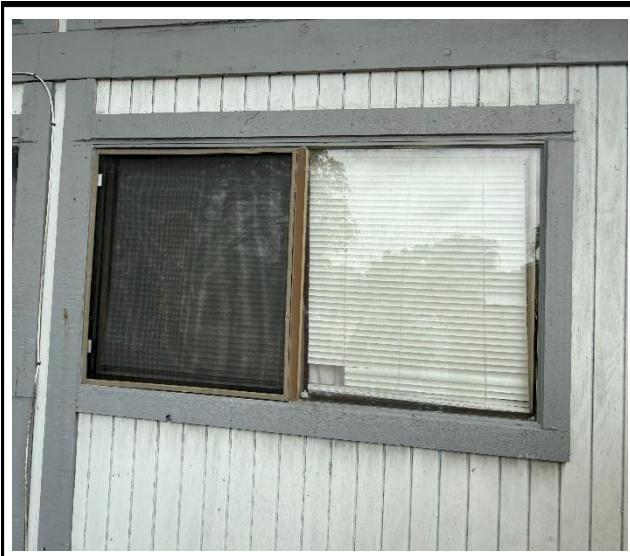
The windows are approximately 40 years old and show typical signs of aging, including potential air and water leakage, degraded seals, reduced energy efficiency, and possible corrosion and/or frame deterioration.

Photo 1 : Existing non-impact-rated window frame

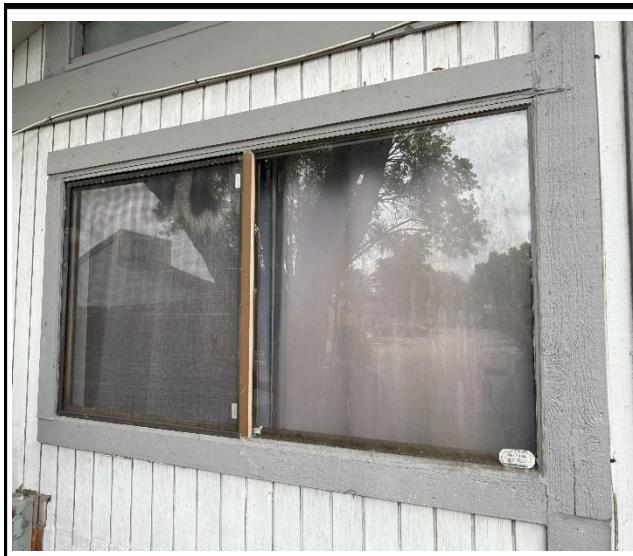
Photo 2 : Existing non-impact-rated window frame

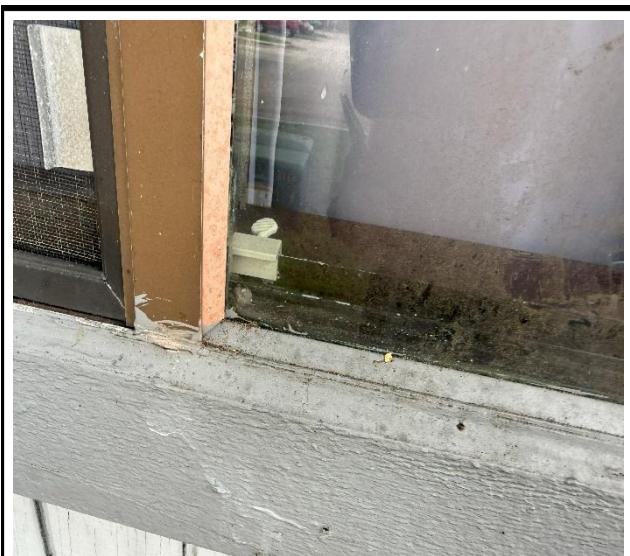
Photo 3 : Existing non-impact-rated window frame

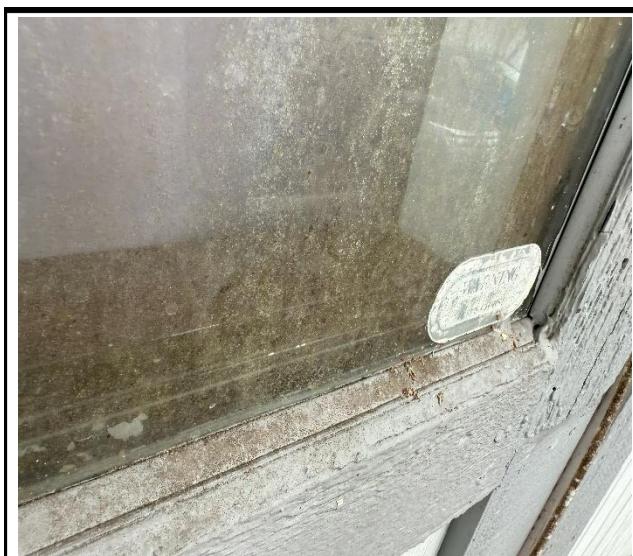
Photo 4 : Existing non-impact-rated window frame

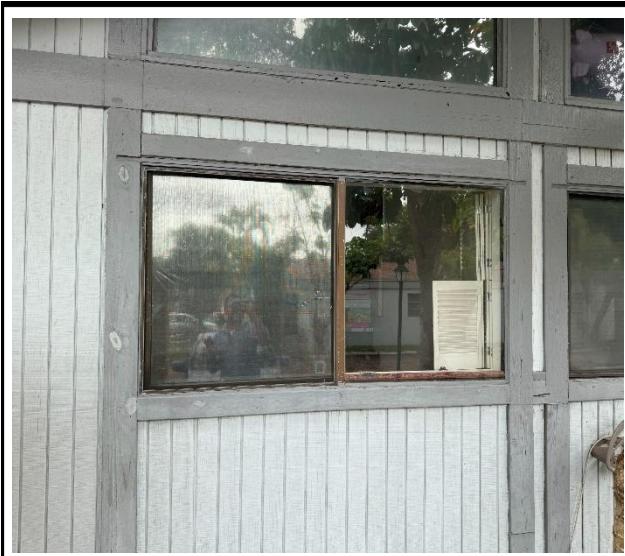
The windows are approximately 40 years old and show typical signs of aging, including potential air and water leakage, degraded seals, reduced energy efficiency, and possible corrosion and/or frame deterioration.

Photo 1 : Existing non-impact-rated window frame

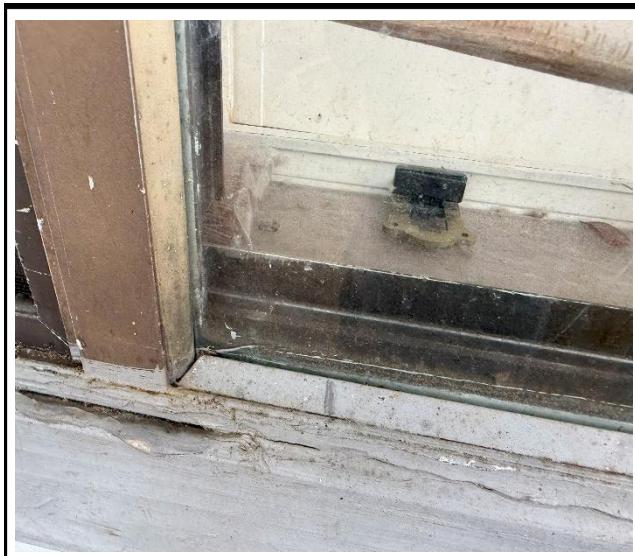
Photo 2 : Existing non-impact-rated window frame

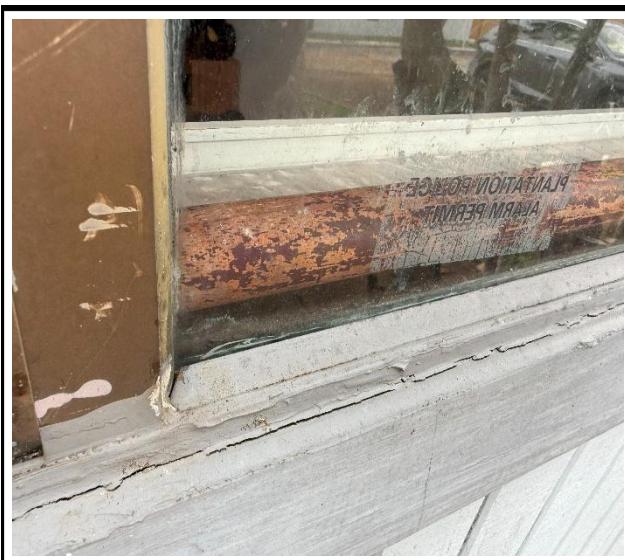
Photo 3 : Existing non-impact-rated window frame

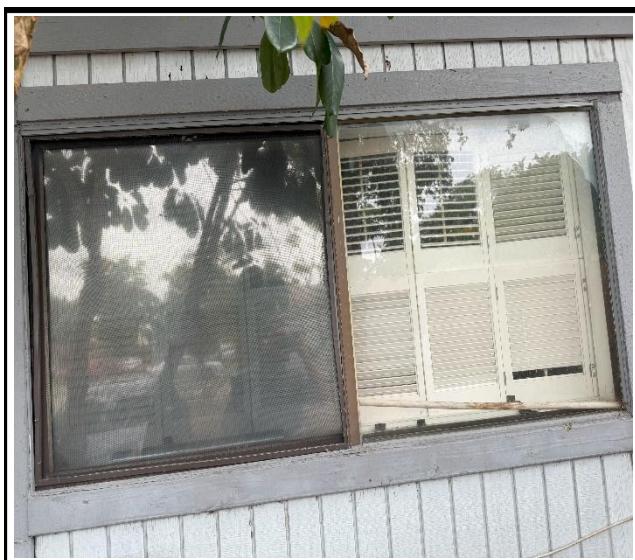
Photo 4 : Existing non-impact-rated window frame

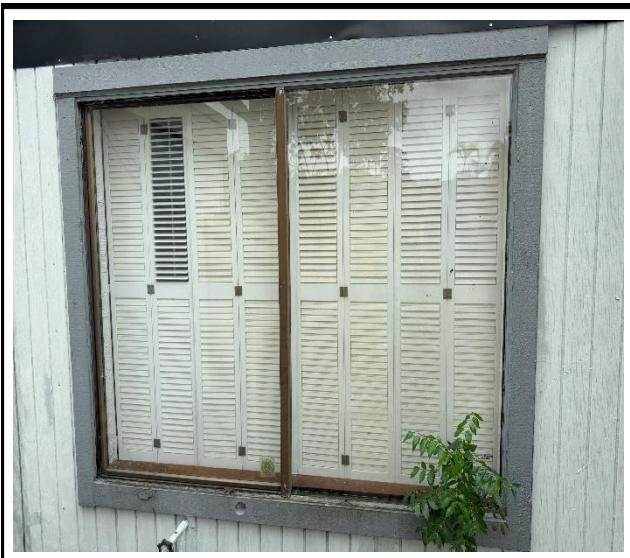
The windows are approximately 40 years old and show typical signs of aging, including potential air and water leakage, degraded seals, reduced energy efficiency, and possible corrosion and/or frame deterioration.

Photo 1 : Existing non-impact-rated window frame

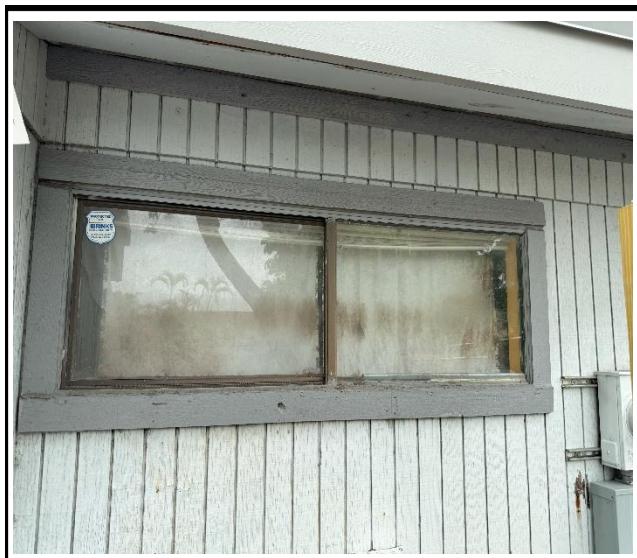
Photo 2 : Existing non-impact-rated window frame

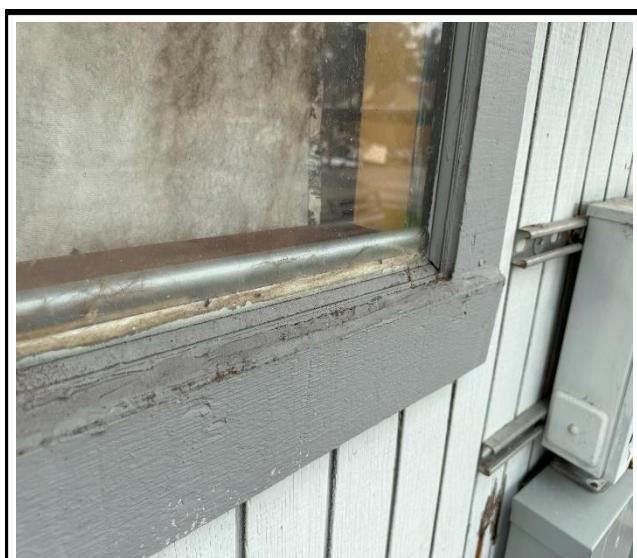
Photo 4 : Existing non-impact-rated window frame

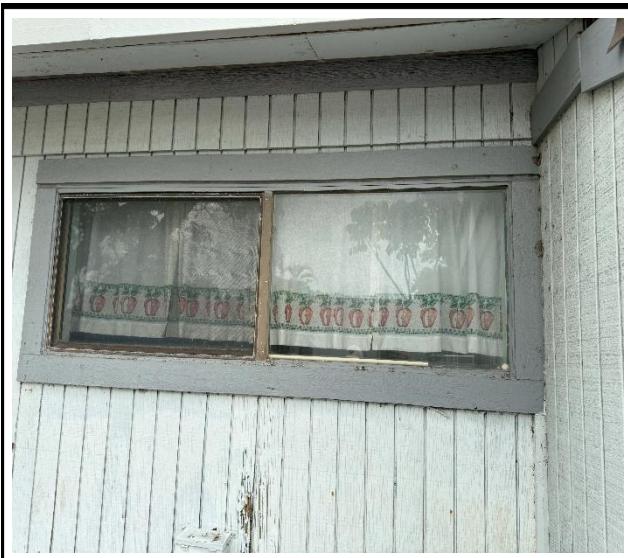
The windows are approximately 40 years old and show typical signs of aging, including potential air and water leakage, degraded seals, reduced energy efficiency, and possible corrosion and/or frame deterioration.

Photo 1 : Existing non-impact-rated window frame

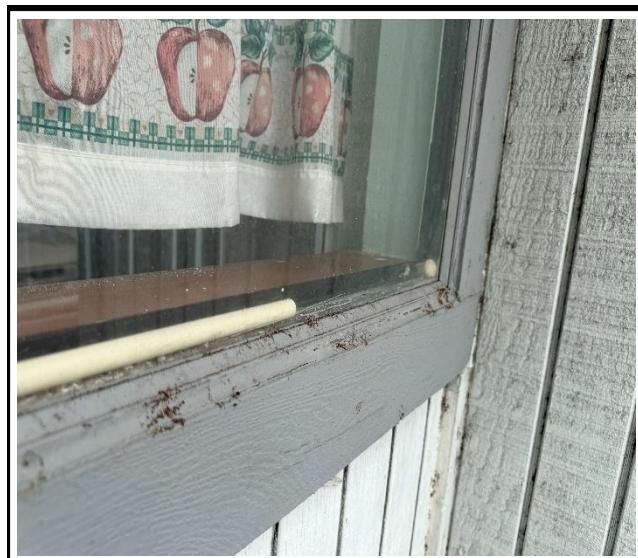
Photo 2 : Existing non-impact-rated window frame

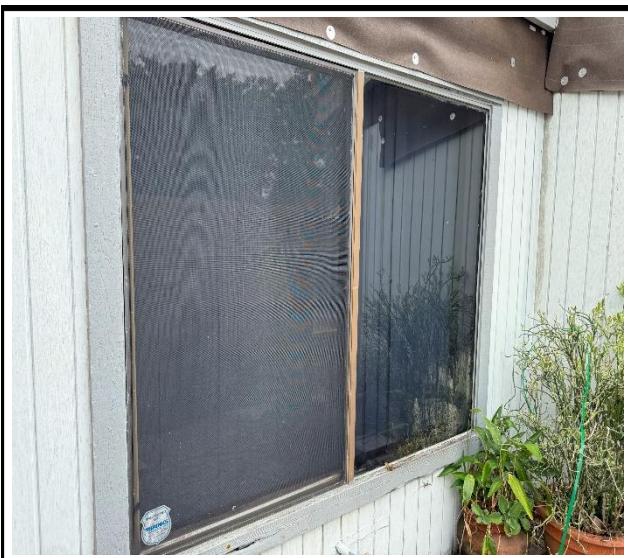
Photo 3 : Existing non-impact-rated window frame

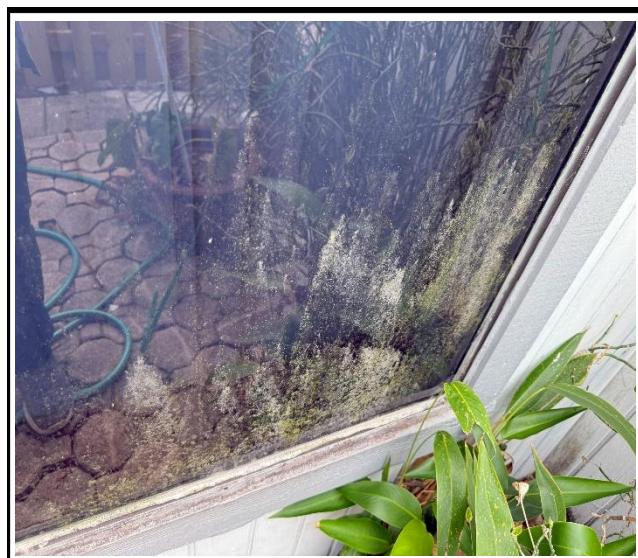
Photo 4 : Existing non-impact-rated window frame

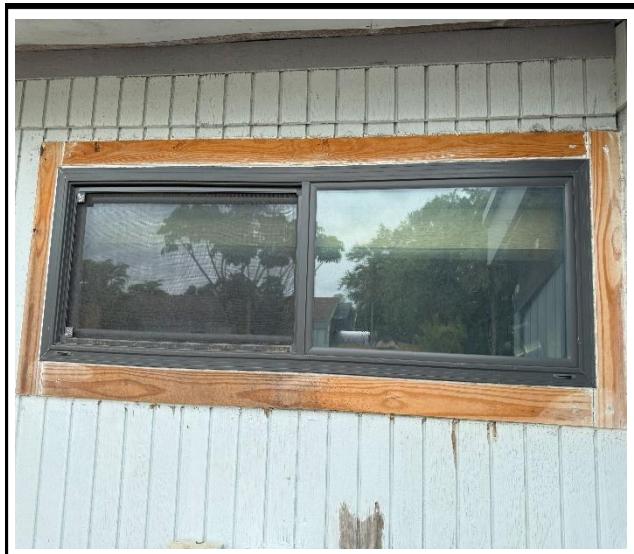
Photo 1 : Existing Window

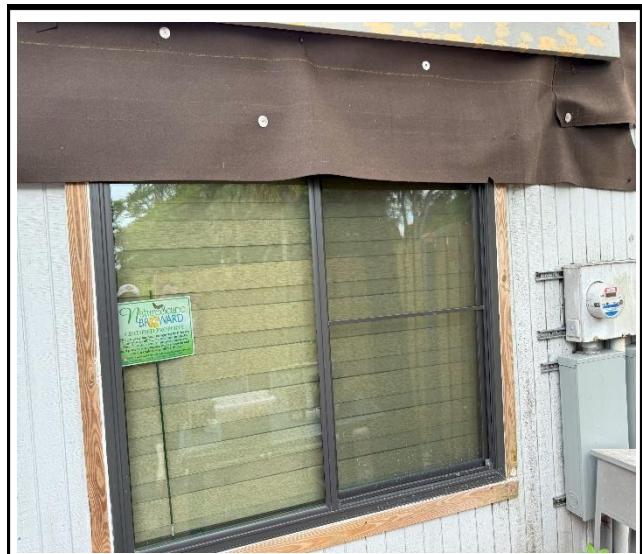
Photo 2 : Existing Window

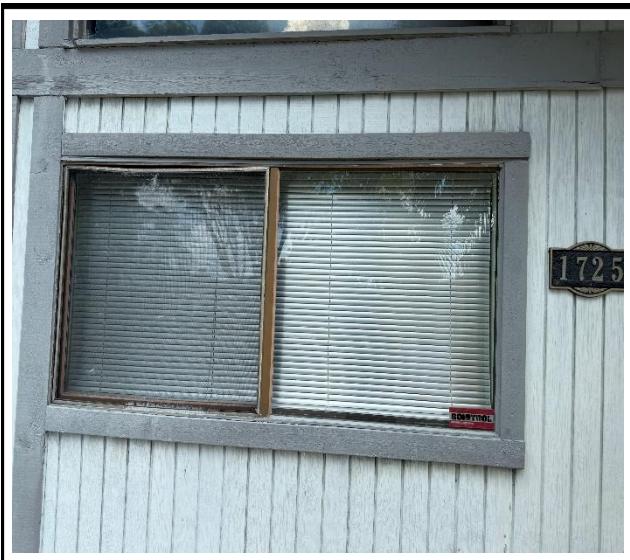
The windows are approximately 40 years old and show typical signs of aging, including potential air and water leakage, degraded seals, reduced energy efficiency, and possible corrosion and/or frame deterioration.

Photo 1 : Existing non-impact-rated window frame

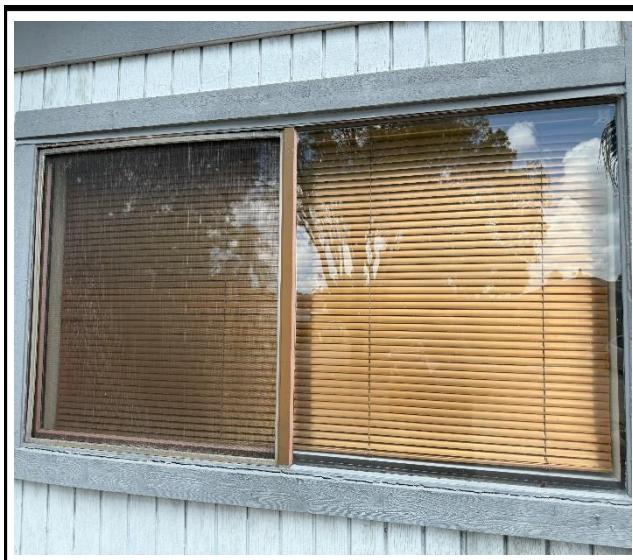
Photo 2 : Existing non-impact-rated window frame

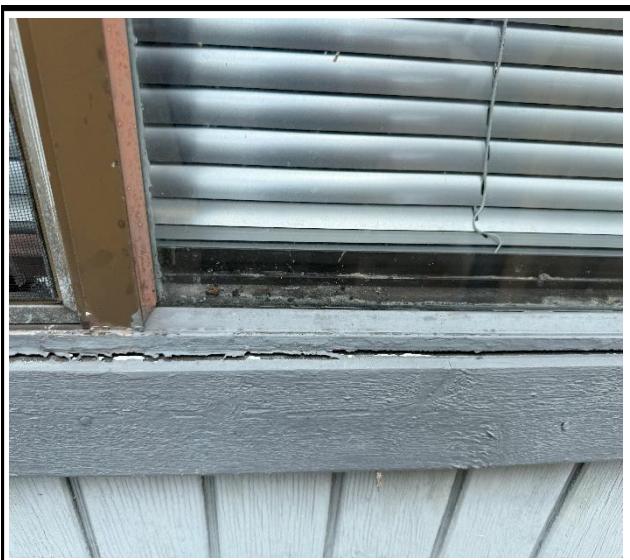
Photo 3 : Existing non-impact-rated window frame

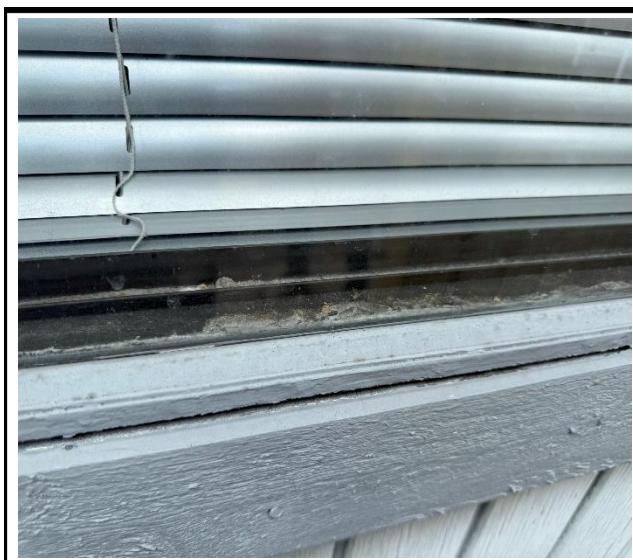
Photo 4 : Existing non-impact-rated window frame

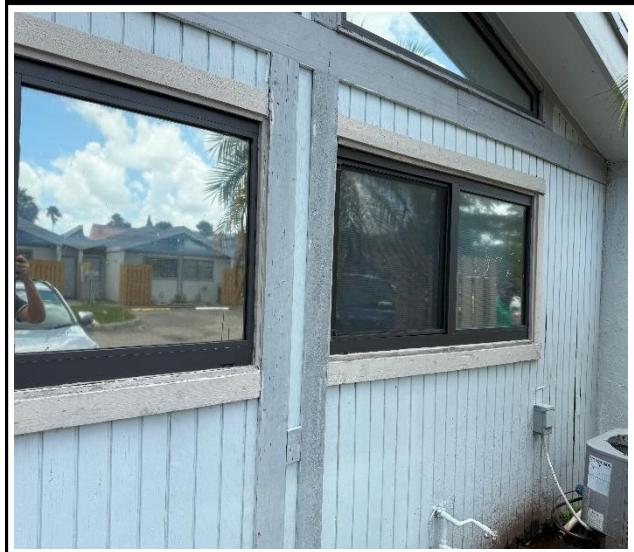
Photo 1 : Existing Window

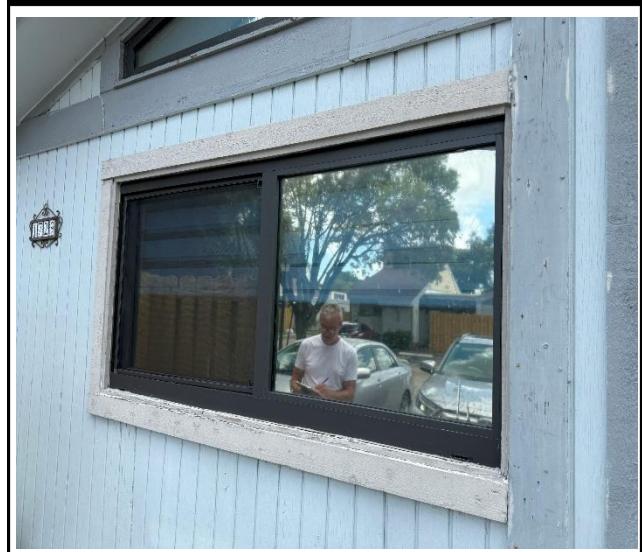
Photo 2 : Existing Window

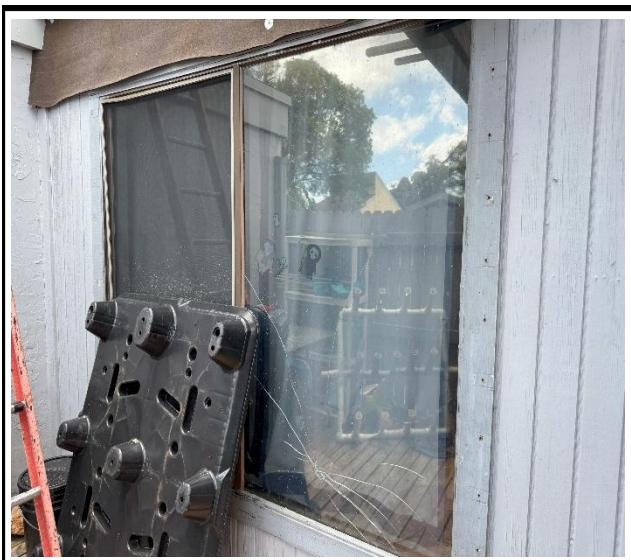
The windows are approximately 40 years old and show typical signs of aging, including potential air and water leakage, degraded seals, reduced energy efficiency, and possible corrosion and/or frame deterioration.

Photo 1 : Existing non-impact-rated window frame
