Omega Villas Condominium Association

1713 NW 72 Avenue,  
Plantation, FL 33313

**Windows Evaluation Report**  
**BLDGs 1 to 15**  
(07/23/2025)

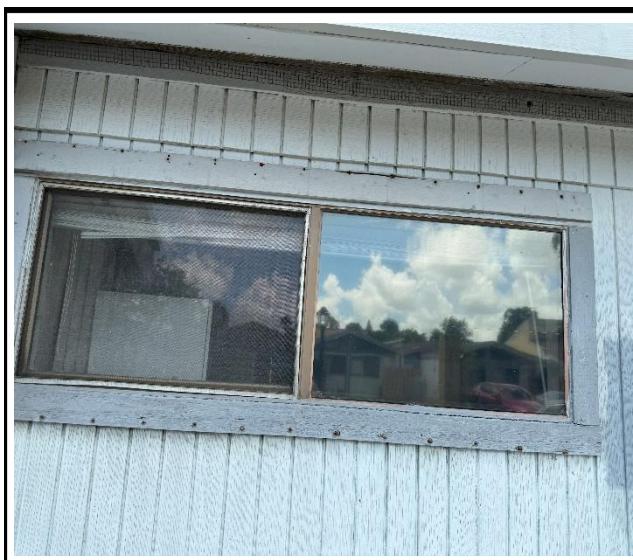
Photo 2 : Existing non-impact-rated window frame

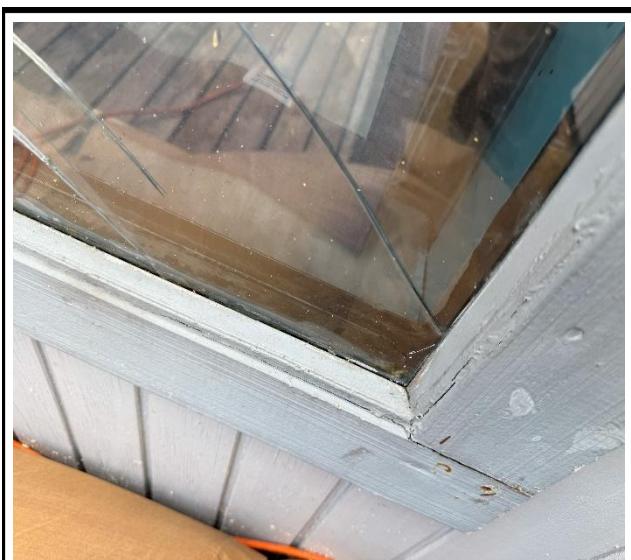
Photo 3 : Existing non-impact-rated window frame

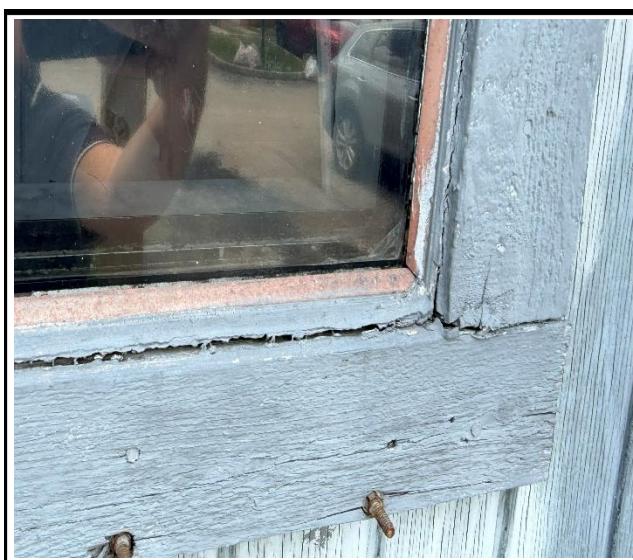
Photo 4 : Existing non-impact-rated window frame

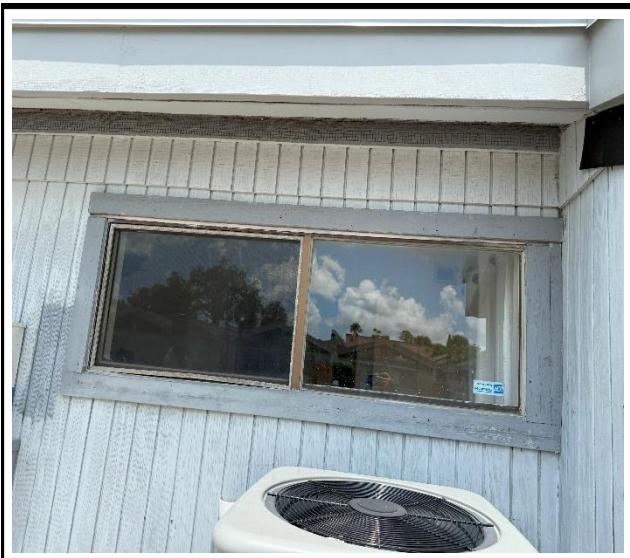
The windows are approximately 40 years old and show typical signs of aging, including potential air and water leakage, degraded seals, reduced energy efficiency, and possible corrosion and/or frame deterioration.

Photo 1 : Existing non-impact-rated window frame

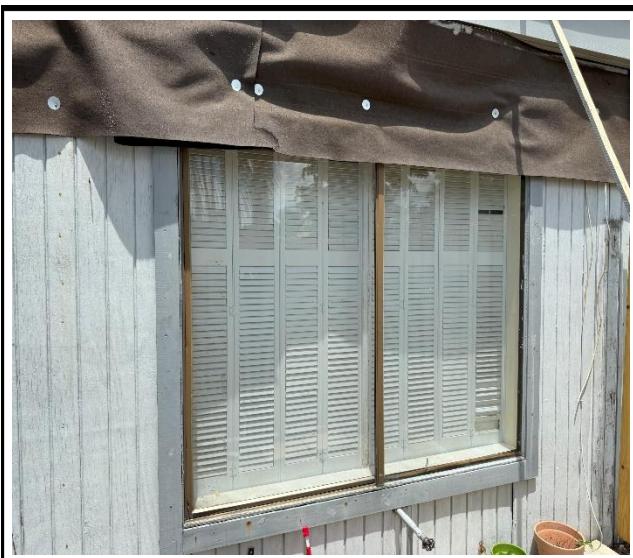
Photo 2 : Existing non-impact-rated window frame

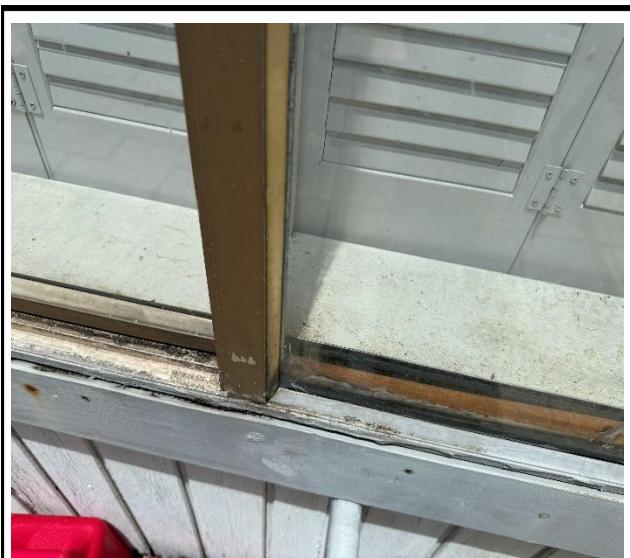
Photo 3 : Existing non-impact-rated window frame

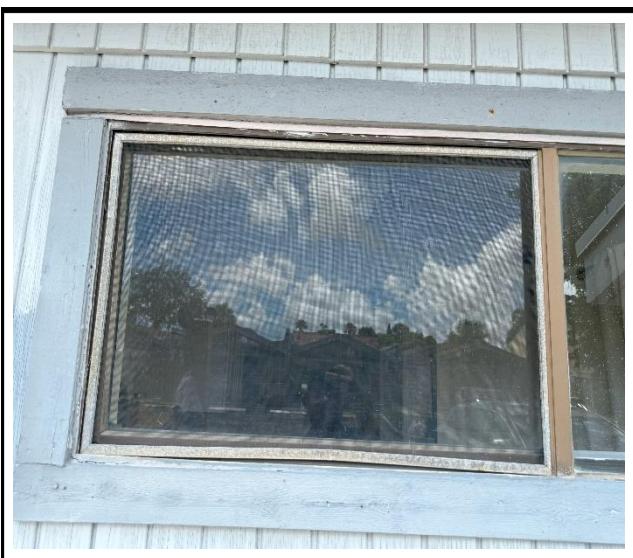
Photo 4 : Existing non-impact-rated window frame

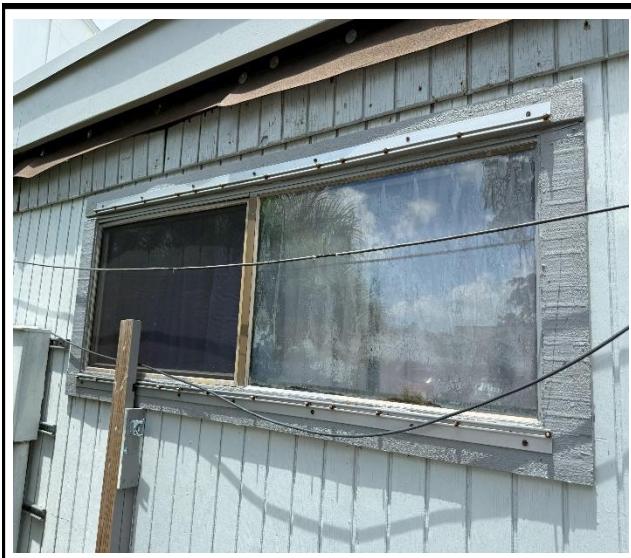
The windows are approximately 40 years old and show typical signs of aging, including potential air and water leakage, degraded seals, reduced energy efficiency, and possible corrosion and/or frame deterioration.

Photo 1 : Existing non-impact-rated window frame

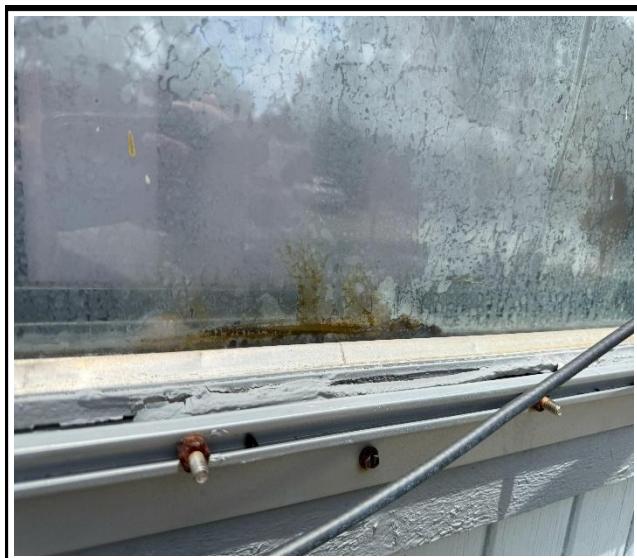
Photo 2 : Existing non-impact-rated window frame

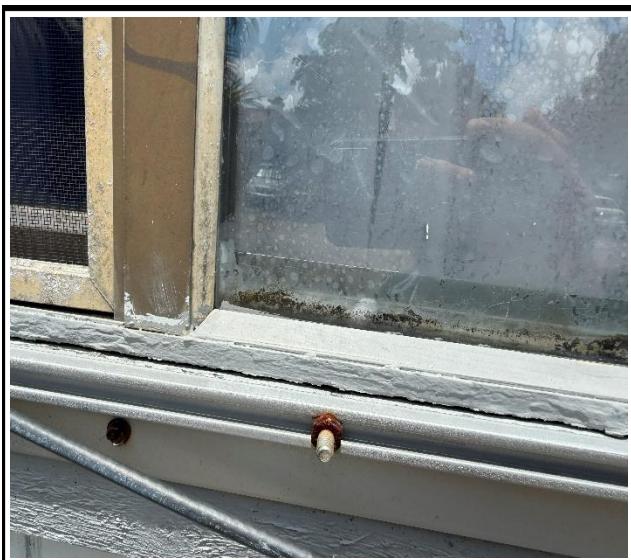
Photo 3 : Existing non-impact-rated window frame

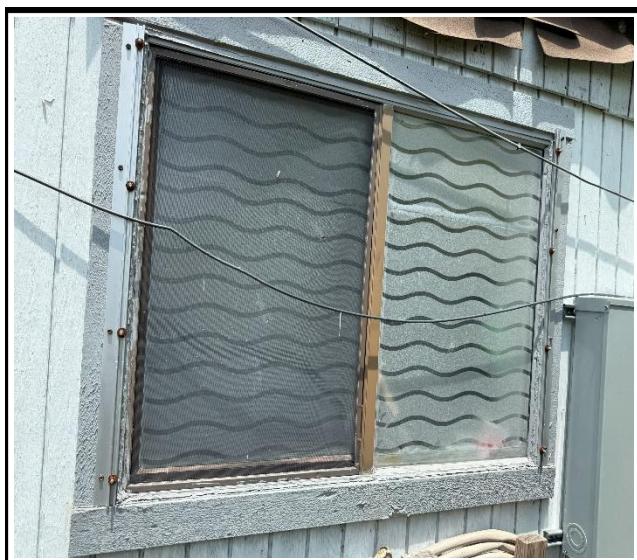
Photo 4 : Existing non-impact-rated window frame

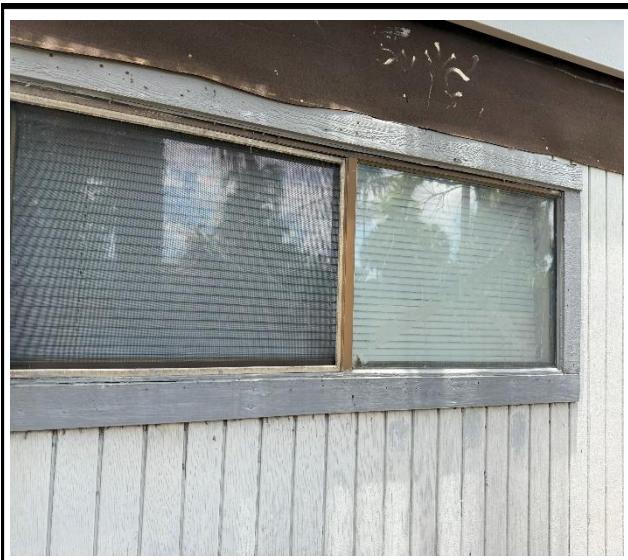
The windows are approximately 40 years old and show typical signs of aging, including potential air and water leakage, degraded seals, reduced energy efficiency, and possible corrosion and/or frame deterioration.

Photo 1 : Existing non-impact-rated window frame

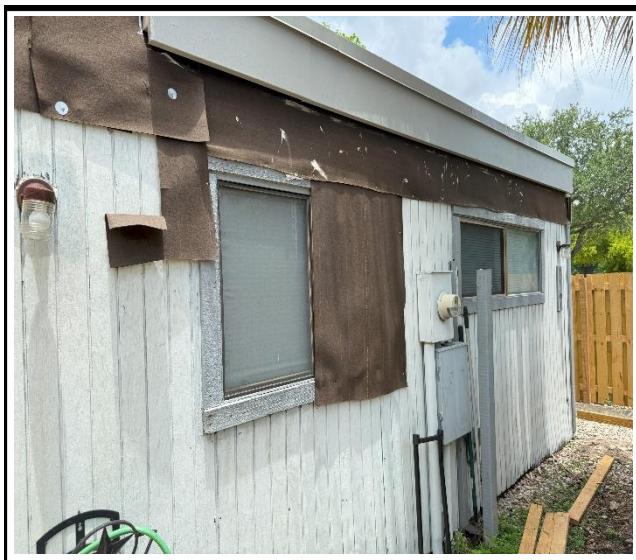
Photo 2 : Existing non-impact-rated window frame

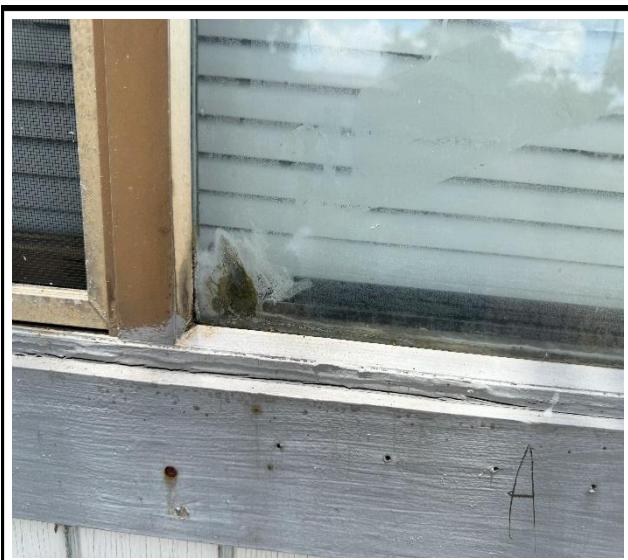
Photo 3 : Existing non-impact-rated window frame

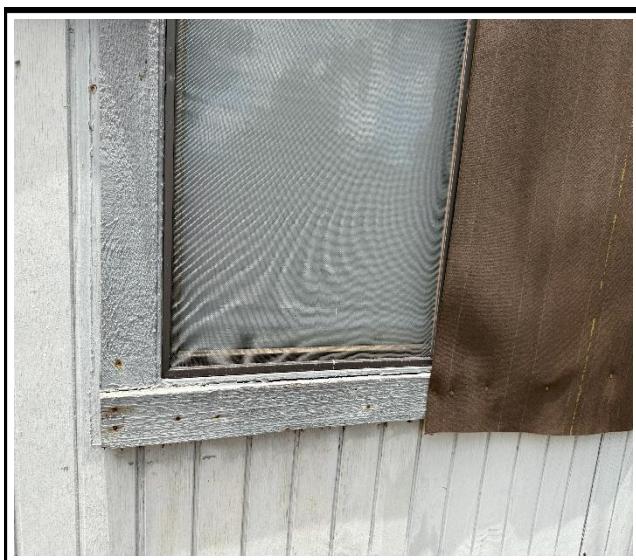
Photo 4 : Existing non-impact-rated window frame

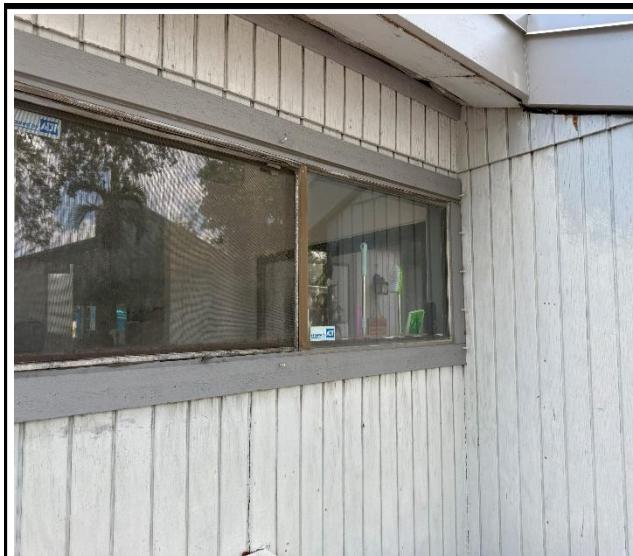
Photo 2 : Existing non-impact-rated window frame

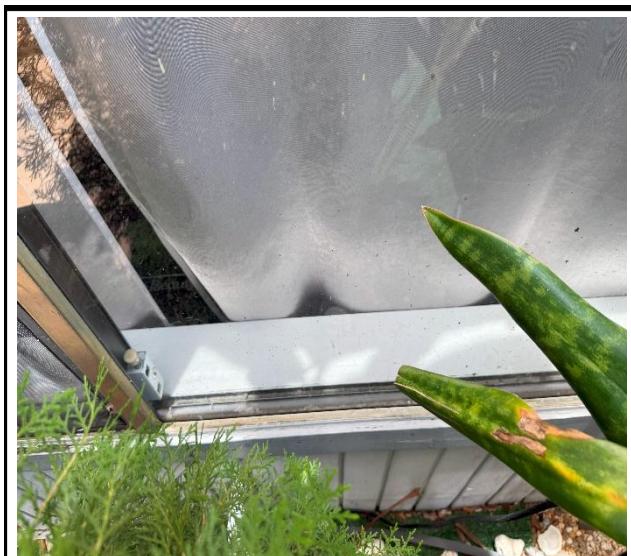
Photo 3 : Existing non-impact-rated window frame

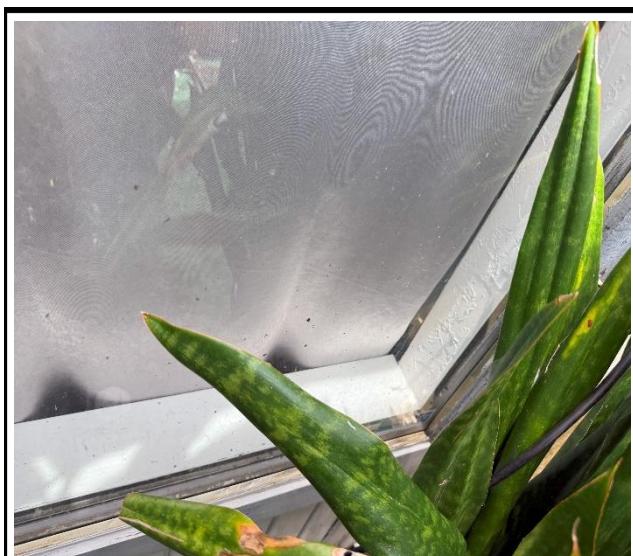
Photo 4 : Existing non-impact-rated window frame

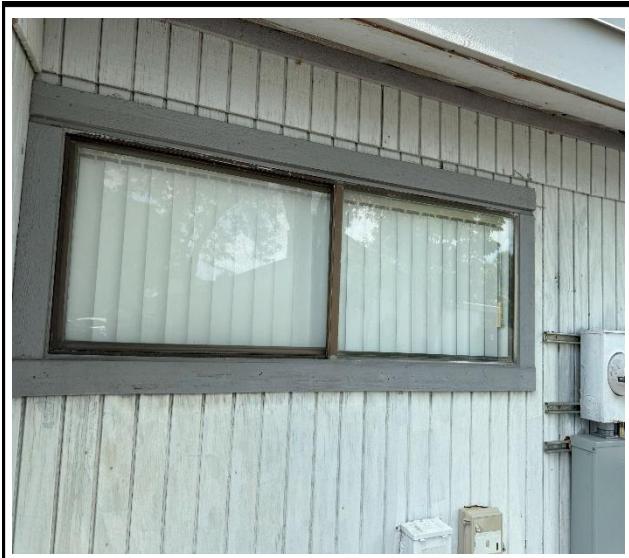
The windows are approximately 40 years old and show typical signs of aging, including potential air and water leakage, degraded seals, reduced energy efficiency, and possible corrosion and/or frame deterioration.

Photo 1 : Existing non-impact-rated window frame

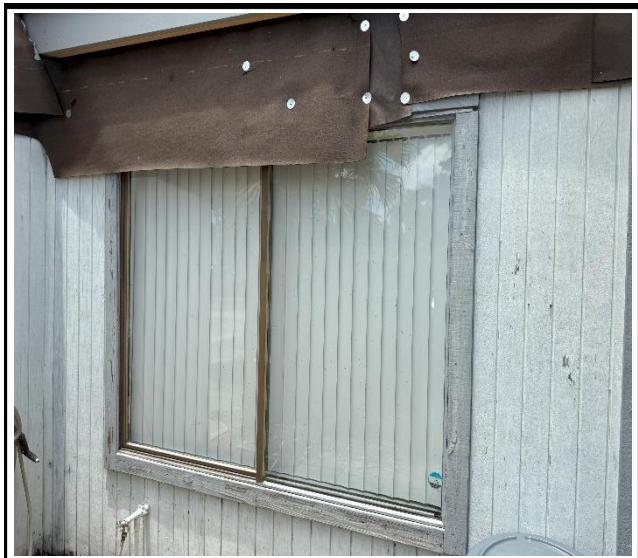
Photo 2 : Existing non-impact-rated window frame

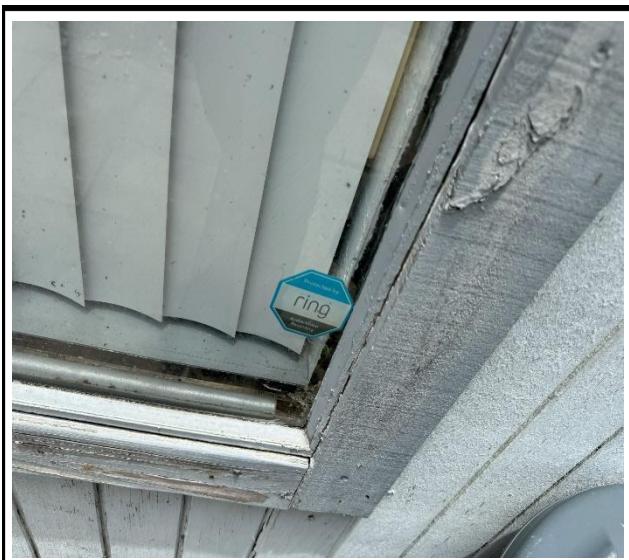
Photo 3 : Existing non-impact-rated window frame

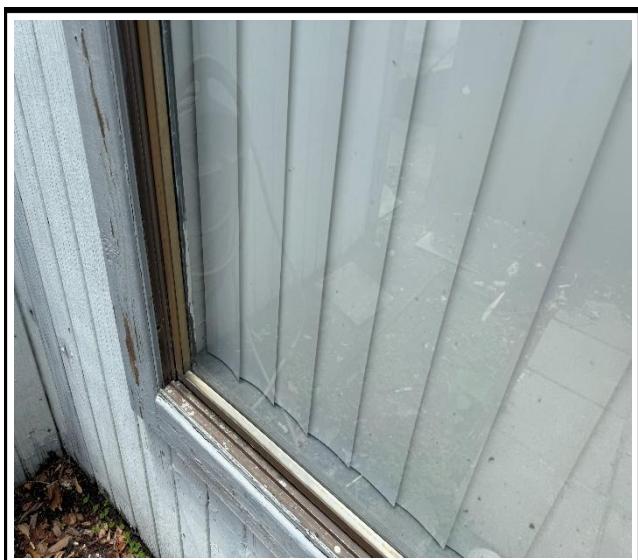
Photo 4 : Existing non-impact-rated window frame

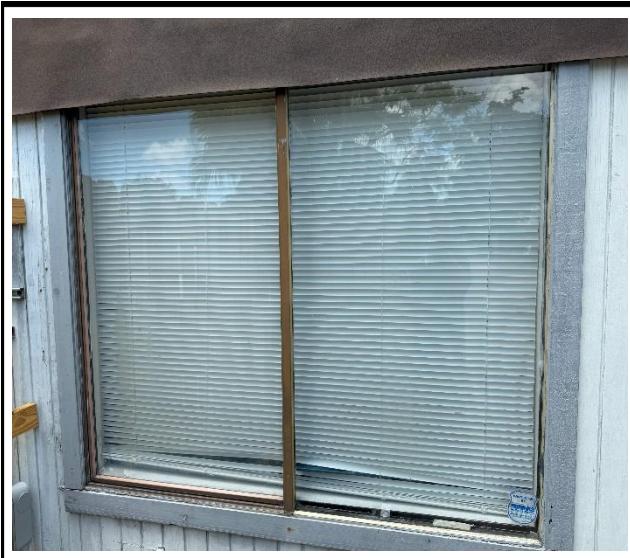
The windows are approximately 40 years old and show typical signs of aging, including potential air and water leakage, degraded seals, reduced energy efficiency, and possible corrosion and/or frame deterioration.

Photo 1 : Existing non-impact-rated window frame

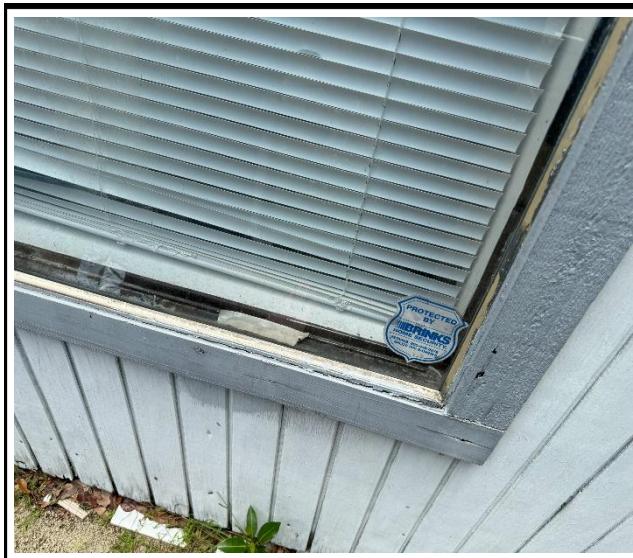
Photo 2 : Existing non-impact-rated window frame

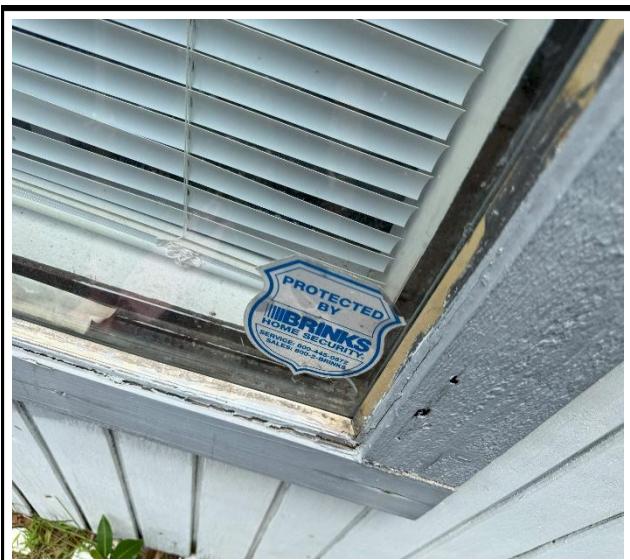
Photo 3 : Existing non-impact-rated window frame

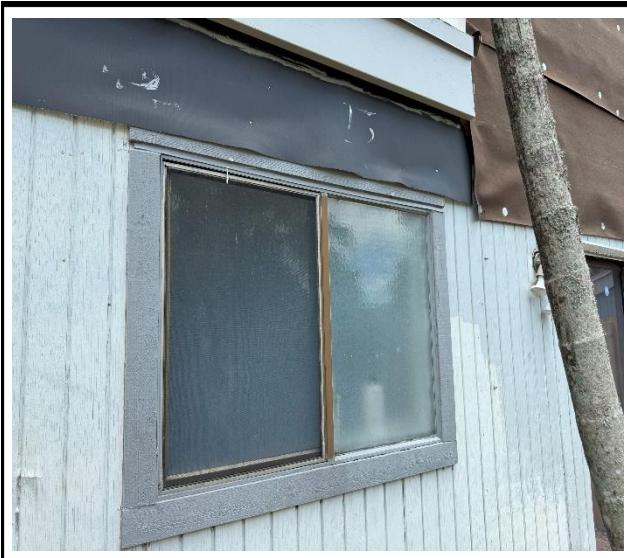
The windows are approximately 40 years old and show typical signs of aging, including potential air and water leakage, degraded seals, reduced energy efficiency, and possible corrosion and/or frame deterioration.

Photo 1 : Existing non-impact-rated window frame

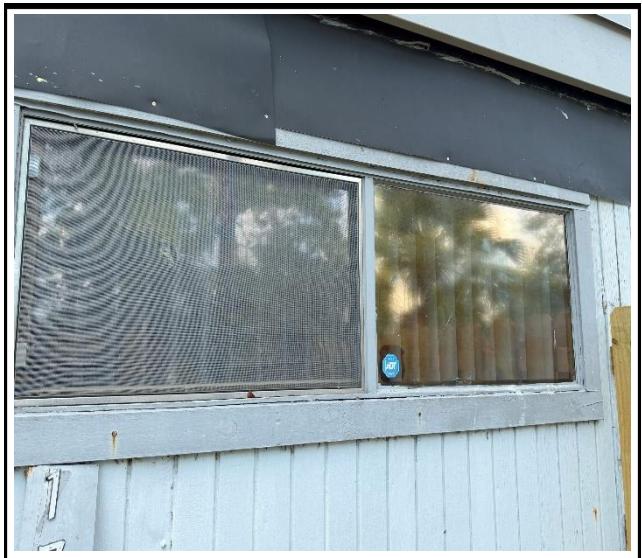
Photo 2 : Existing non-impact-rated window frame

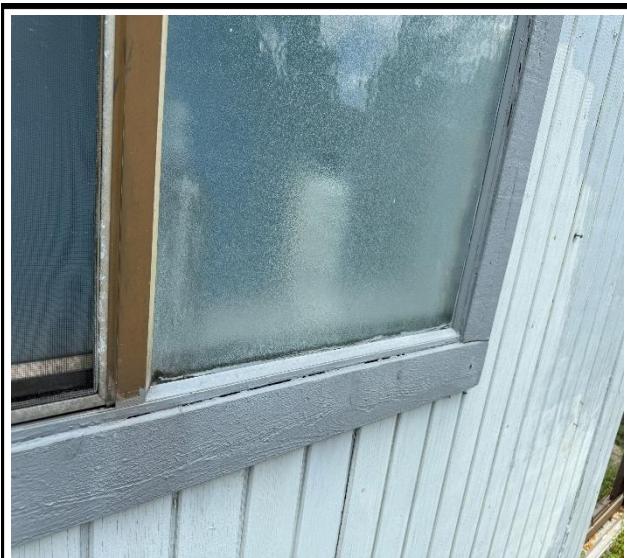
Photo 3 : Existing non-impact-rated window frame

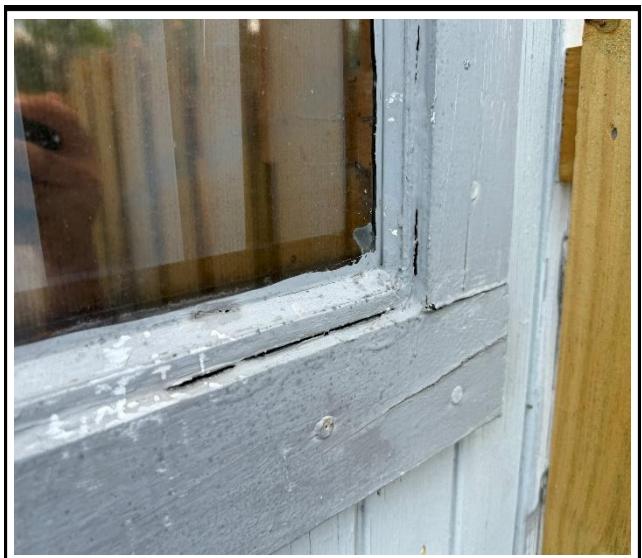
Photo 4 : Existing non-impact-rated window frame

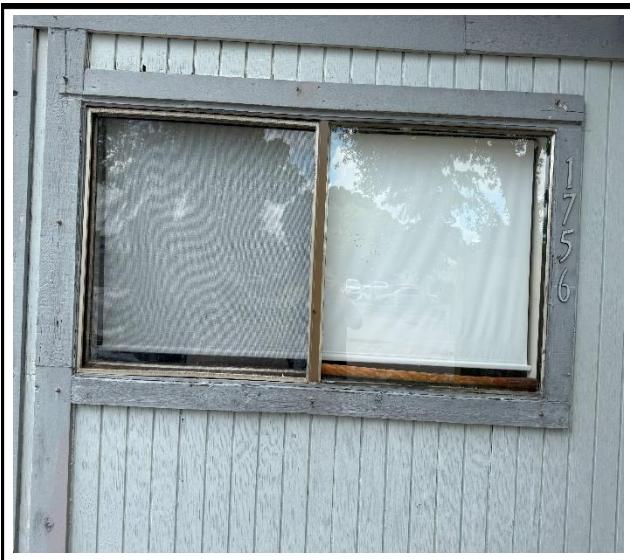
The windows are approximately 40 years old and show typical signs of aging, including potential air and water leakage, degraded seals, reduced energy efficiency, and possible corrosion and/or frame deterioration.

Photo 1 : Existing non-impact-rated window frame

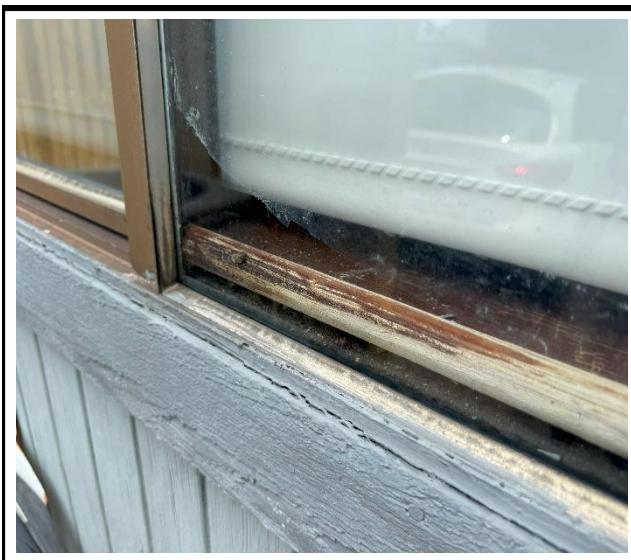
Photo 2 : Existing non-impact-rated window frame

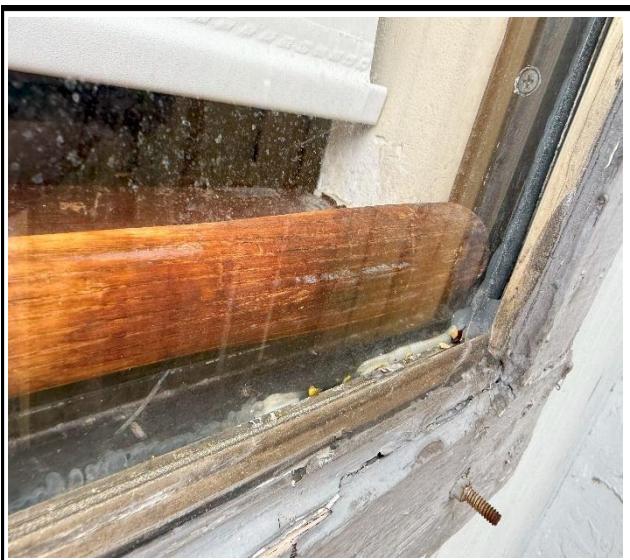
Photo 3 : Existing non-impact-rated window frame

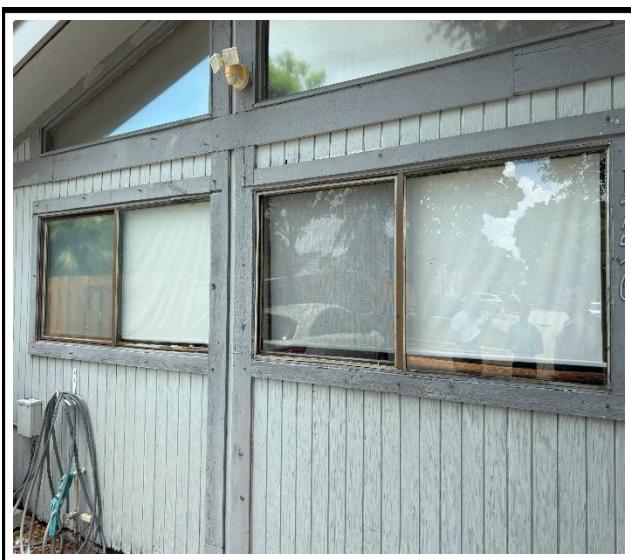
Photo 4 : Existing non-impact-rated window frame

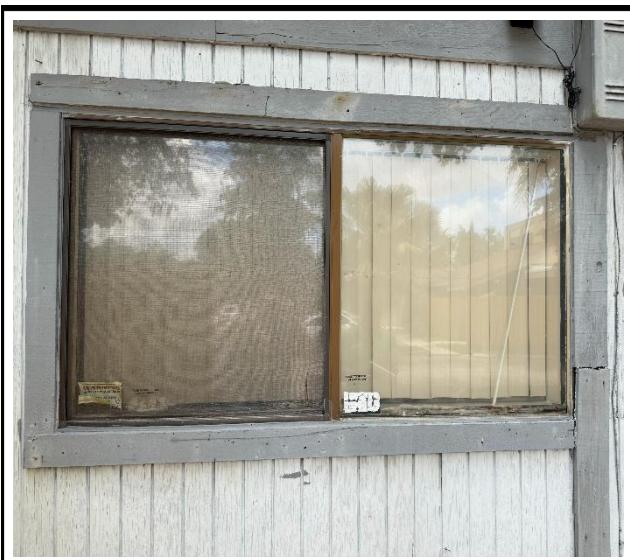
The windows are approximately 40 years old and show typical signs of aging, including potential air and water leakage, degraded seals, reduced energy efficiency, and possible corrosion and/or frame deterioration.

Photo 1 : Existing non-impact-rated window frame

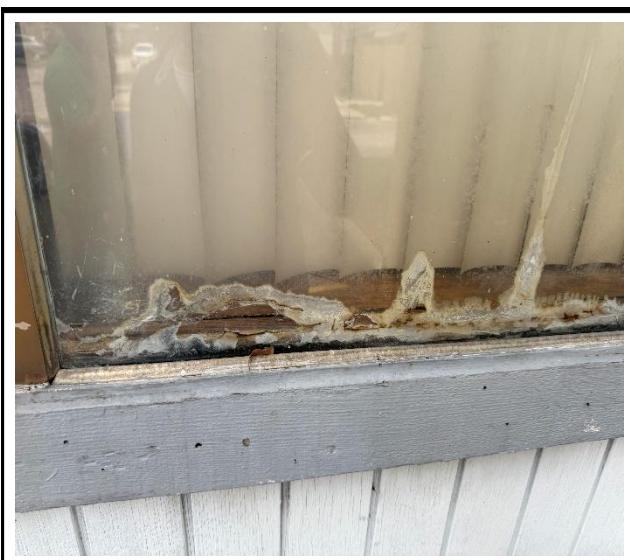
Photo 2 : Existing non-impact-rated window frame

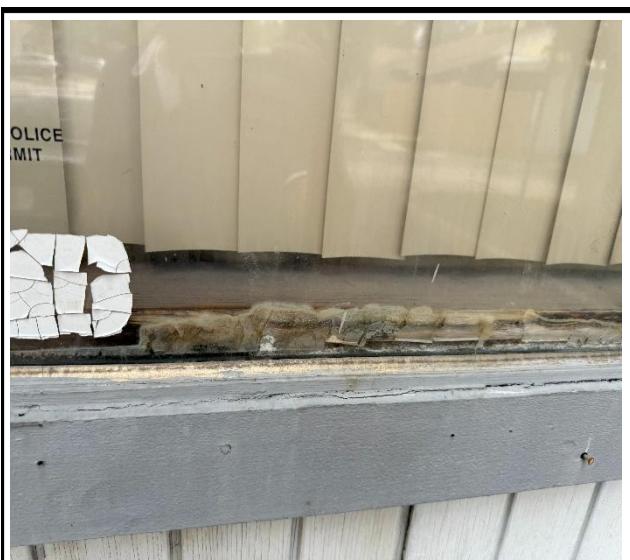
Photo 3 : Existing non-impact-rated window frame

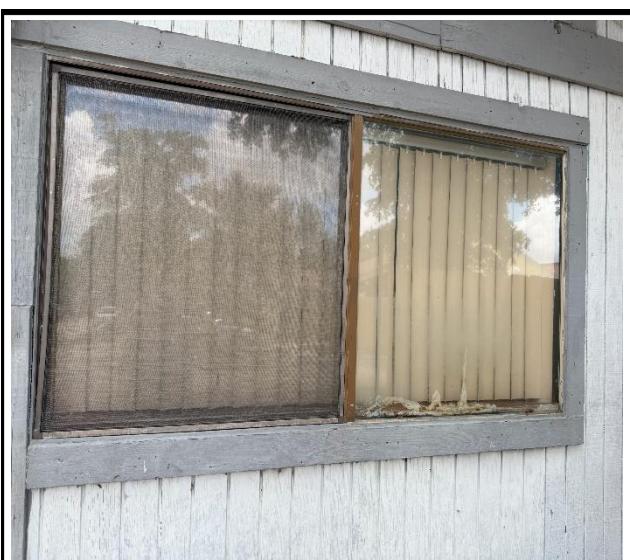
Photo 4 : Existing non-impact-rated window frame

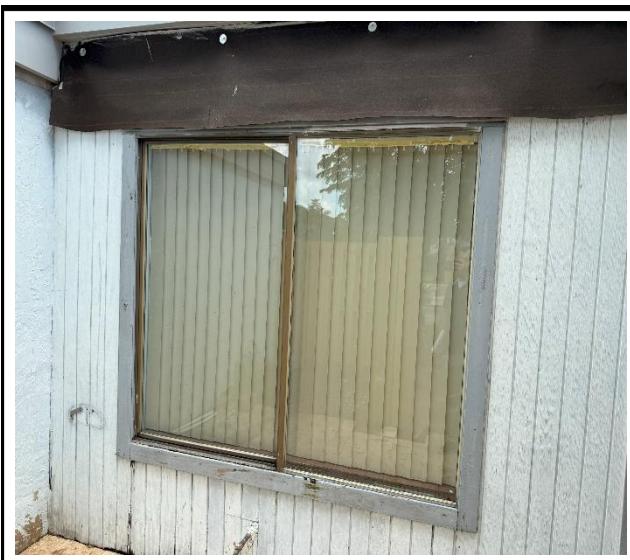
The windows are approximately 40 years old and show typical signs of aging, including potential air and water leakage, degraded seals, reduced energy efficiency, and possible corrosion and/or frame deterioration.

Photo 1 : Existing non-impact-rated window frame

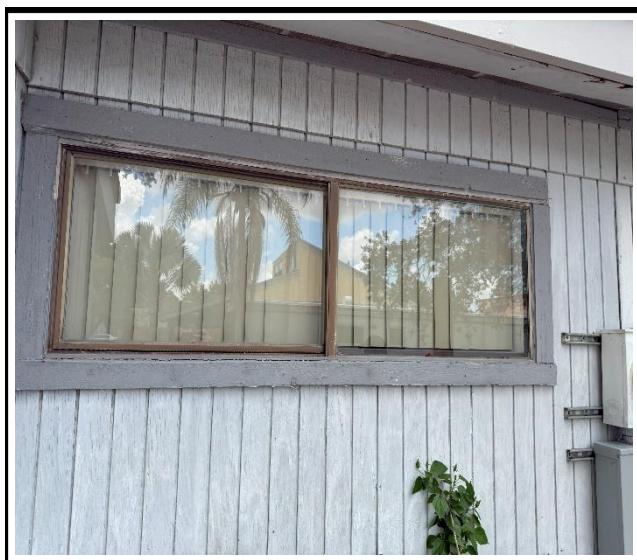
Photo 2 : Existing non-impact-rated window frame

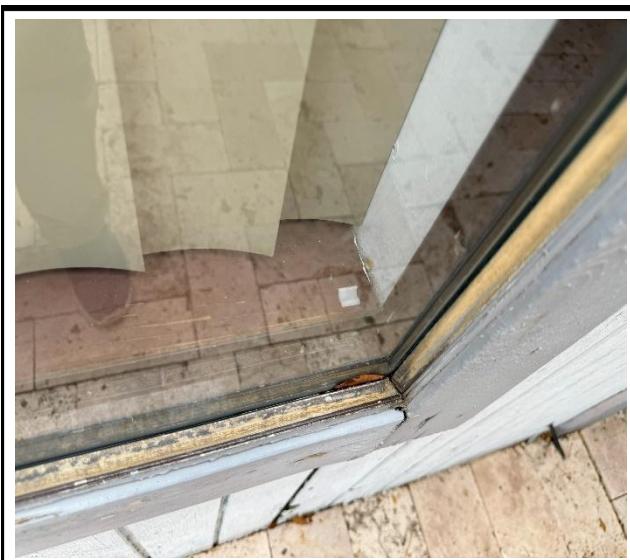
Photo 3 : Existing non-impact-rated window frame

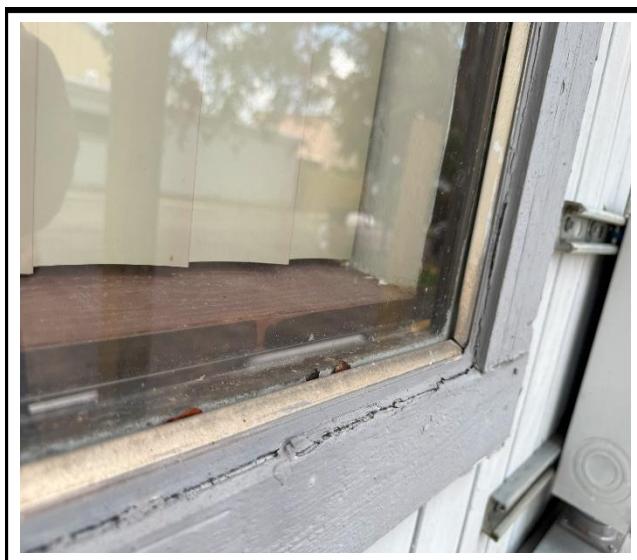
Photo 4 : Existing non-impact-rated window frame

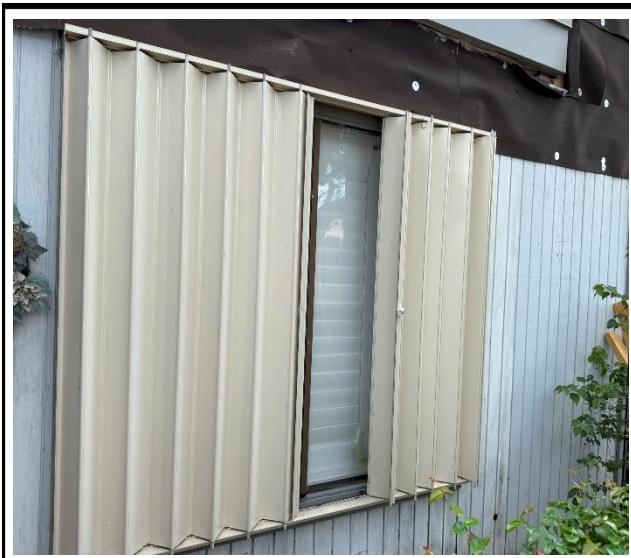
The windows are approximately 40 years old and show typical signs of aging, including potential air and water leakage, degraded seals, reduced energy efficiency, and possible corrosion and/or frame deterioration.

Photo 1 : Existing non-impact-rated window frame

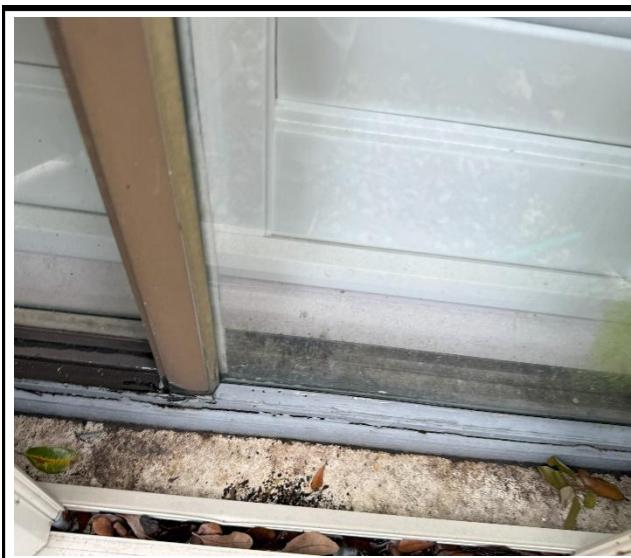
Photo 2 : Existing non-impact-rated window frame

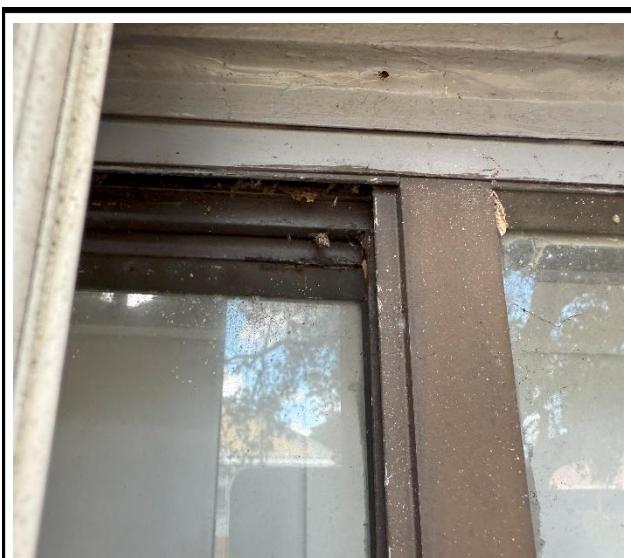
Photo 3 : Existing non-impact-rated window frame

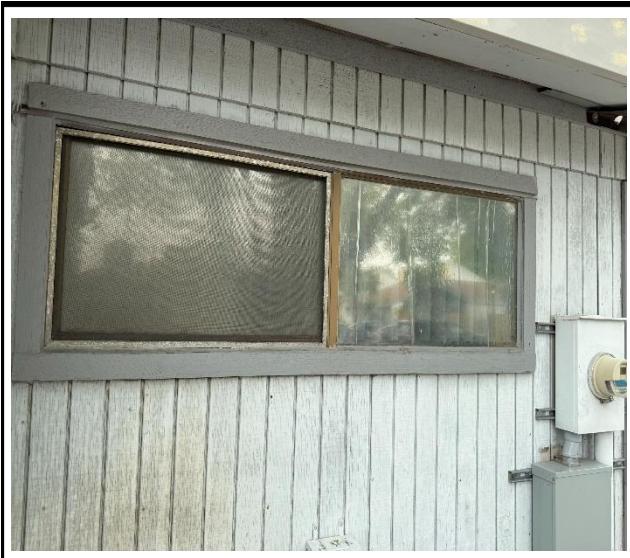
The windows are approximately 40 years old and show typical signs of aging, including potential air and water leakage, degraded seals, reduced energy efficiency, and possible corrosion and/or frame deterioration.

Photo 1 : Existing non-impact-rated window frame

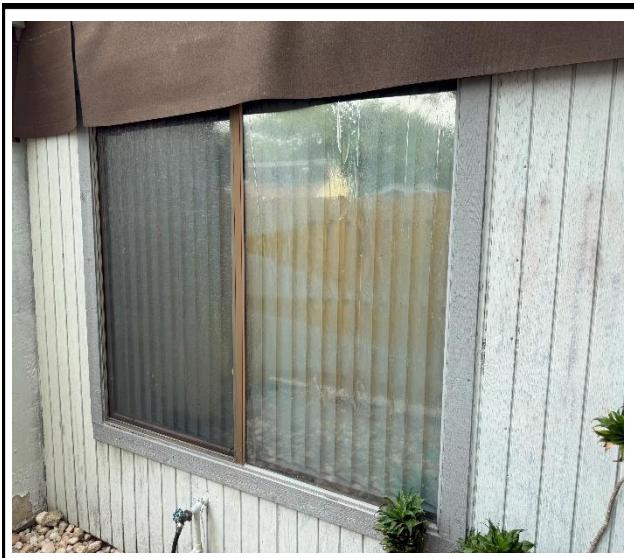
Photo 2 : Existing non-impact-rated window frame

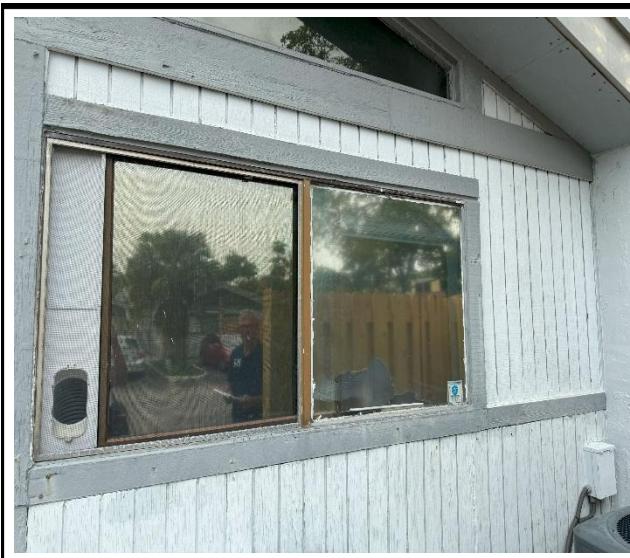
The windows are approximately 40 years old and show typical signs of aging, including potential air and water leakage, degraded seals, reduced energy efficiency, and possible corrosion and/or frame deterioration.

Photo 1 : Existing non-impact-rated window frame

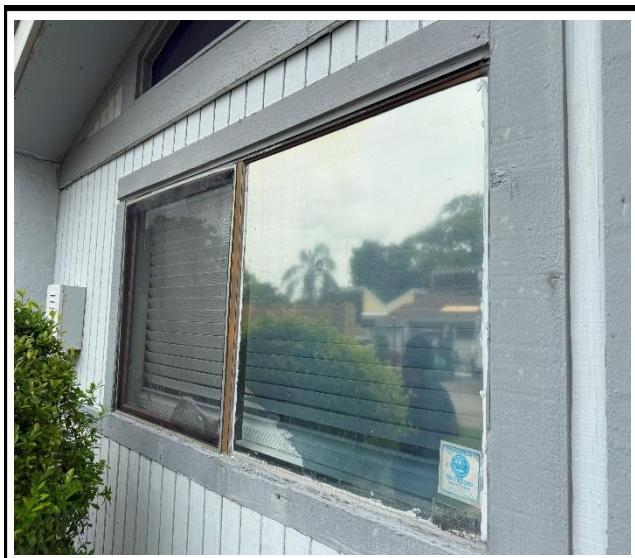
Photo 2 : Existing non-impact-rated window frame

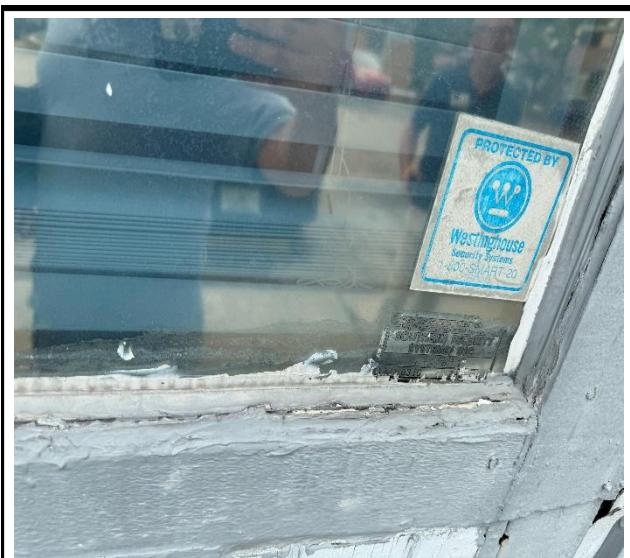
Photo 3 : Existing non-impact-rated window frame

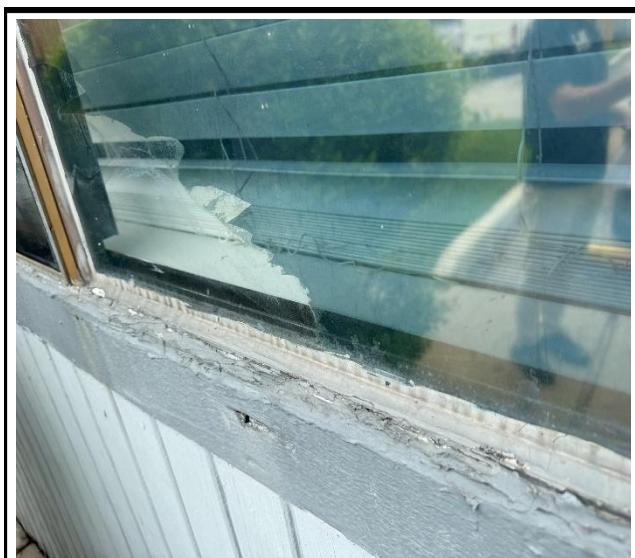
Photo 4 : Existing non-impact-rated window frame

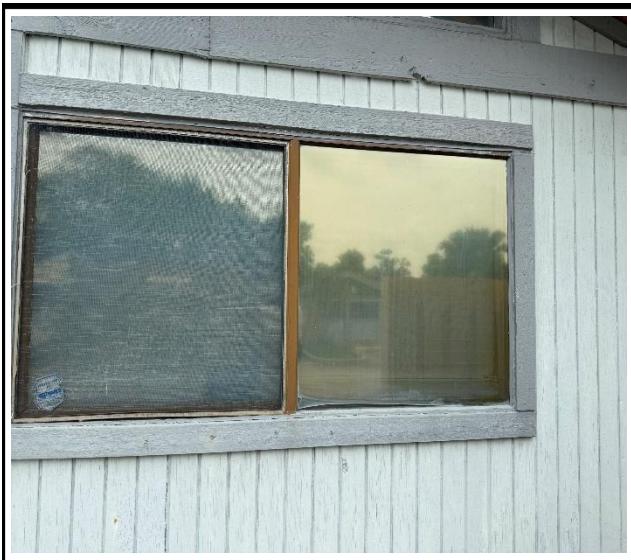
The windows are approximately 40 years old and show typical signs of aging, including potential air and water leakage, degraded seals, reduced energy efficiency, and possible corrosion and/or frame deterioration.

Photo 1 : Existing non-impact-rated window frame

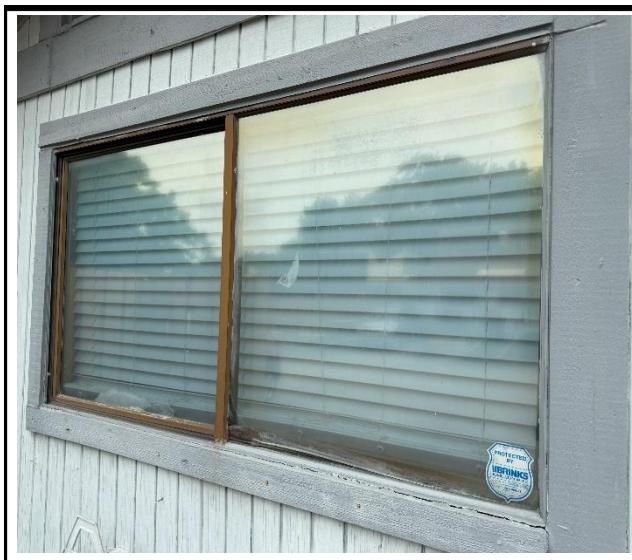
Photo 2 : Existing non-impact-rated window frame

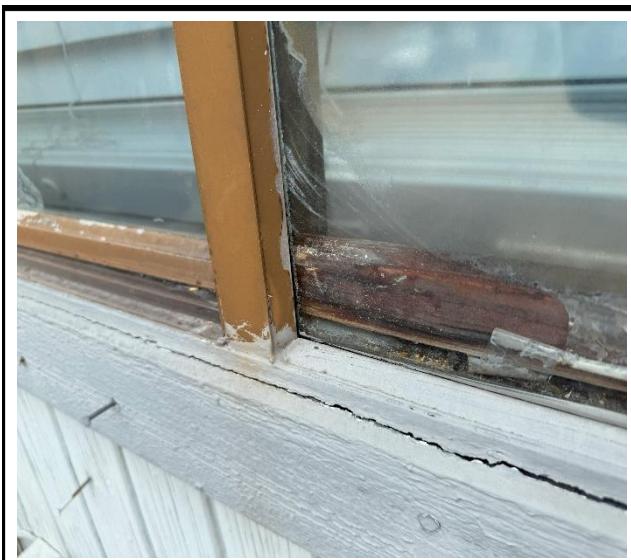
Photo 3 : Existing non-impact-rated window frame

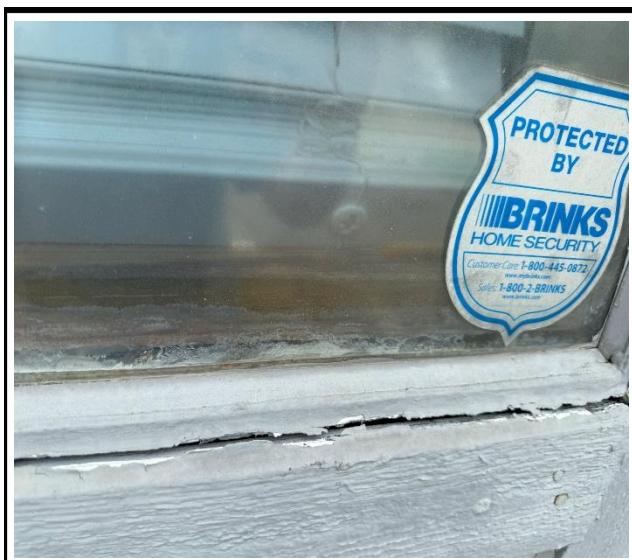
Photo 4 : Existing non-impact-rated window frame

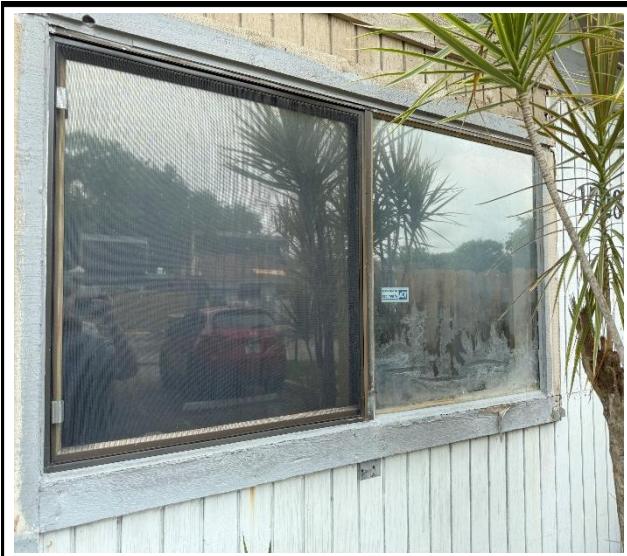
The windows are approximately 40 years old and show typical signs of aging, including potential air and water leakage, degraded seals, reduced energy efficiency, and possible corrosion and/or frame deterioration.

Photo 1 : Existing non-impact-rated window frame

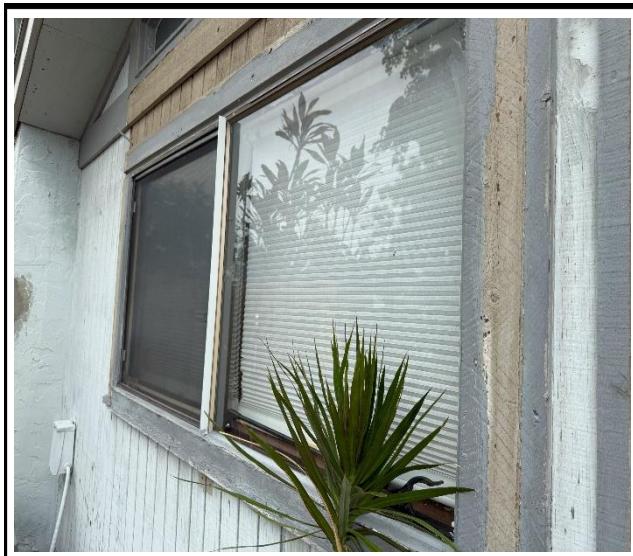
Photo 2 : Existing non-impact-rated window frame

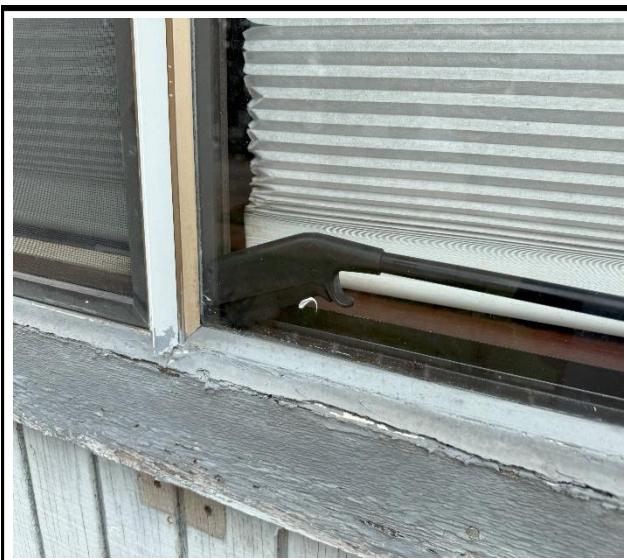
Photo 3 : Existing non-impact-rated window frame

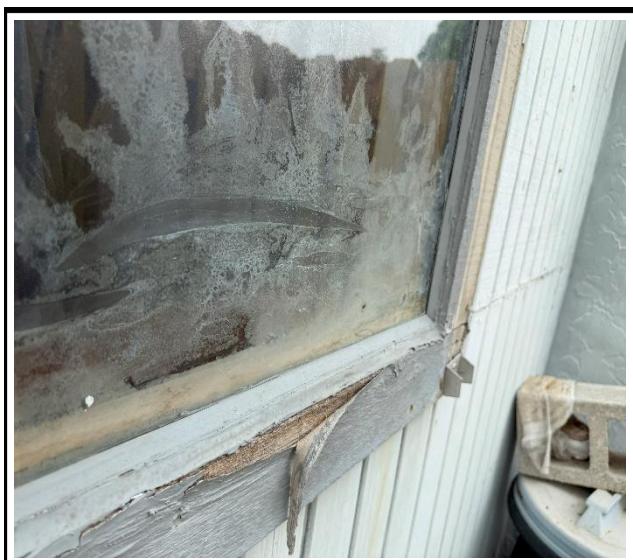
Photo 4 : Existing non-impact-rated window frame

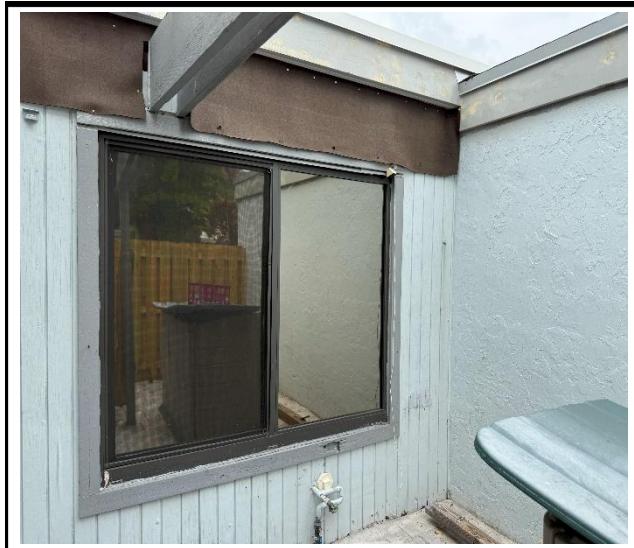
Photo 1 : Existing Window

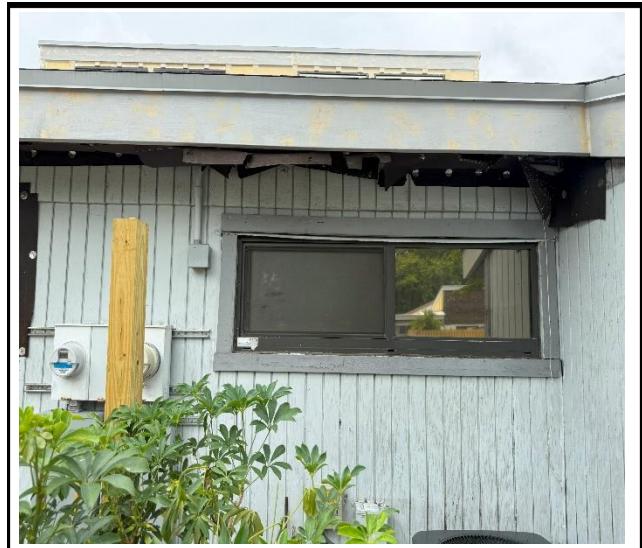
Photo 2 : Existing Window
