Omega Villas Condominium Association

1713 NW 72 Avenue,  
Plantation, FL 33313

**Windows Evaluation Report**  
**BLDGs 1 to 15**  
(07/23/2025)

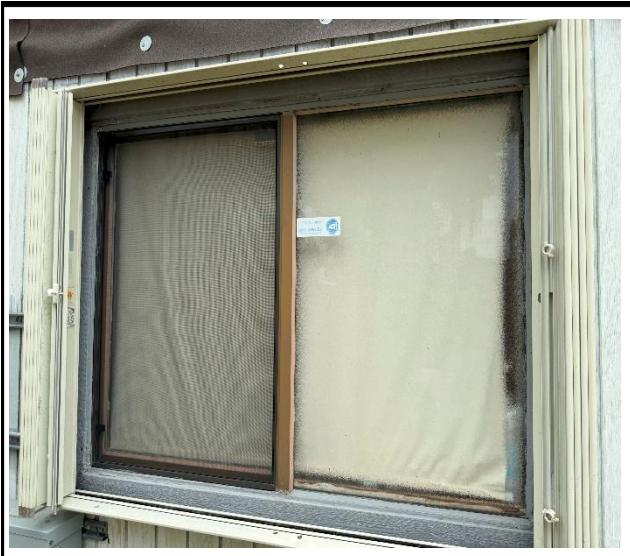
The windows are approximately 40 years old and show typical signs of aging, including potential air and water leakage, degraded seals, reduced energy efficiency, and possible corrosion and/or frame deterioration.

Photo 1 : Existing non-impact-rated window frame

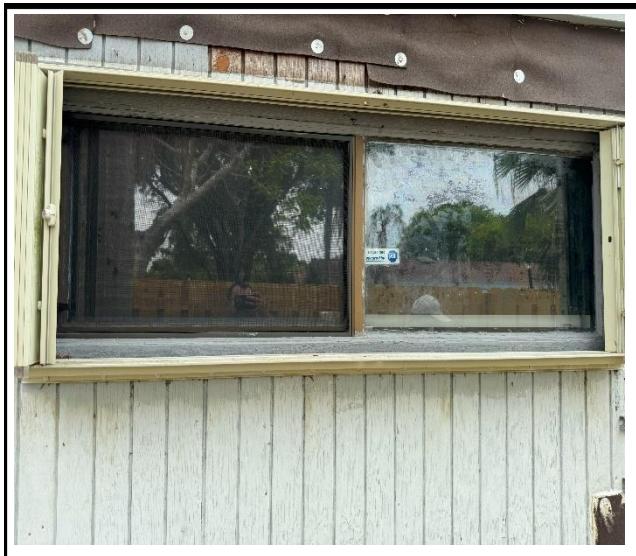
Photo 2 : Existing non-impact-rated window frame

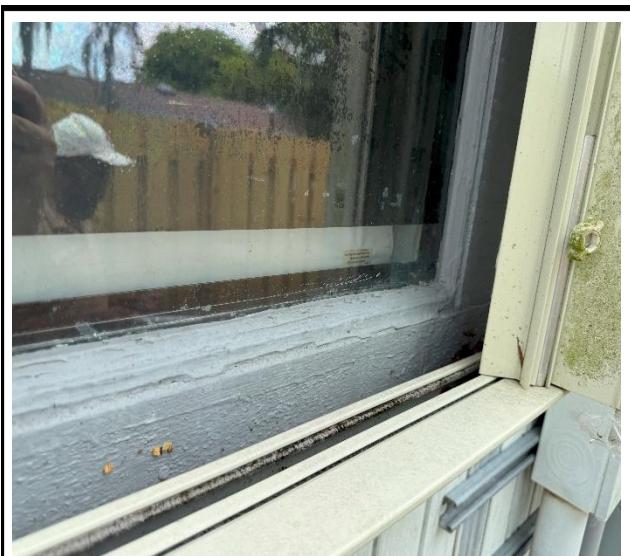
Photo 3 : Existing non-impact-rated window frame

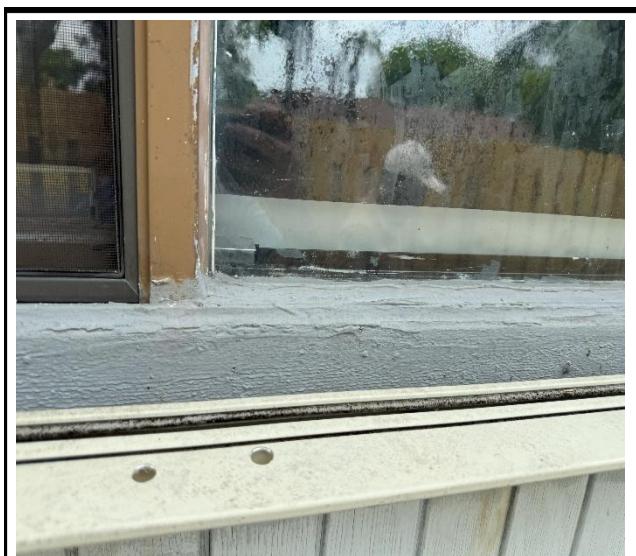
Photo 4 : Existing non-impact-rated window frame

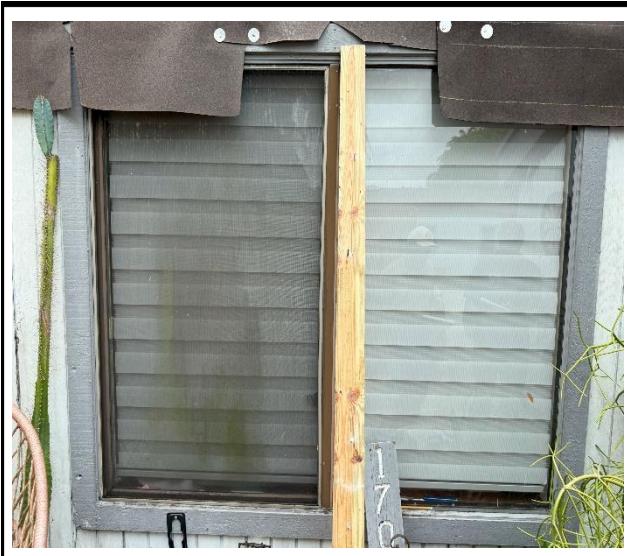
The windows are approximately 40 years old and show typical signs of aging, including potential air and water leakage, degraded seals, reduced energy efficiency, and possible corrosion and/or frame deterioration.

Photo 1 : Existing non-impact-rated window frame

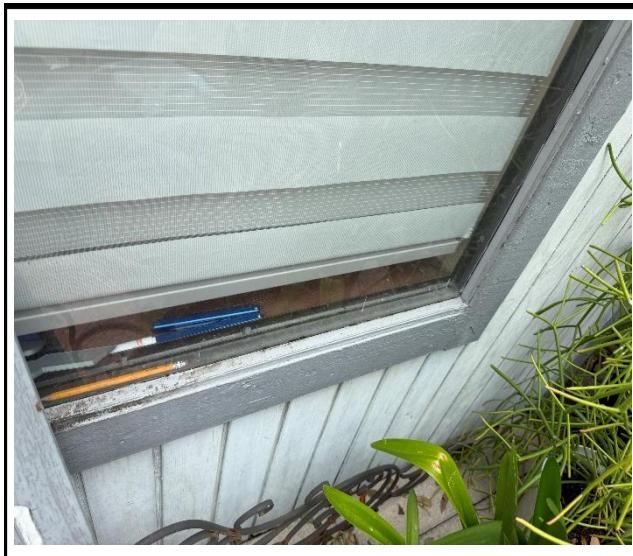
Photo 2 : Existing non-impact-rated window frame

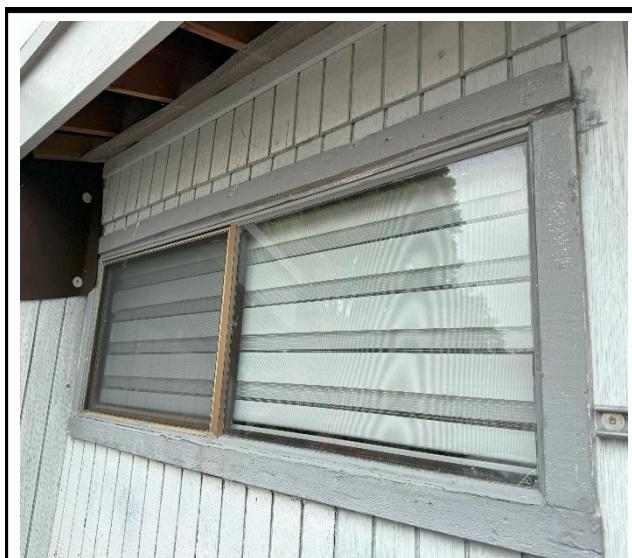
Photo 3 : Existing non-impact-rated window frame

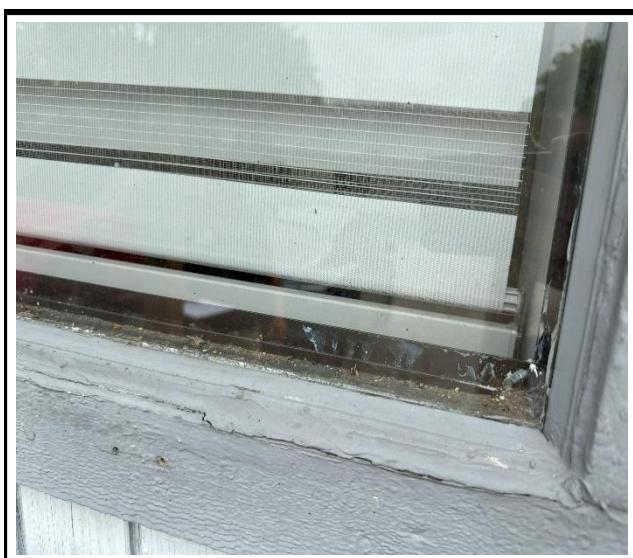
Photo 4 : Existing non-impact-rated window frame

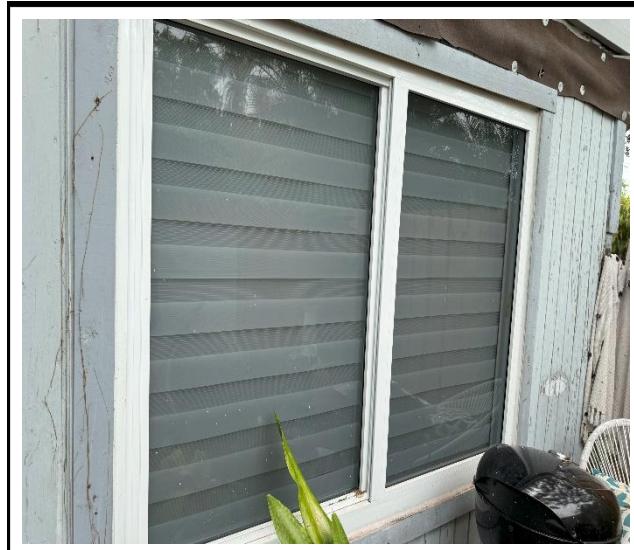
Photo 1 : Existing Window

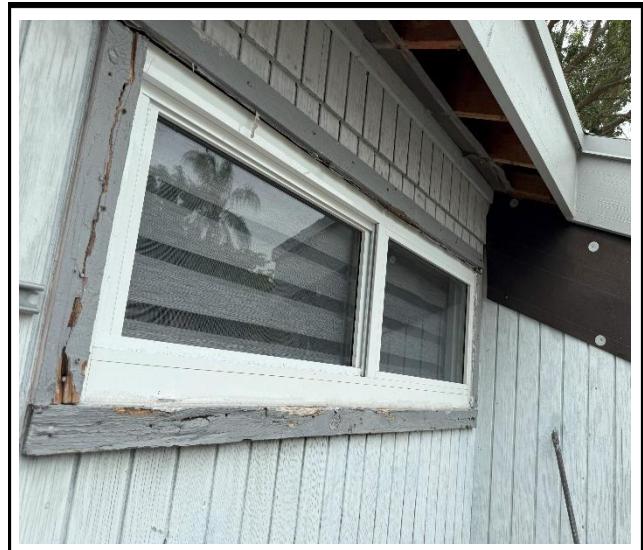
Photo 2 : Existing Window

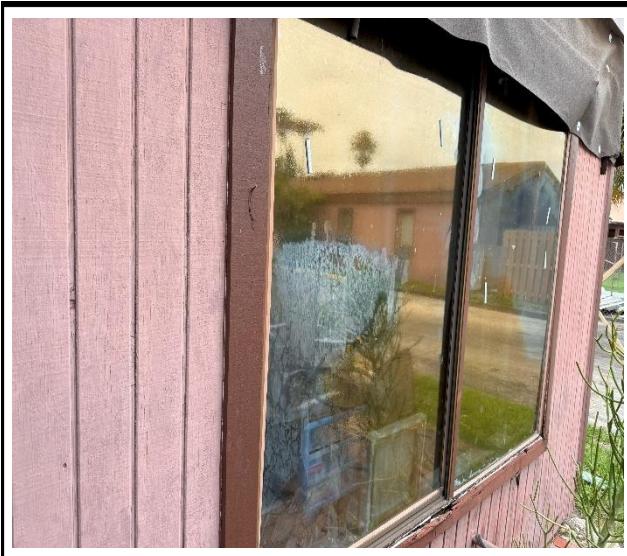
The windows are approximately 40 years old and show typical signs of aging, including potential air and water leakage, degraded seals, reduced energy efficiency, and possible corrosion and/or frame deterioration.

Photo 1 : Existing non-impact-rated window frame

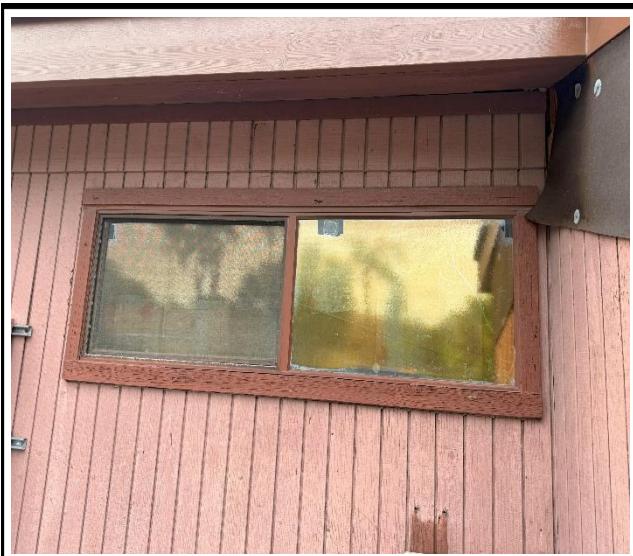
Photo 2 : Existing non-impact-rated window frame

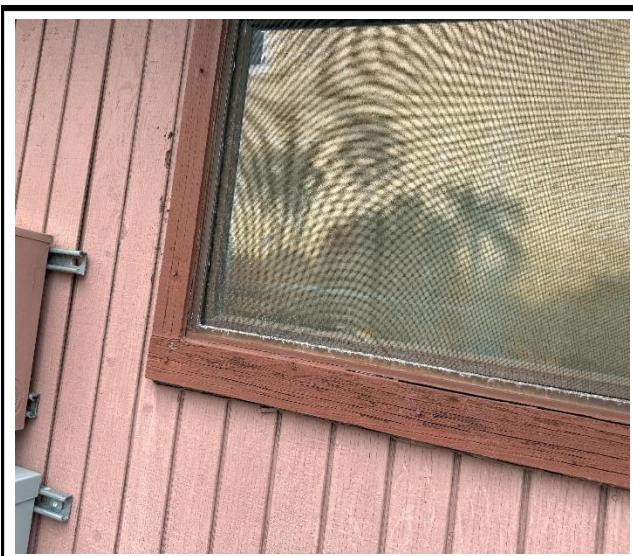
Photo 4 : Existing non-impact-rated window frame

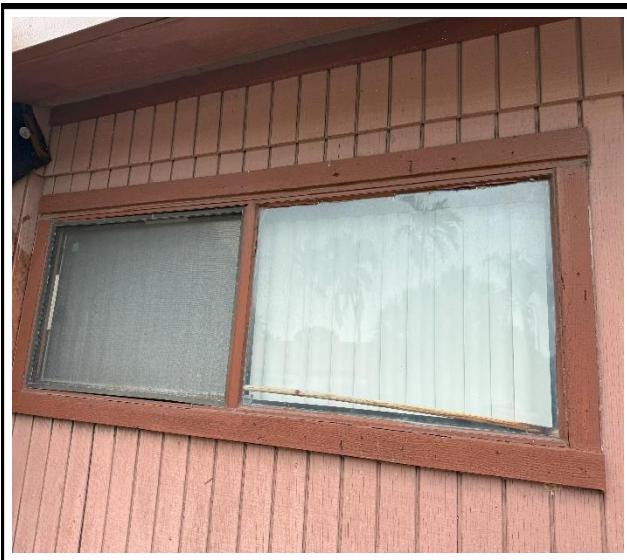
The windows are approximately 40 years old and show typical signs of aging, including potential air and water leakage, degraded seals, reduced energy efficiency, and possible corrosion and/or frame deterioration.

Photo 1 : Existing non-impact-rated window frame

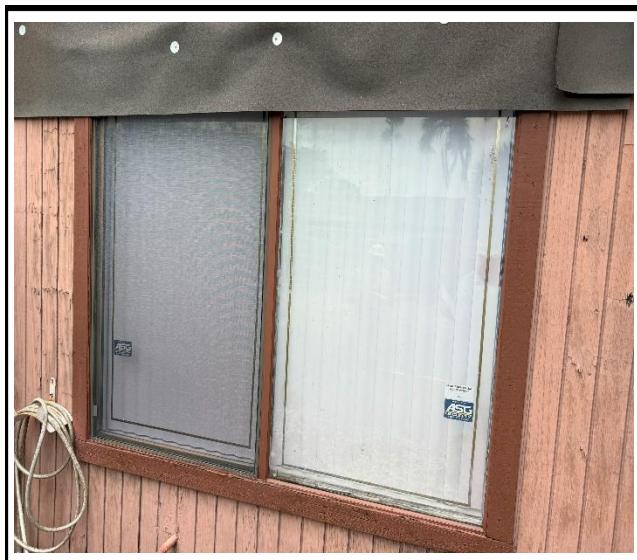
Photo 2 : Existing non-impact-rated window frame

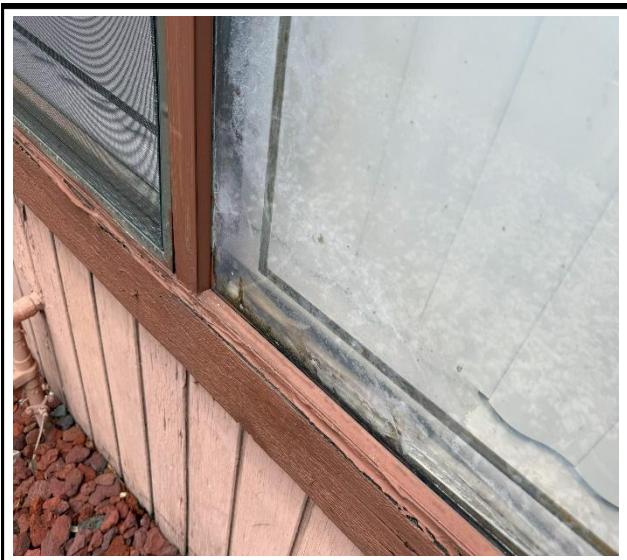
Photo 3 : Existing non-impact-rated window frame

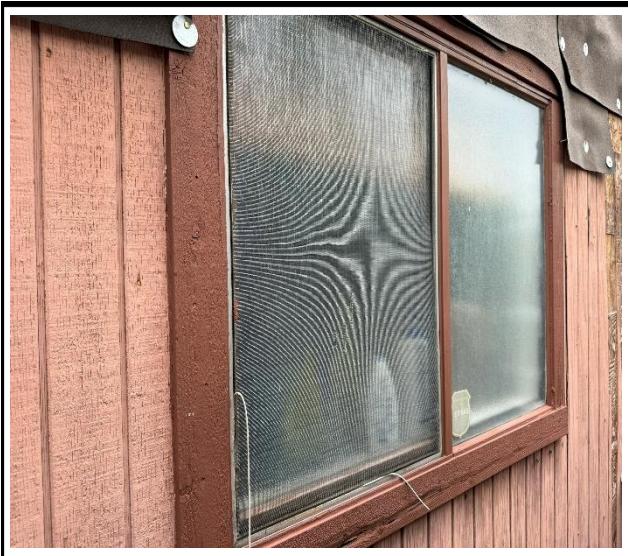
The windows are approximately 40 years old and show typical signs of aging, including potential air and water leakage, degraded seals, reduced energy efficiency, and possible corrosion and/or frame deterioration.

Photo 1 : Existing non-impact-rated window frame

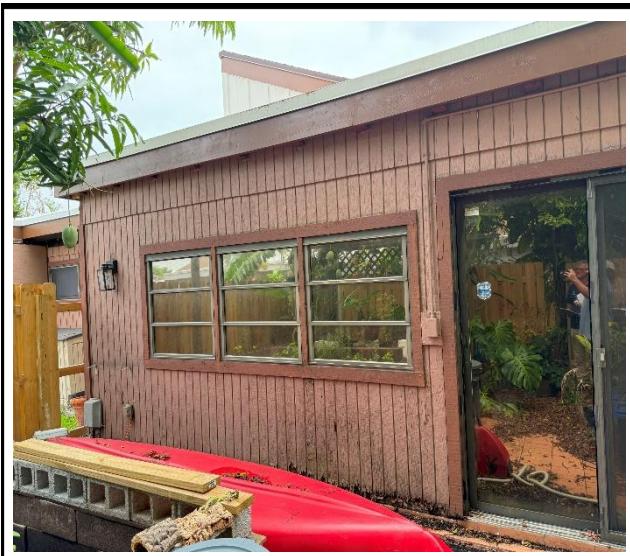
Photo 2 : Existing non-impact-rated window frame

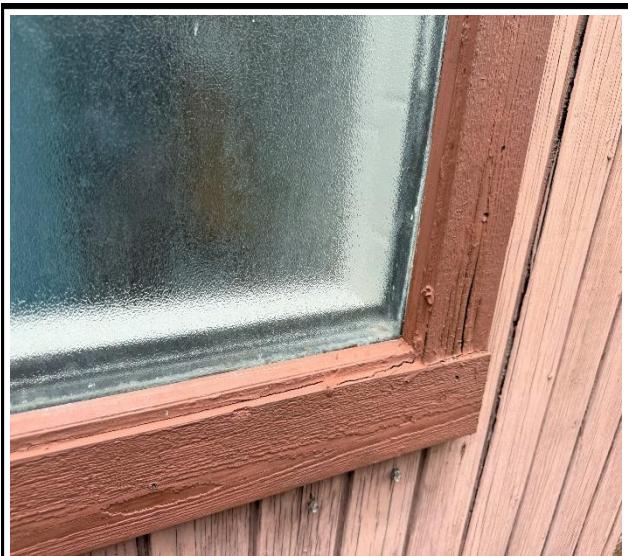
Photo 3 : Existing non-impact-rated window frame

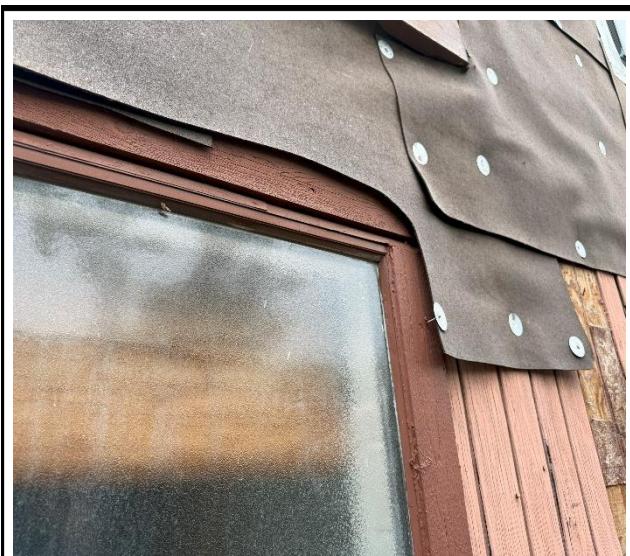
Photo 4 : Existing non-impact-rated window frame

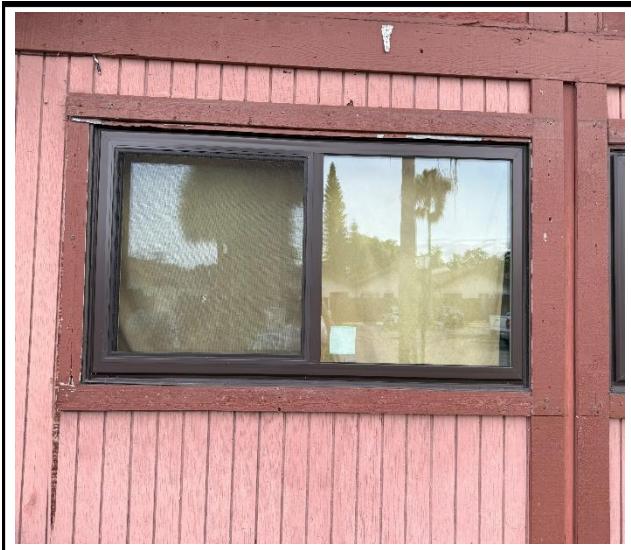
Photo 1 : Existing Window

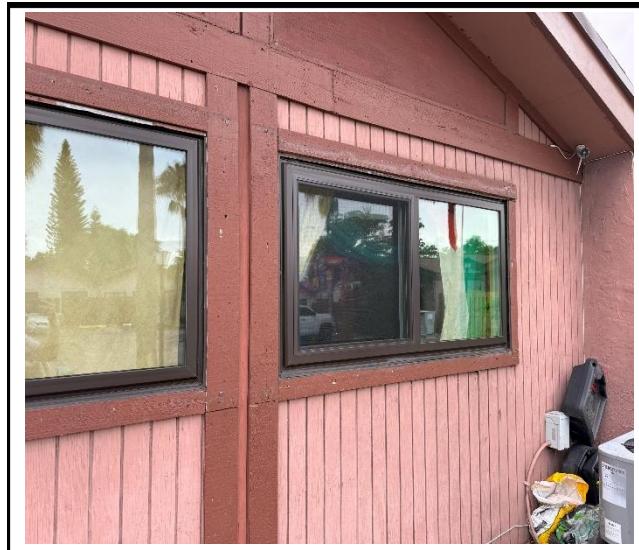
Photo 2 : Existing Window

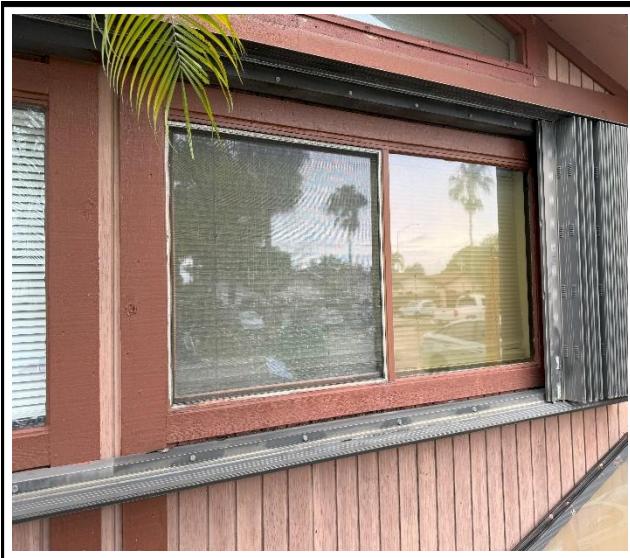
The windows are approximately 40 years old and show typical signs of aging, including potential air and water leakage, degraded seals, reduced energy efficiency, and possible corrosion and/or frame deterioration.

Photo 1 : Existing non-impact-rated window frame

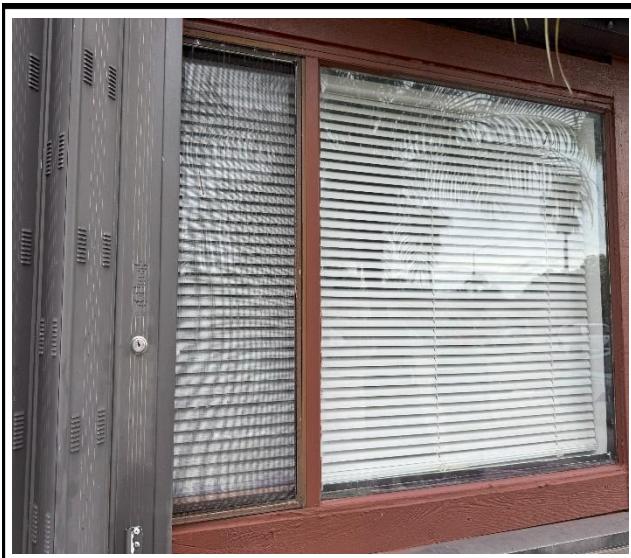
Photo 2 : Existing non-impact-rated window frame

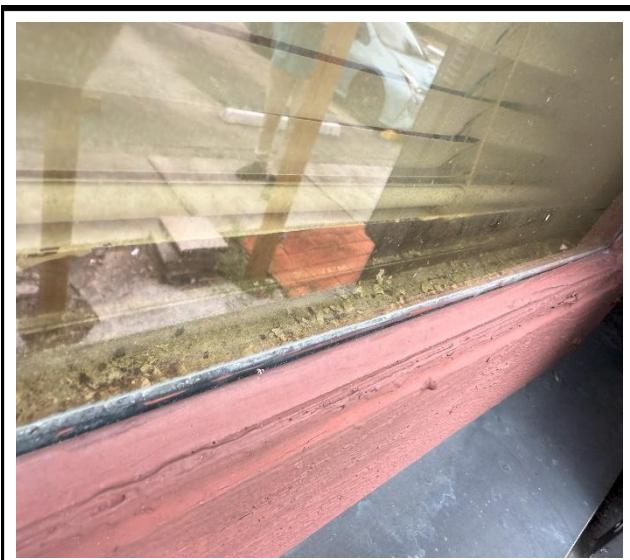
Photo 3 : Existing non-impact-rated window frame

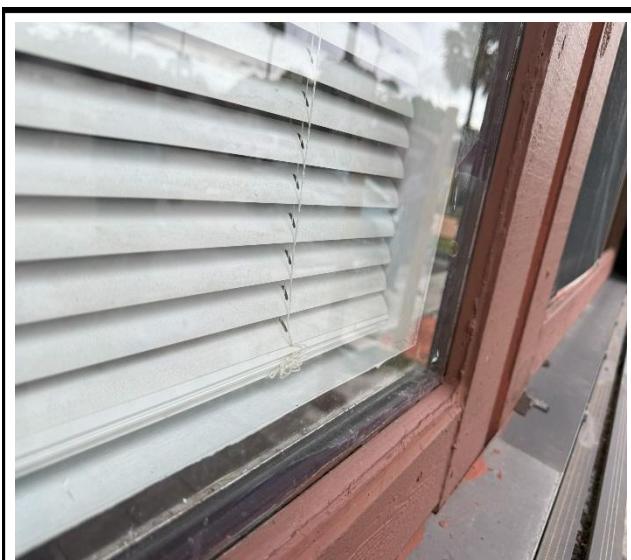
Photo 4 : Existing non-impact-rated window frame

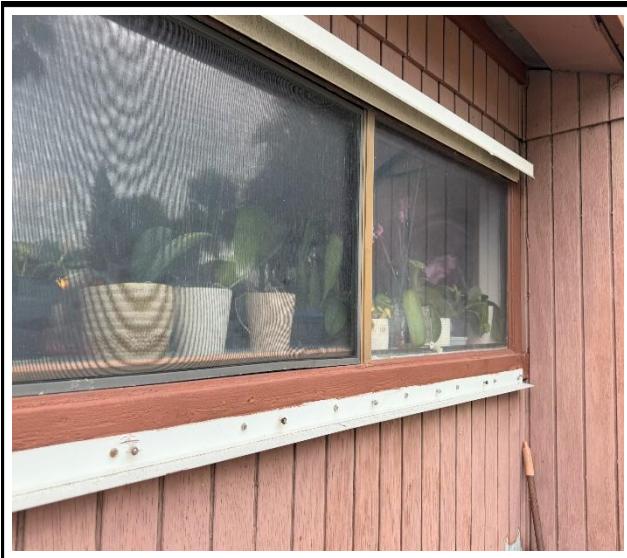
The windows are approximately 40 years old and show typical signs of aging, including potential air and water leakage, degraded seals, reduced energy efficiency, and possible corrosion and/or frame deterioration.

Photo 1 : Existing non-impact-rated window frame

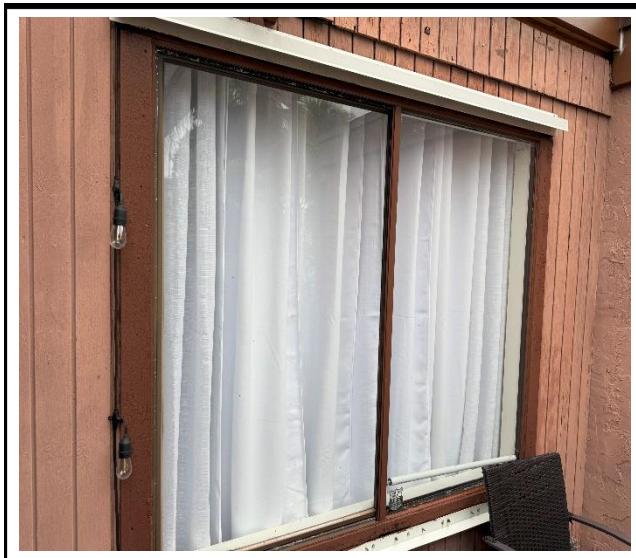
Photo 2 : Existing non-impact-rated window frame

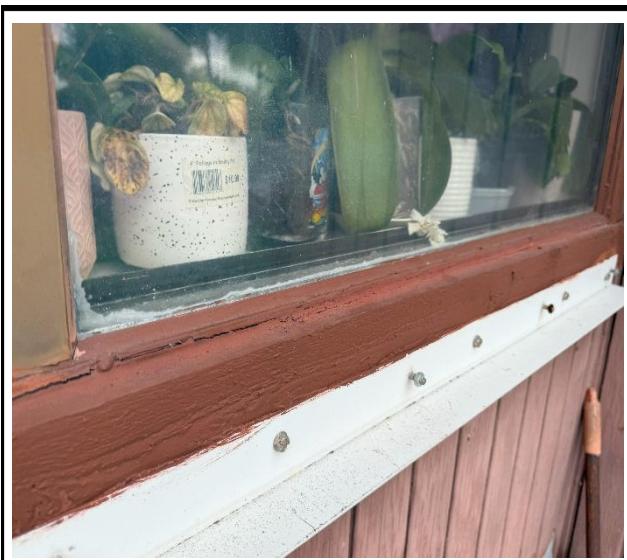
Photo 3 : Existing non-impact-rated window frame

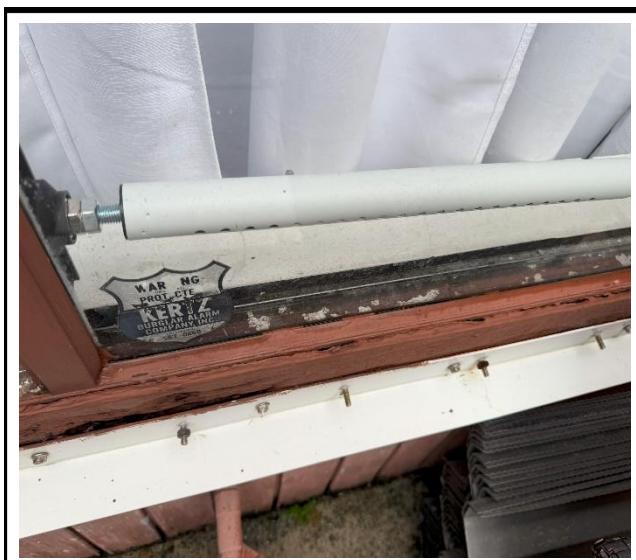
Photo 4 : Existing non-impact-rated window frame

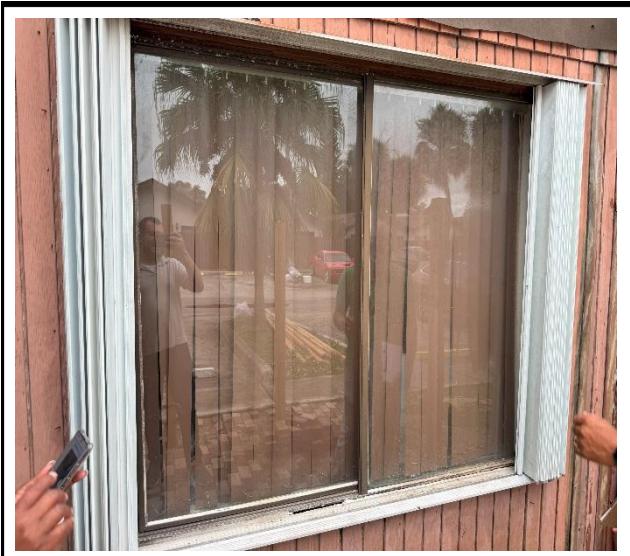
The windows are approximately 40 years old and show typical signs of aging, including potential air and water leakage, degraded seals, reduced energy efficiency, and possible corrosion and/or frame deterioration.

Photo 1 : Existing non-impact-rated window frame

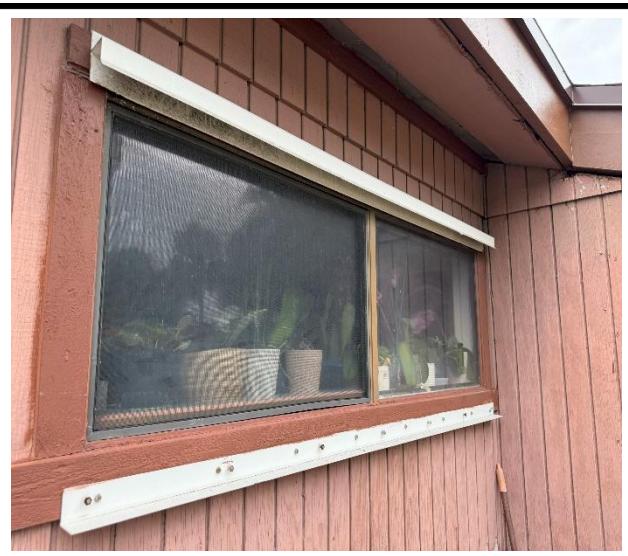
Photo 2 : Existing non-impact-rated window frame

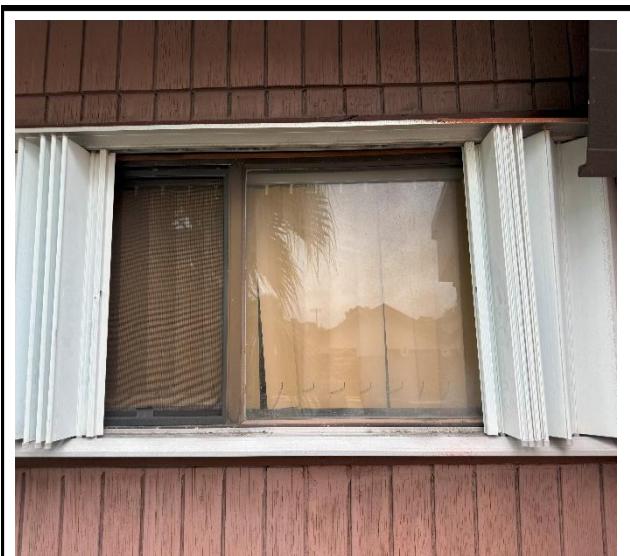
Photo 3 : Existing non-impact-rated window frame

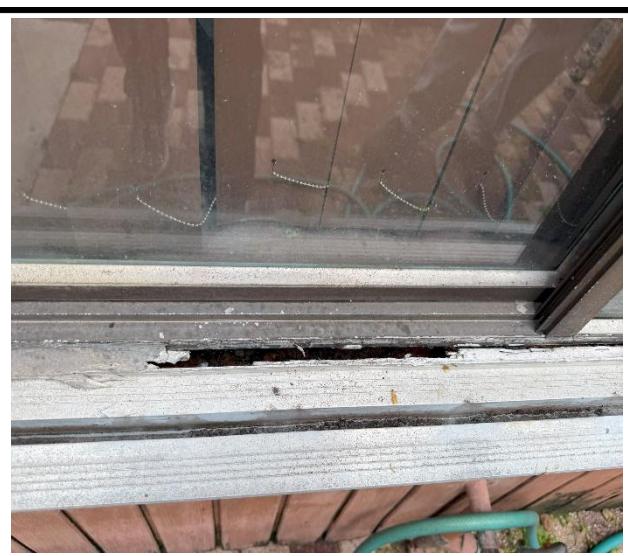
Photo 4 : Existing non-impact-rated window frame

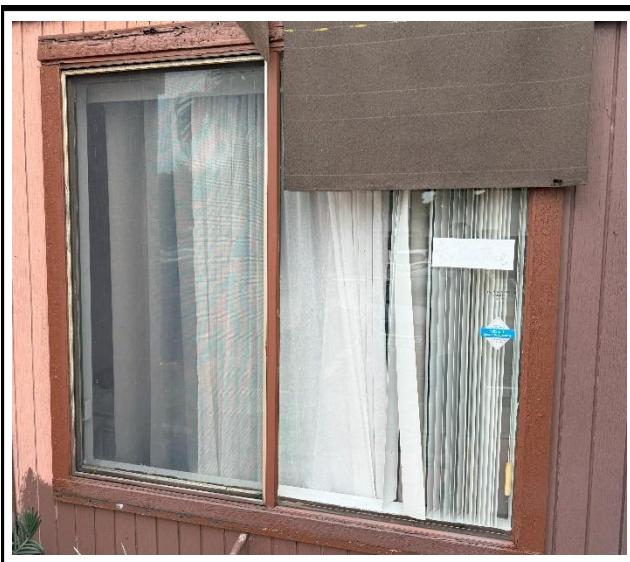
The windows are approximately 40 years old and show typical signs of aging, including potential air and water leakage, degraded seals, reduced energy efficiency, and possible corrosion and/or frame deterioration.

Photo 1 : Existing non-impact-rated window frame

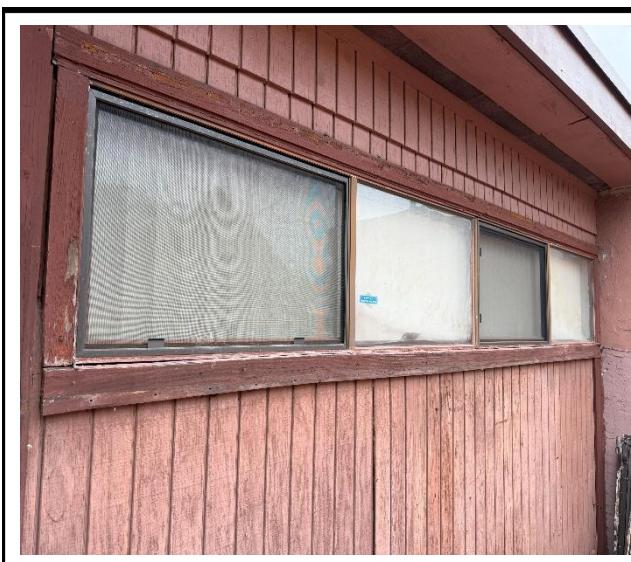
Photo 2 : Existing non-impact-rated window frame

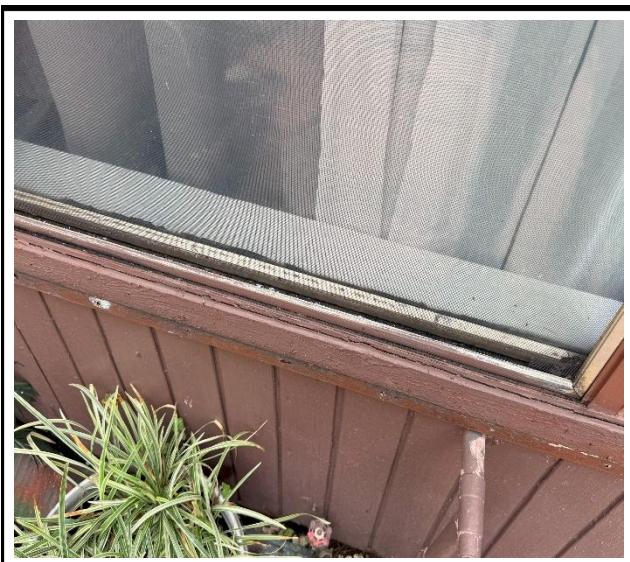
Photo 3 : Existing non-impact-rated window frame

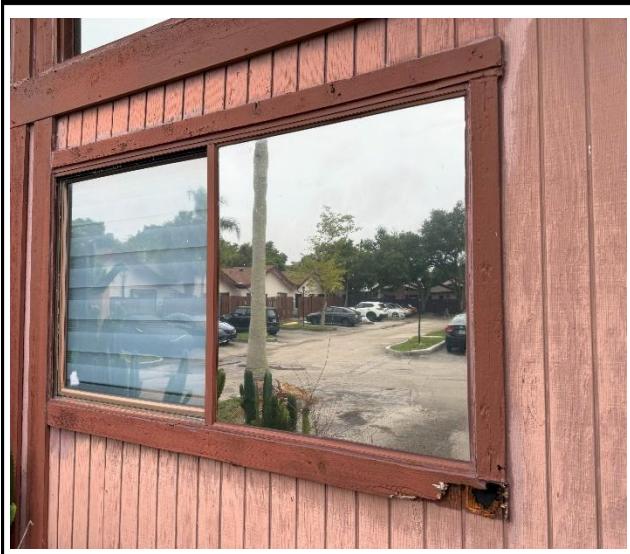
The windows are approximately 40 years old and show typical signs of aging, including potential air and water leakage, degraded seals, reduced energy efficiency, and possible corrosion and/or frame deterioration.

Photo 1 : Existing non-impact-rated window frame

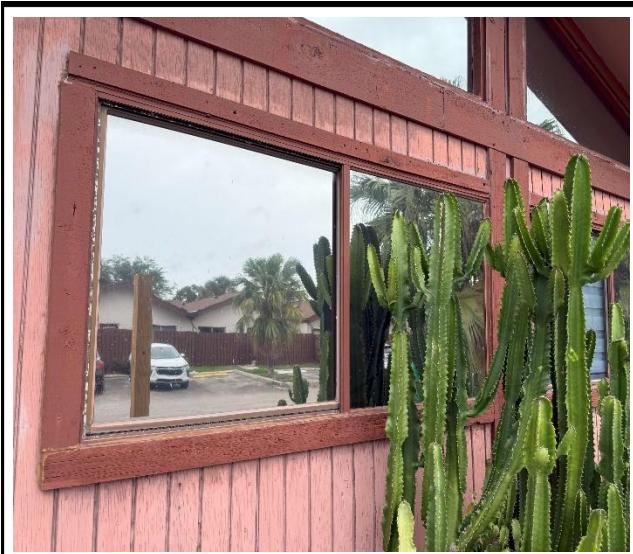
Photo 2 : Existing non-impact-rated window frame

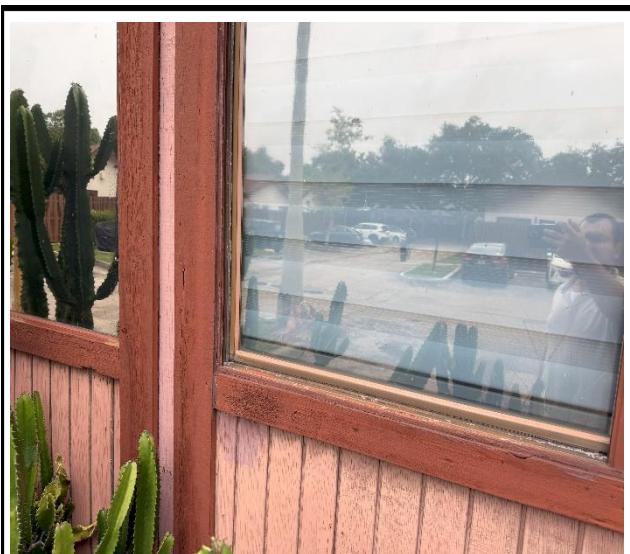
Photo 3 : Existing non-impact-rated window frame

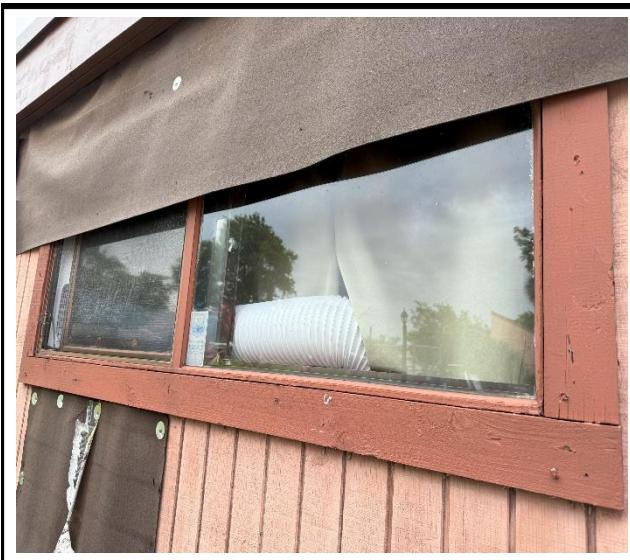
The windows are approximately 40 years old and show typical signs of aging, including potential air and water leakage, degraded seals, reduced energy efficiency, and possible corrosion and/or frame deterioration.

Photo 1 : Existing non-impact-rated window frame

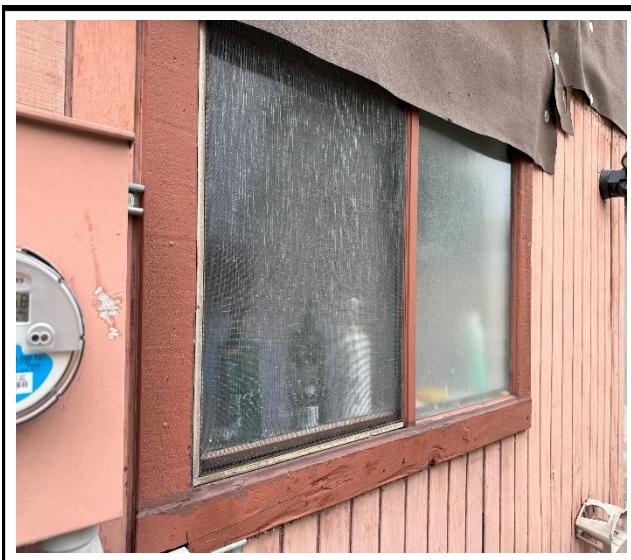
Photo 2 : Existing non-impact-rated window frame

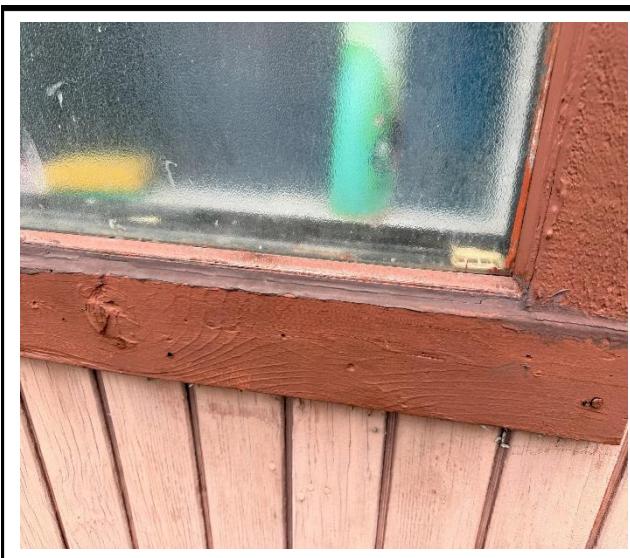
Photo 3 : Existing non-impact-rated window frame

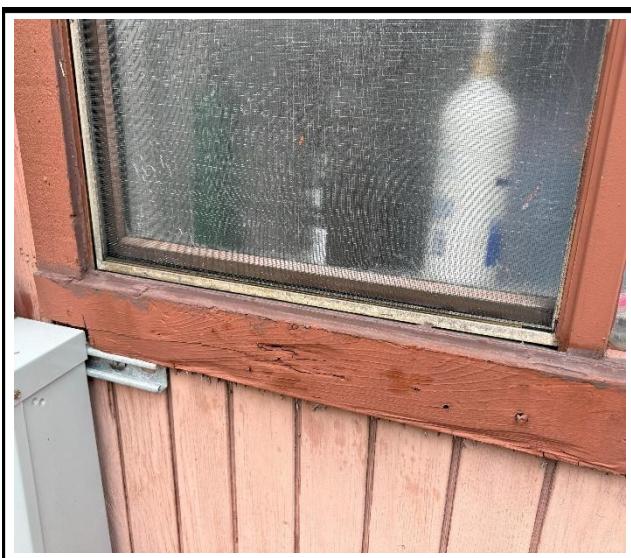
Photo 4 : Existing non-impact-rated window frame

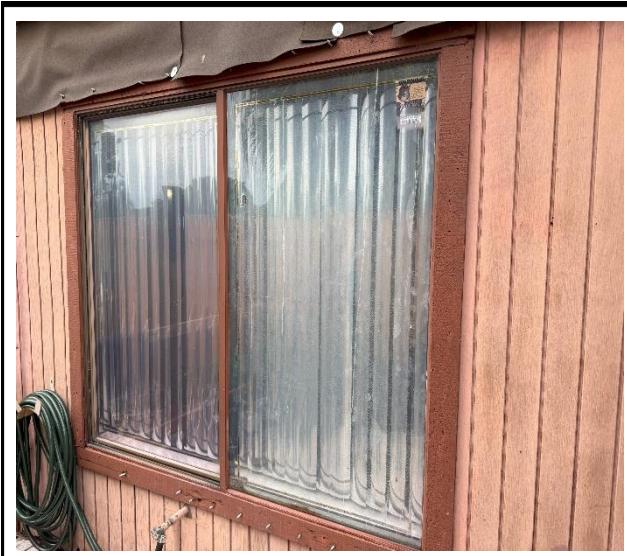
The windows are approximately 40 years old and show typical signs of aging, including potential air and water leakage, degraded seals, reduced energy efficiency, and possible corrosion and/or frame deterioration.

Photo 1 : Existing non-impact-rated window frame

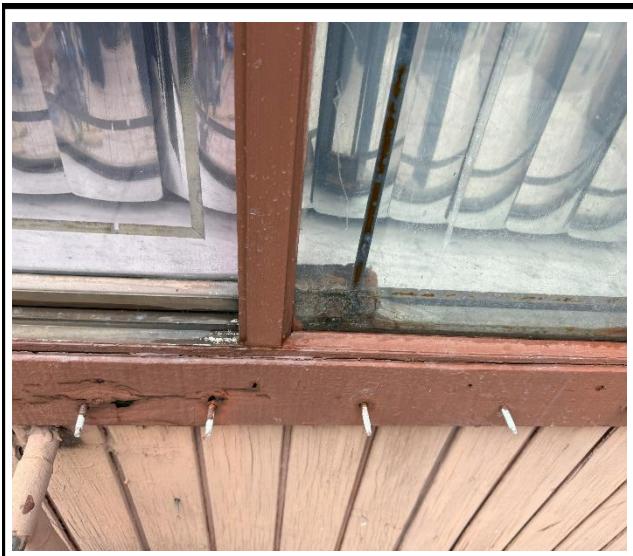
Photo 2 : Existing non-impact-rated window frame

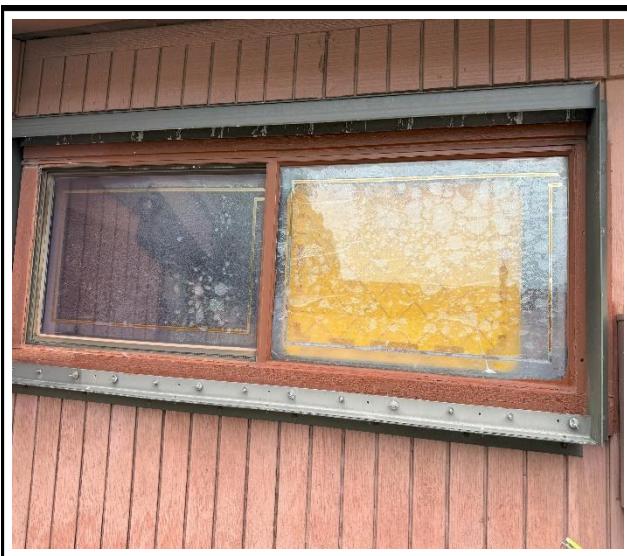
Photo 3 : Existing non-impact-rated window frame

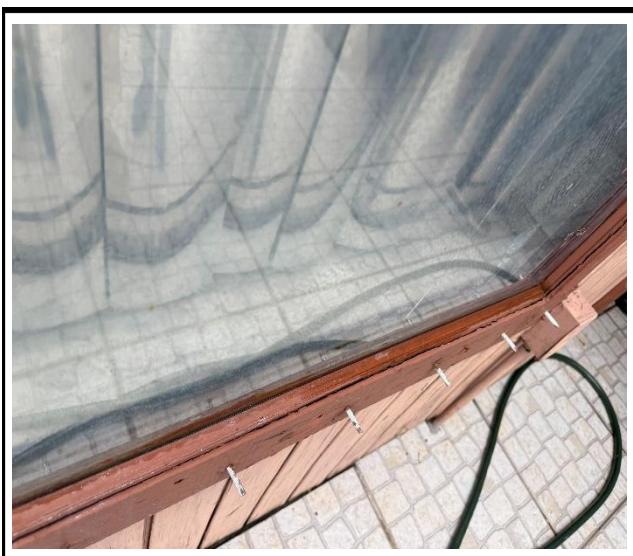
Photo 4 : Existing non-impact-rated window frame

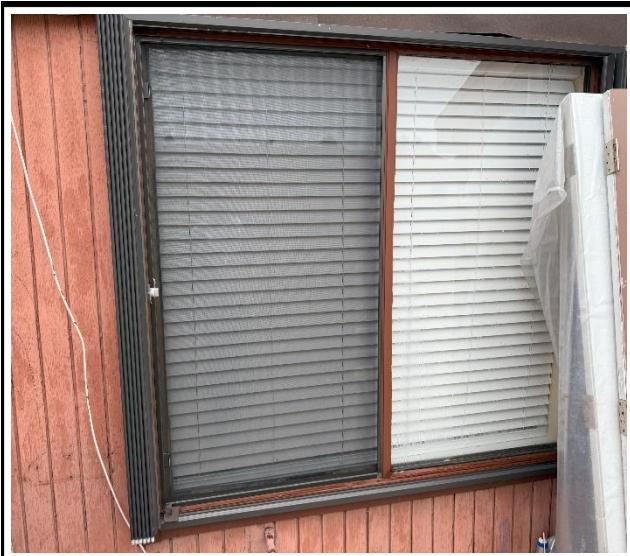
The windows are approximately 40 years old and show typical signs of aging, including potential air and water leakage, degraded seals, reduced energy efficiency, and possible corrosion and/or frame deterioration.

Photo 1 : Existing non-impact-rated window frame

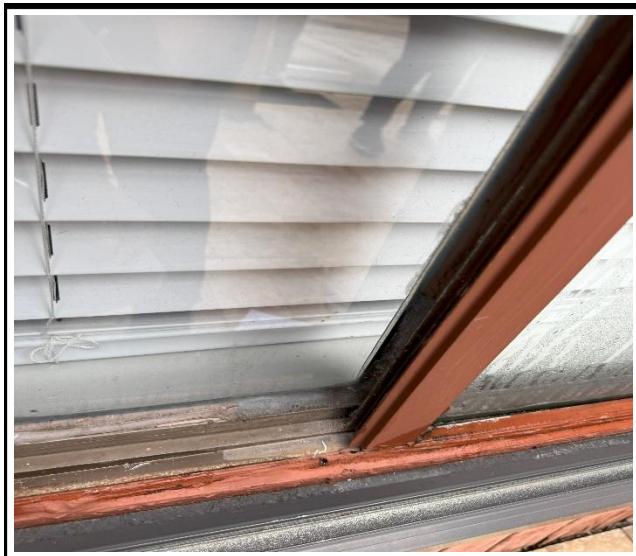
Photo 2 : Existing non-impact-rated window frame

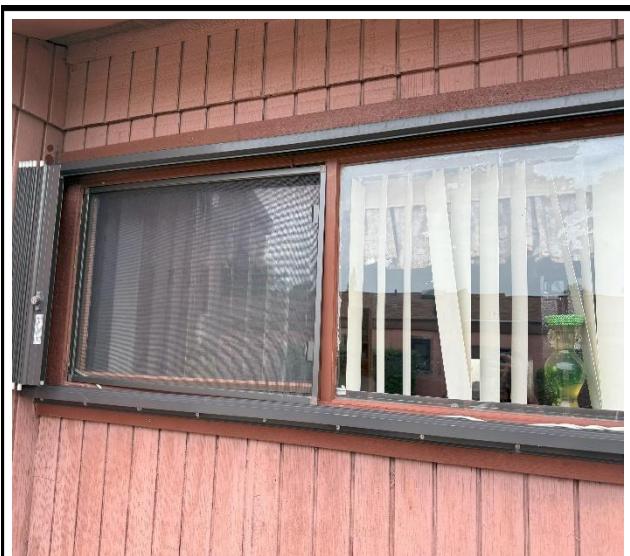
Photo 3 : Existing non-impact-rated window frame

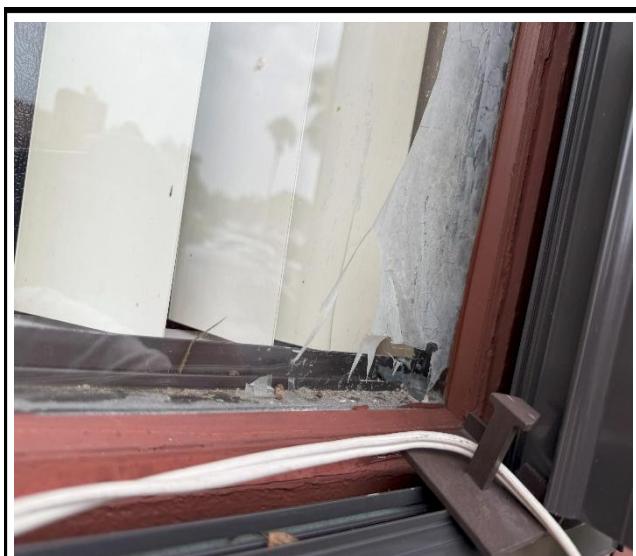
Photo 4 : Existing non-impact-rated window frame

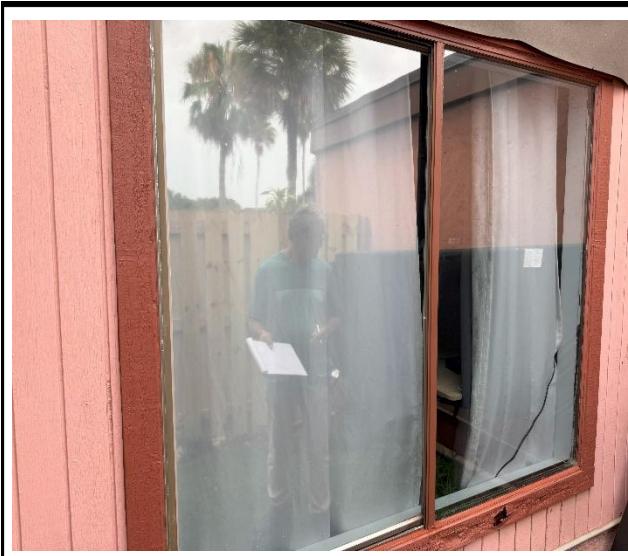
The windows are approximately 40 years old and show typical signs of aging, including potential air and water leakage, degraded seals, reduced energy efficiency, and possible corrosion and/or frame deterioration.

Photo 1 : Existing non-impact-rated window frame

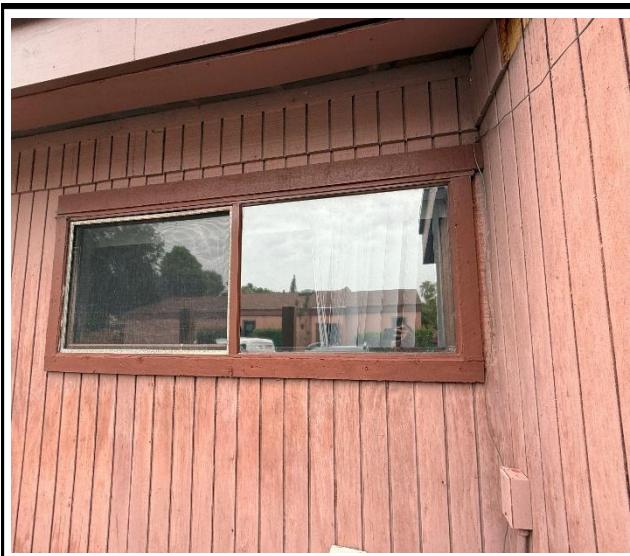
Photo 2 : Existing non-impact-rated window frame

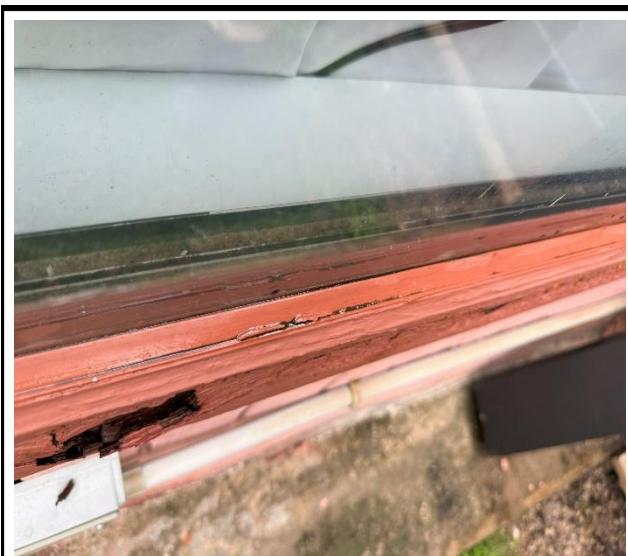
Photo 3 : Existing non-impact-rated window frame

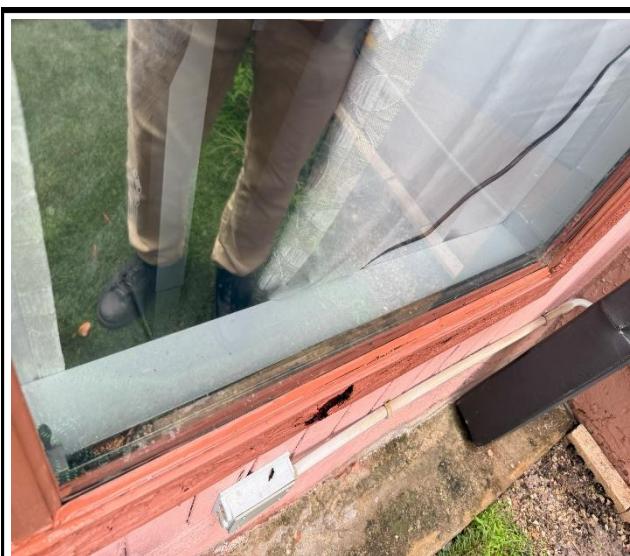
Photo 4 : Existing non-impact-rated window frame

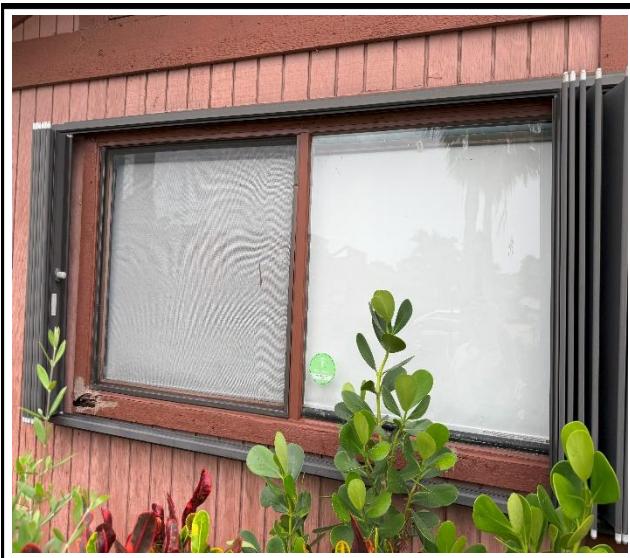
The windows are approximately 40 years old and show typical signs of aging, including potential air and water leakage, degraded seals, reduced energy efficiency, and possible corrosion and/or frame deterioration.

Photo 1 : Existing non-impact-rated window frame

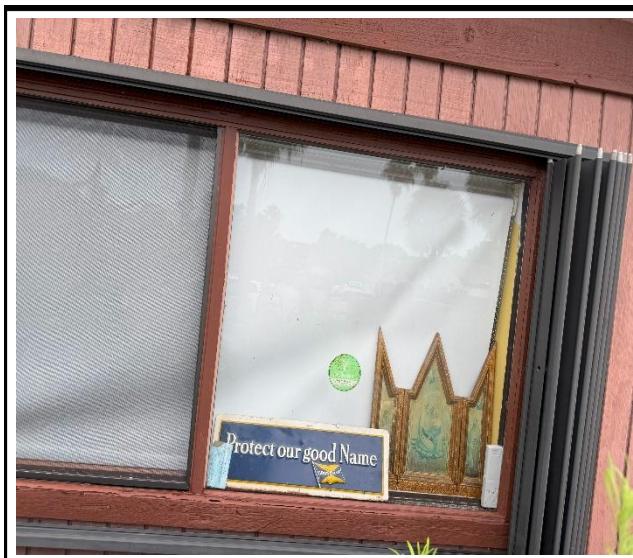
Photo 2 : Existing non-impact-rated window frame

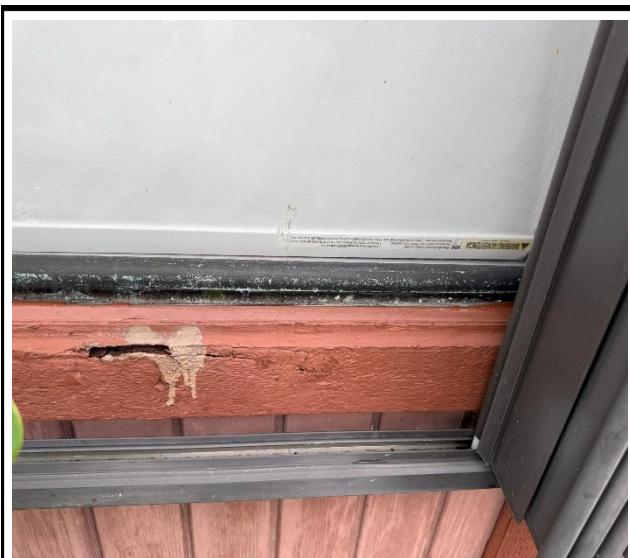
Photo 3 : Existing non-impact-rated window frame

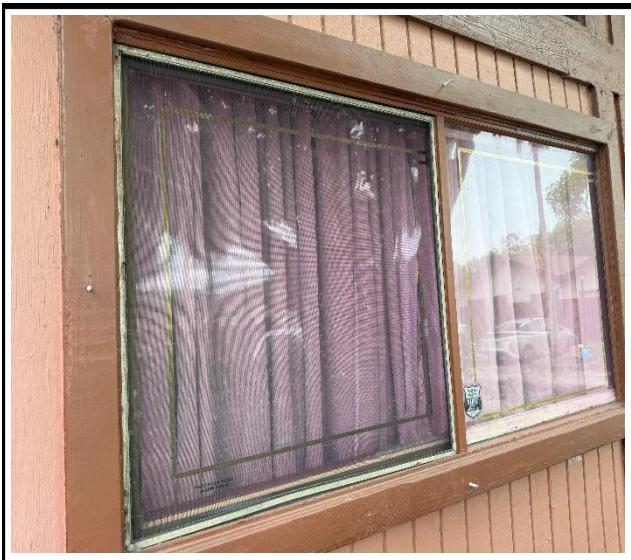
The windows are approximately 40 years old and show typical signs of aging, including potential air and water leakage, degraded seals, reduced energy efficiency, and possible corrosion and/or frame deterioration.

Photo 1 : Existing non-impact-rated window frame

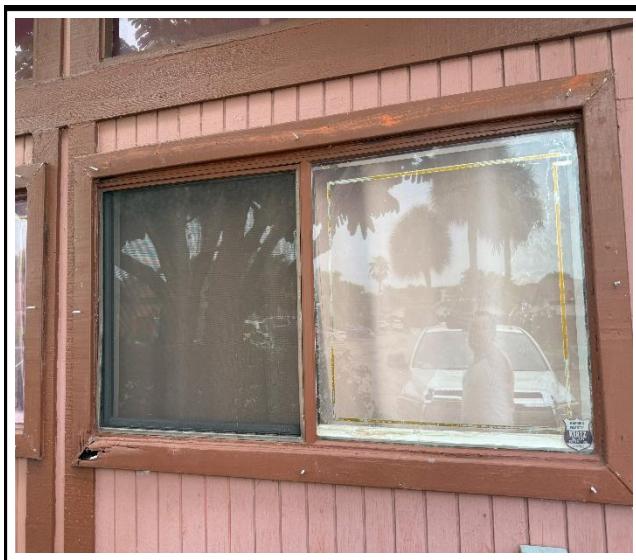
Photo 2 : Existing non-impact-rated window frame
