Omega Villas Condominium Association

1713 NW 72 Avenue,  
Plantation, FL 33313

**Windows Evaluation Report**  
**BLDGs 1 to 15**  
(07/23/2025)

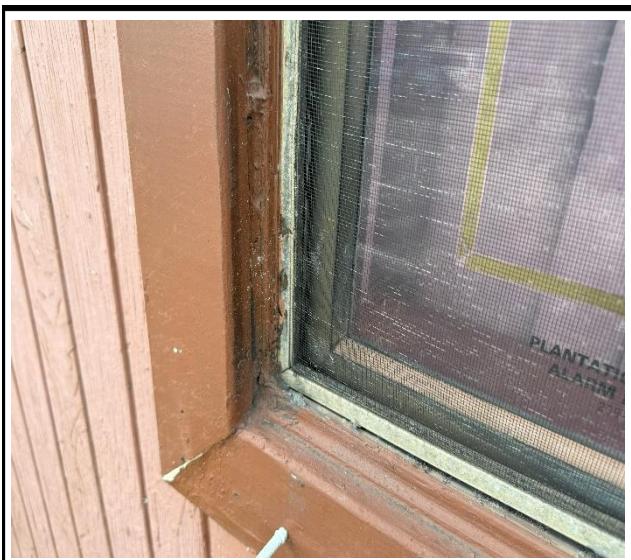
Photo 3 : Existing non-impact-rated window frame
